**Report 06-106, express freight Train 826, signalling irregularity, Cora Lynn,  
31 July 2006**

**Report 06-106**  
**express freight Train 826**  
**signalling irregularity**  
**Cora Lynn**  
**31 July 2006**

On Monday 31 July 2006 at about 2054, eastbound express freight Train 826 stopped at Cora Lynn Arrival Signal 10244 on the Midland Line. The arrival signal was displaying a green aspect, while at the same time the facing points were set in the reverse position and the “L” light was not illuminated.

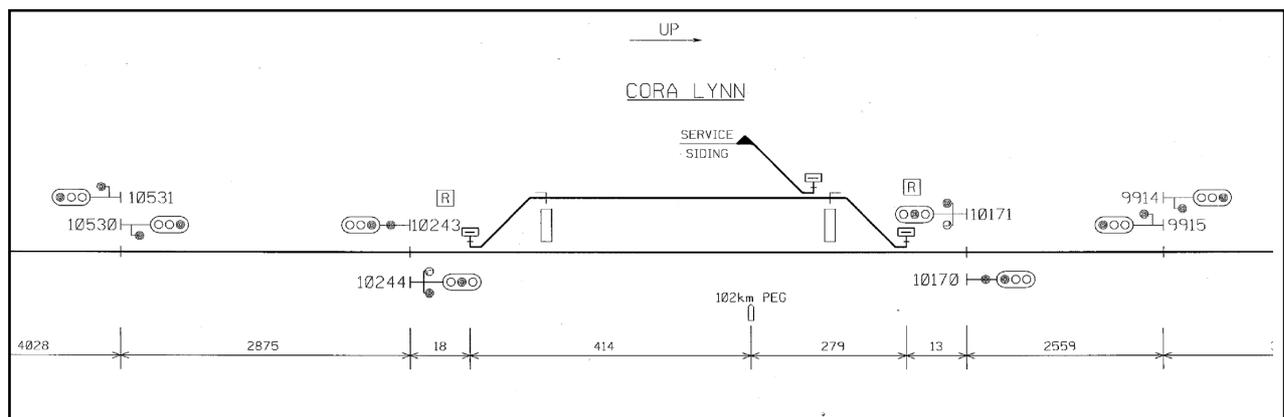
**Figure 1**  
**Signals and interlocking diagram for Cora Lynn**

- 1.1.8 The locomotive engineer stopped the train short of Arrival Signal 10244, which was displaying a green aspect and the associated "L" light was not illuminated. He alighted from the locomotive and confirmed that the west-end points were locked in the reverse position, then he contacted the train controller to advise him of the signalling irregularity.

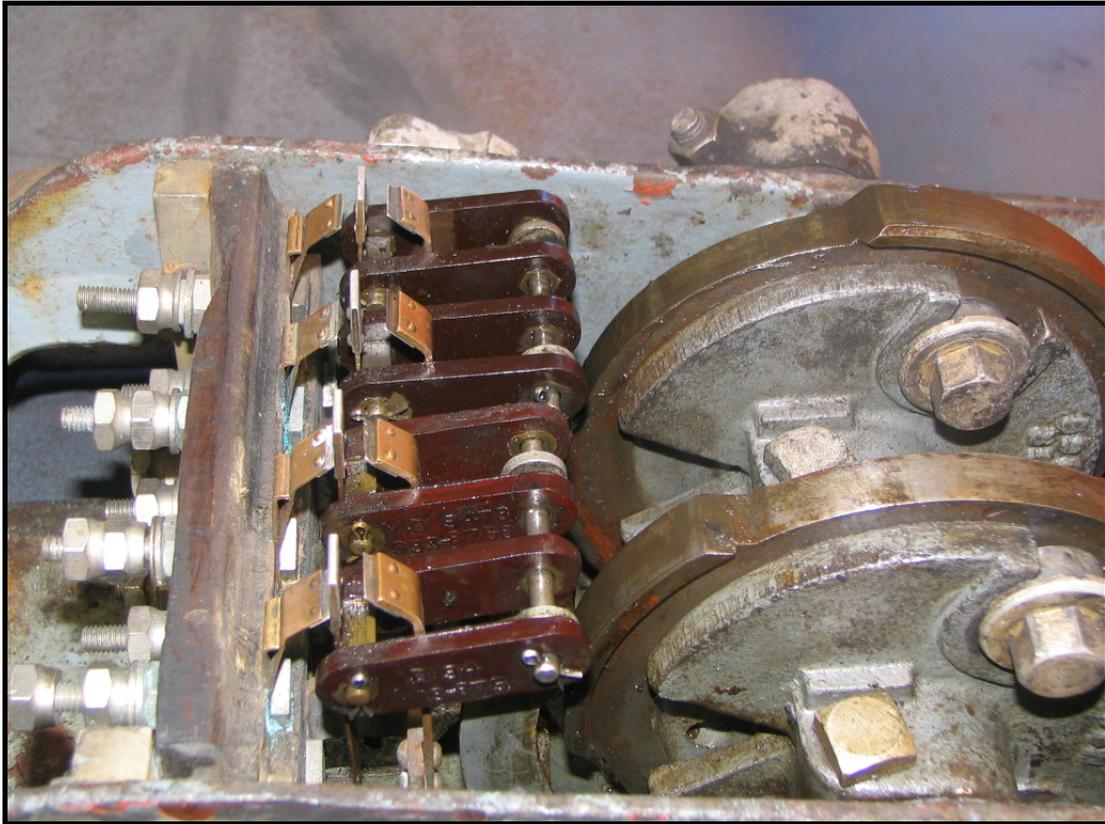
**Figure 2**  
**Universal switch controller contacts**

- 1.1.11 At about 2245, the incoming train controller was apprised of the situation at Cora Lynn during the handover.
- 1.1.12 The following morning, the signal maintainer examined the points but could not see any initial cause for the signalling irregularity. He tried, without success, to replicate the fault by repeatedly moving the points from the normal position to reverse and back again. With the points left in the reverse position, he examined the universal switch controller to find that the contacts for the "Normal" position opened only about one or 2 millimetres (mm) and that there was contaminated moisture on top of the contacts (see Figure 2).

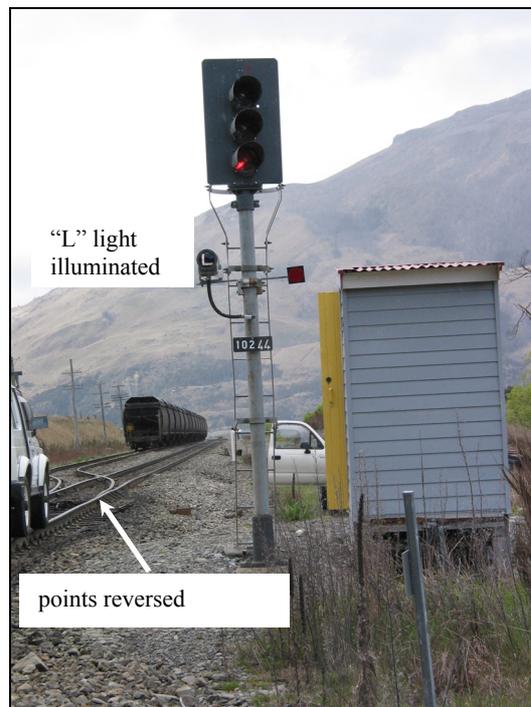
**Figure 5**  
**Arrival Signal 10244 at Cora Lynn with the “L” light illuminated**

1.3.8 Arrival signals were fitted with a short-range light, which showed an illuminated white letter “L” when the facing points were set for the loop (see Figure 5) and the points for any diverging lines off the loop were in the normal position. With the points set for the loop, the arrival signal controlling the entrance of a train into the station was at “stop”. The illuminated “L” light confirmed that the route was set for the loop, but not that the loop was unobstructed. A locomotive engineer on a train entering a loop was not required to stop at the arrival signal when the “L” light was illuminated, but was required to be satisfied that the route was clear before proceeding at a maximum speed of 25 km/h.

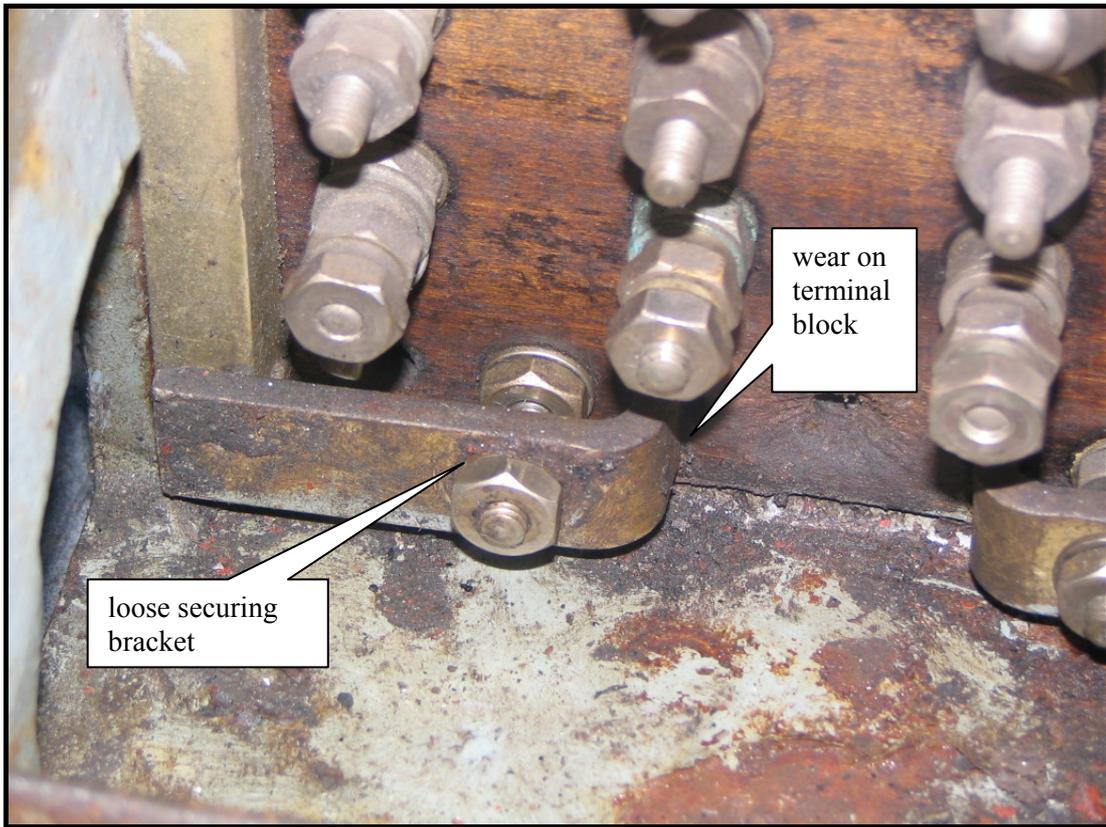
**Figure 7**  
**Failed universal switch controller**

- 1.7.1 The initial inspection of the failed universal switch controller confirmed the terminal block was not fastened securely to the cast-iron casing. The upper-left terminal mounting bolt was missing and the upper-right connection was loose. Similarly, the 2 lower securing brackets were also loose (see Figure 7). Although there was some minor pitting of the contacts, it was not sufficient to cause electrical continuity problems.
- 1.7.2 Because the available dimensional drawings did not show clearances, critical clearances on the failed unit were measured and compared with those of an overhauled unit. The cam follower clearances were measured initially as left-hand side (LHS) 4.6 mm, right-hand side (RHS) 3.7 mm. Once the securing bolts were tightened the clearances were re-measured as LHS 4.7 mm and RHS 3.8 mm.

- 2.14 The wrong-side failure at Signal 10244 resulted from excessive clearance between the cam and the cam followers, leading to the incomplete operation of the double throw switches. The excessive clearance allowed the moving contact on the normal cam to move and touch the fixed normal contact, even though the points had been changed from the normal position and were locked in the reverse position.

- 2.15 The excessive clearance that developed between the cam and cam followers was caused by the bolts securing the pivot brackets becoming loose in service and allowing the pivot brackets to fret against the terminal block. The extent of the wear on the terminal block suggested that the bracket had been loose for a considerable period of time. Because the 3-monthly testing regime did not require clearance measurements to be taken and recorded, the wear continued undetected. To reduce the risk of similar occurrences, Ontrack issued a Significant Information Notice on 1 July 2007 that required extra checks on all single-arm and split-cam detectors every 3 months (see “Safety Actions”).

- 2.16 Immediately following this incident, Ontrack issued an instruction to inspect all similar Westinghouse universal switch controllers. All terminal mounting bolts were checked for tightness and that the bottom bolts were double-nutted for security, so no safety recommendation was necessary.

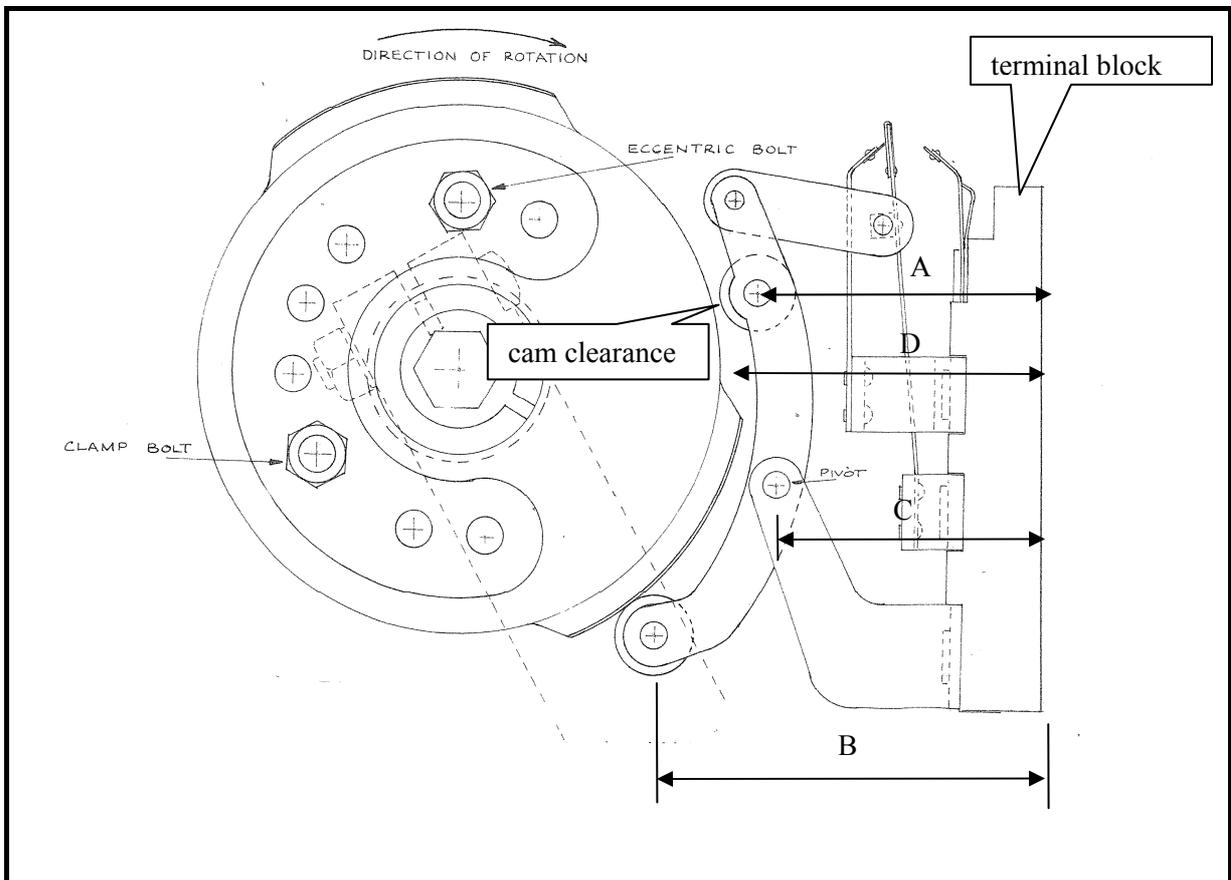
**Figure 8**  
**Location of critical dimensions**

1.7.3 Critical dimensions, as indicated in Figure 8, were measured on the failed unit. In order to demonstrate that the increase in clearance between the cam followers and the cams was, in most part, due to the wear in the terminal block and not the result of other causes, the worn area in the terminal block was restored with epoxy filler then the unit was reassembled and re-measured. These new dimensions were then compared with those of a fully overhauled and correctly adjusted unit. All dimensions in the table below are in mm.

Cam Clearance		A		B		C		D	
	LHS	RHS	LHS	RHS	LHS	RHS	LHS	RHS	LHS	RHS
Failed unit	4.71	3.81	70.4	69.59	101.37	100.46	67.46	67.19	87.03	87.03
Failed unit after repair	2.45	1.16	76.54	77.35	108.58	110.97	73.56	75.32	87.03	87.03
Overhauled unit	0.5	0.21	72.48	72.5	104.76	105.05	69.67	70.1	86.51	86.55
