**Report 06-110, passenger Train 4045, uncontrolled movement, between Britomart station and Quay Park junction, 9 October 2006**

**Report 06-110**  
**passenger Train 4045**  
**uncontrolled movement**  
**between Britomart station and Quay Park junction**  
**9 October 2006**

On Monday 9 October 2006 at 0806, passenger Train 4045 travelled 526 metres between Britomart station and Quay Park junction with the locomotive engineer not at the controls of the train. The locomotive engineer had left the train to operate a valve to restore air-brake pressure following an uninitiated emergency brake application. Once air-brake pressure had been restored, the train began to move before the locomotive engineer re-boarded the train.

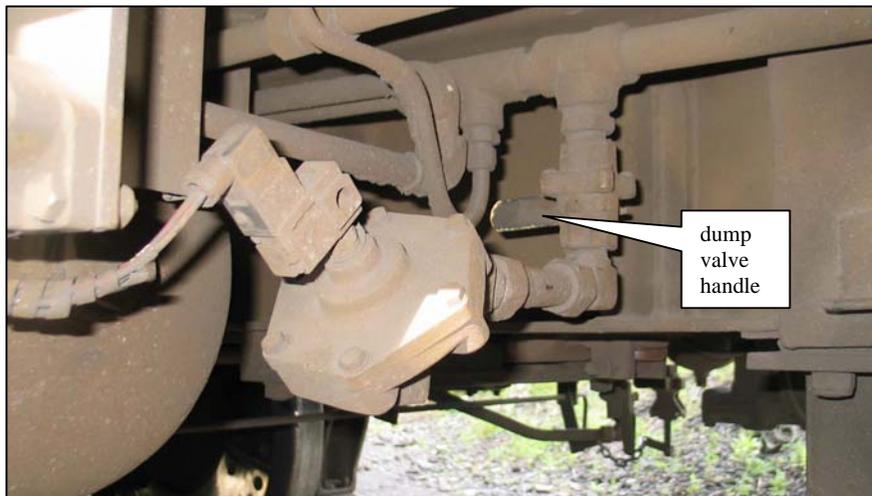
**Figure 1**  
**Dump valve**

- 1.1.4 The locomotive engineer then isolated<sup>3</sup> the master controller, left his cab and walked to an emergency brake valve isolating cock (dump valve) located under the non-driving end of ADC860 (see Figure 1). He isolated and restored the valve, and the brake pipe air pressure restored to normal. He returned to his driving position and radioed details of the fault to staff in Britomart station, where it was recorded in Veolia's fleet management protocol (FMP) system. He also wrote up details of the fault in the Toll NZ Consolidated Limited (Toll Rail) 54D book.

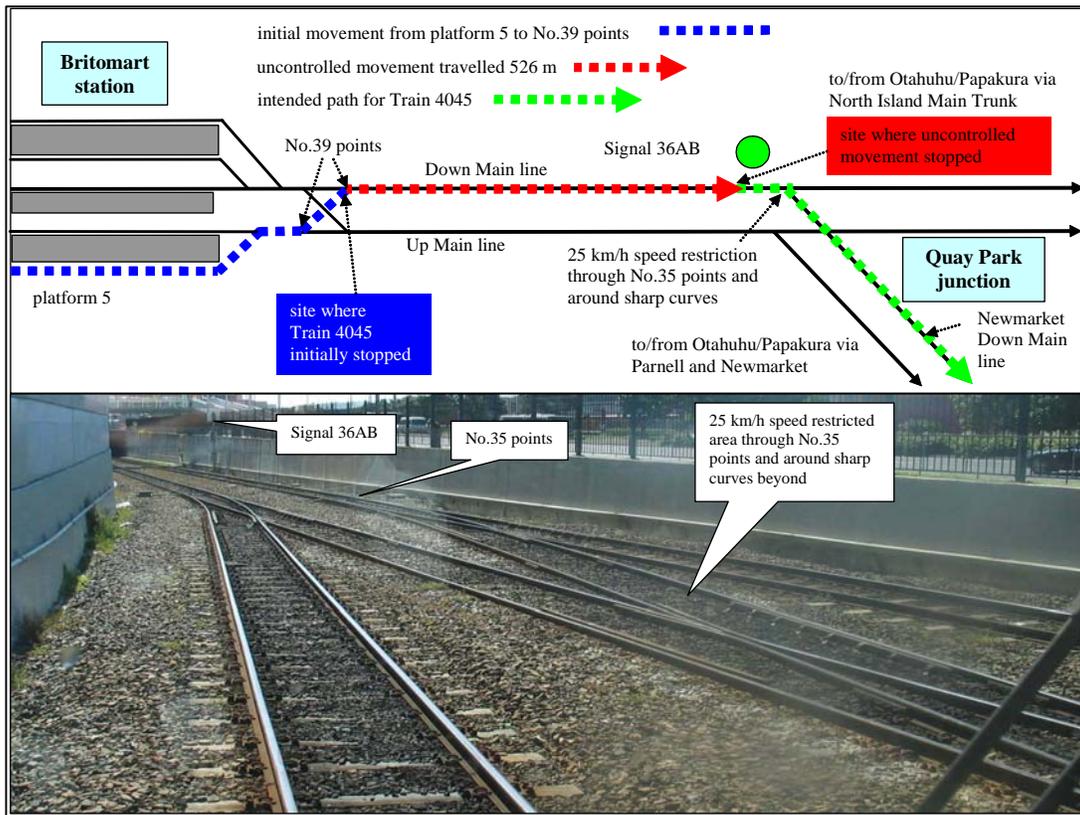
**Figure 2**

**Schematic plot of Train 4045 movements (not to scale); and below, Quay Park junction**

- 1.1.10 After about one minute, the air brakes automatically applied, bringing the train to a stop. The set had travelled 526 m in that time, stopping 68 m in front of Signal 36AB and about 100 m before the entry to the curved road of No.35 points.

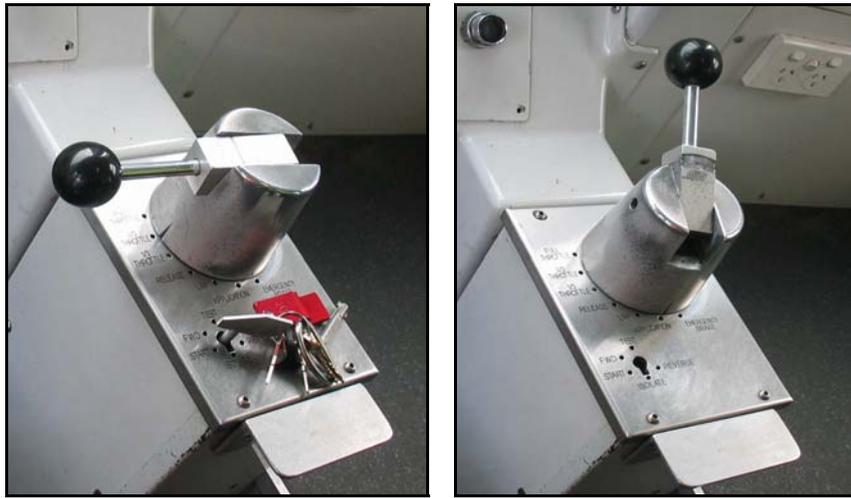
**Figure 3**  
**The master controller handle in the throttle 2 setting left;**  
**and right, in the application position with the reverser key removed**

- 1.1.14 On arrival at the train, the supervisor marked the ground where the set was standing and boarded the front cab. The supervisor saw the master controller handle was in the throttle 2 position and also noted the electro-pneumatic (EP) brake was fully applied, the brake cylinder pressure registering 300 kilopascals (kPa) on ADL810 and 240 kPa on ADC860, and the emergency brake was fully applied.
- 1.1.15 The supervisor drove the set back to Britomart station, where it was taken out of service.

- 1.6.7 To start Train 4045 from the platform at Britomart, the locomotive engineer motioned the control handle from the application position to the throttle 1 position. As the DMU neared No.39 points, the locomotive engineer returned the control handle to the release position to slow the DMU and advancing the control handle to the throttle 1 position once through the points, but could not recall complying with the 25 km/h speed restriction through the points. The locomotive engineer recalled advancing it to the throttle 2 position (where it was later found) for the climb to Quay Park junction.

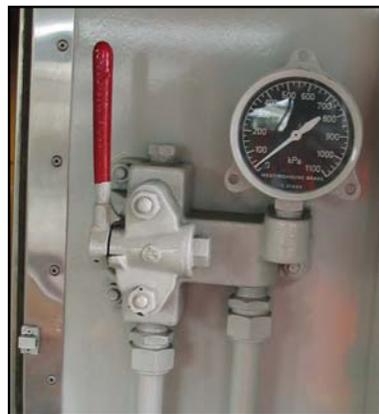
**Figure 4**  
**Emergency brake handle on back wall of both cabs**

- 1.1.12 The train manager returned to the front cab then back to the rear cab again, looking for the locomotive engineer. He posted a passenger operator to each cab position. The train manager then received a telephone call requesting him to telephone the locomotive engineer, which he did. The locomotive engineer instructed the train manager to apply the emergency brake in the cab he was in, which he did (see Figure 4).

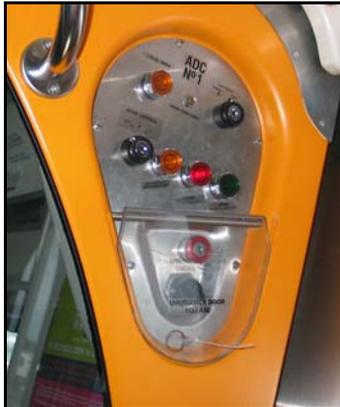
**Figure 6**  
**Passenger emergency stop button**

- emergency stop buttons were located at each of the 4 bi-parting doors in the ADL car and the ADC car. The operation of any one of the 8 push-buttons, which were self-locking when pressed, would apply full braking effort by dumping air from the brake pipe. Once the push-button was locked in, it could only be released by using the train manager's key (see Figure 6)

- 3.3 The intermittent fault that caused the uninitiated emergency brake applications was most likely an electrical fault on one of the passenger emergency stop button mechanisms located in ADL810.
