RAILWAY OCCURRENCE REPORT

06-112

Report 06-112, loss of airbrakes and collision, Tram 244,
Christchurch

November 2006

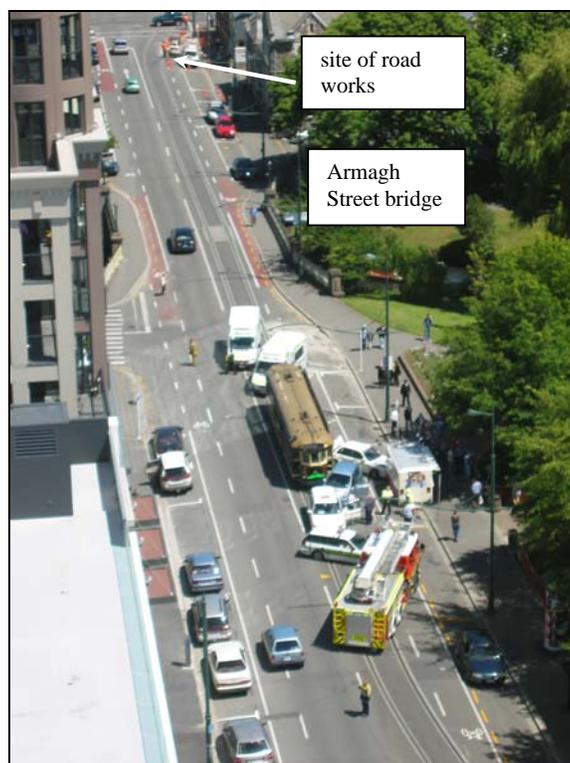
Figure 1
Position of the vehicles after the collision (courtesy Christchurch Tramway)

- 1.1.5 The point of impact was about 95 m past the worksite. The impact of the collision propelled the rear car forward in a nose-to-tail collision with 2 cars in front of it. The tram sustained minor damage and the 3 cars were extensively damaged. There were no injuries.

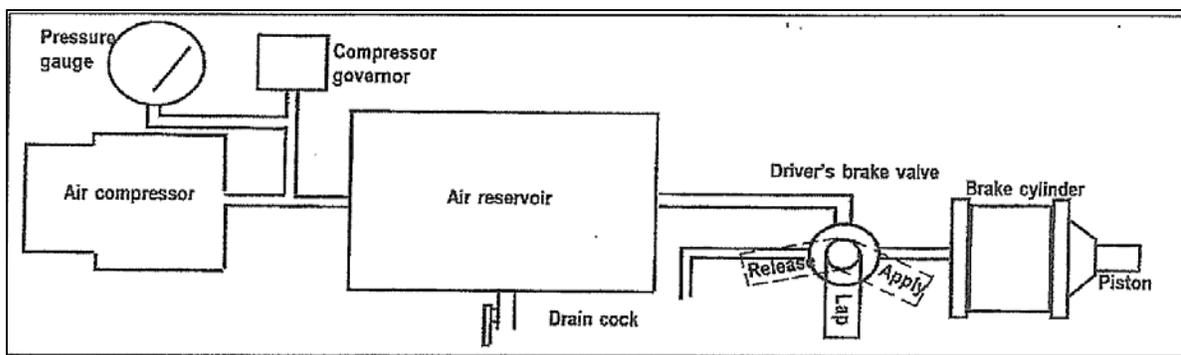
Figure 3
Schematic diagram of the air brake system on Tram 244 (not to scale)

- 1.3.1 The air brake used compressed air from a reservoir that was charged by an electrically powered compressor. The compressor was controlled by a governor,⁴ which switched off the compressor when the reservoir reached its maximum prescribed pressure of 73 pounds per square inch (psi) (496 kilopascals (kPa)). The compressor switched on again when the reservoir pressure fell to 55 psi (379 kPa).

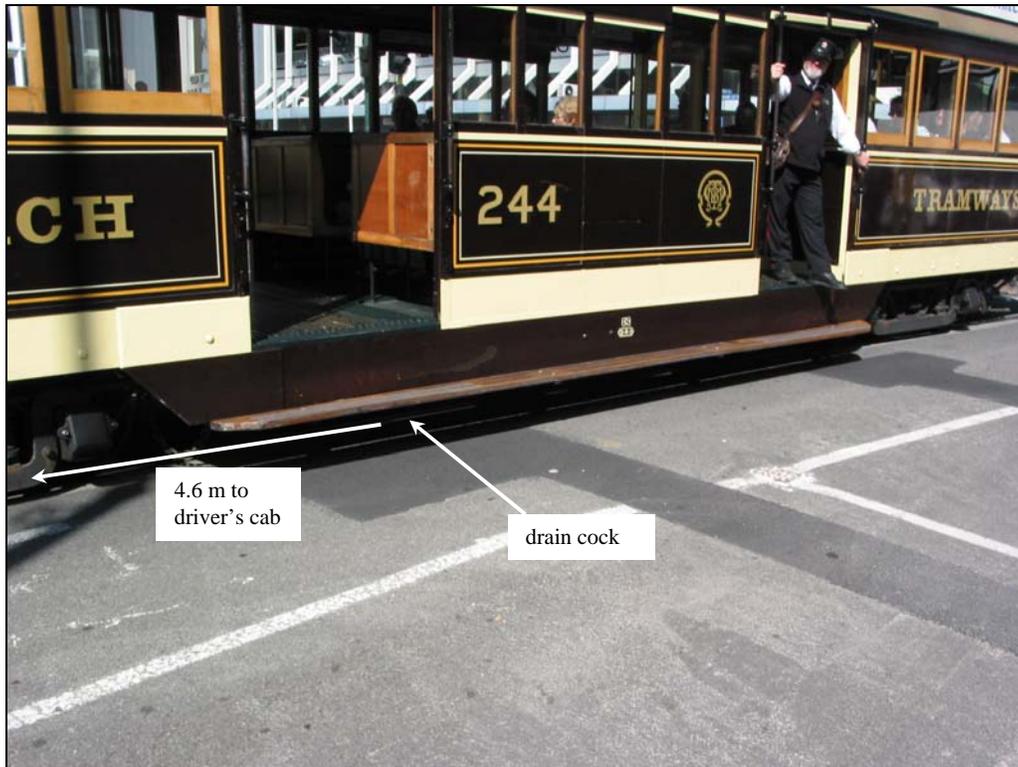
Figure 6
Location of drain cock from outside tram

- 1.3.3 A drain cock⁶ was attached to the air reservoir. The cock was at right angles to the side of the tram, 200 mm in from the outside edge of the running board (see Figure 5). There was an 85 mm clearance between the drain cock and the ground. The drain cock was located 1 m from the start of the running board and was 4.6 m behind the tram driver's cab (see Figure 6).

- 2.1 The tram lost air pressure in the brake system because of the design and positioning of the air reservoir drain cock. The drain cock was in such a position that if its tap was knocked by an obstacle under the tram, the cock would go to the open position and bleed the reservoir of air pressure, thereby removing the tram's braking ability. Because the tram was not equipped with an emergency air reservoir, there was no back-up air pressure for the braking system.

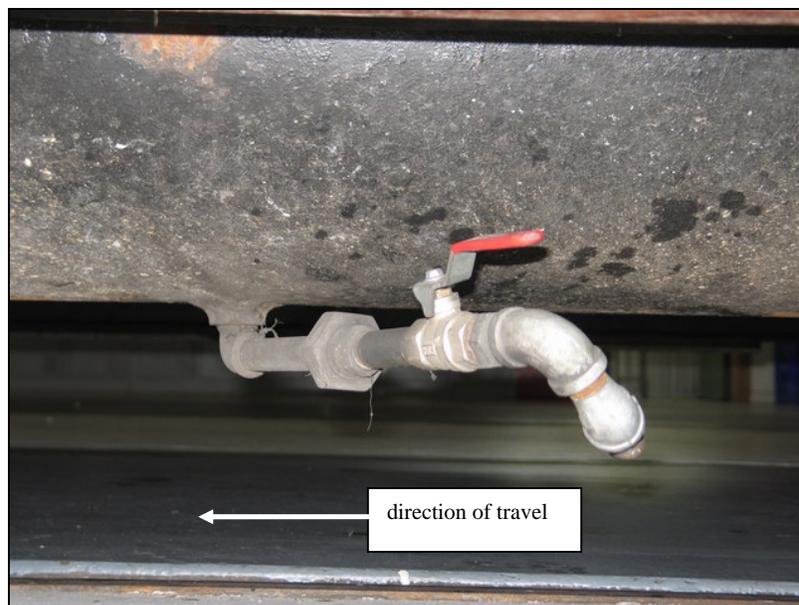
Figure 8
Drain cock on Tram 244 in the open position (courtesy Christchurch Tramway)

- 1.3.4 When the drain cock was open (see Figure 8), the air escaped from the reservoir through a half-inch (nominal 15 mm) diameter valve. The air escaped more quickly than the compressor could compensate for the leakage, with the result that the system ran out of air pressure and the tram had no air brakes. Tests carried out following the collision showed that with the drain cock open the air reservoir drained from 72 psi (496 kPa) to zero psi in 30 seconds.

- 2.6 The replacement of the original nominal 15 mm drain valve with a 6 mm drain valve meant that the compressor was able to compensate for the air loss and even rebuild the air pressure back up to normal while the valve remained open. Therefore, if for any reason the drain cock was accidentally opened and did not swing back to the closed position immediately, the compressor would ensure that sufficient air pressure was retained in the air reservoir so that the brakes could be operated. In view of this action taken, no safety recommendation covering this issue has been made.

- the nominal 15 mm drain cock valve on Tram 244 had been replaced with a 6 mm valve
- during testing of the 6 mm valve the air reservoir had been pumped up to full pressure of 72 psi (496 kPa). After the compressor cut out, the drain valve was opened and the pressure dropped to 55 psi (379 kPa) when the compressor cut back in. The drain valve was kept open while the compressor pumped back up to cut-out pressure again. This took about 60 seconds. Following the satisfactory results of the tests, the new drain valves had been fitted to all the trams in the fleet

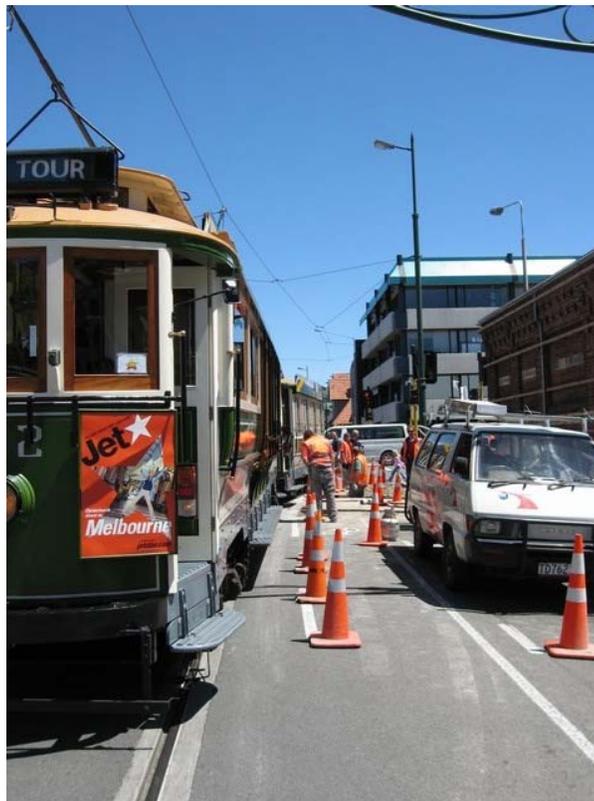
Figure 9
Worksite at the intersection of Armagh Street and Durham Street North

- 1.4.4 The road works near the intersection of Durham Street North and Armagh Street involved trenching work and installing cable ducting under the tram carriageway and pedestrian footpaths. The worksite had been protected by traffic warning cones (see Figure 9).

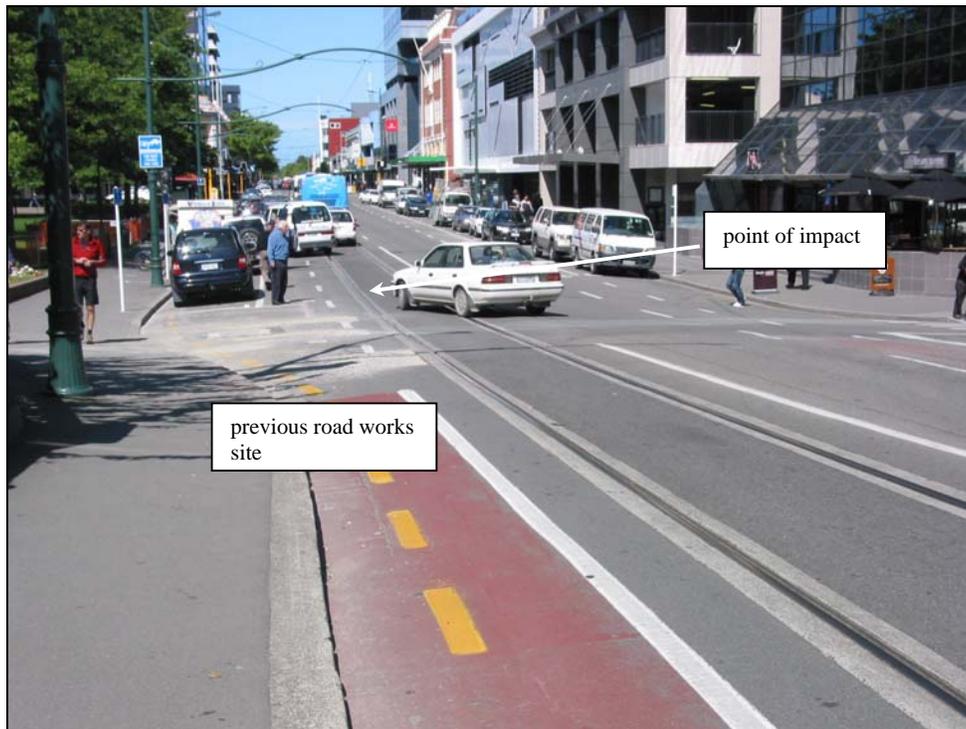
Figure 10
Point of impact

- 1.4.5 Road works had been continuing near the tram lines at several sites along Armagh Street during the morning. Figure 10 shows a previous worksite and the falling grade from Armagh Street bridge to the point of impact. The downhill grade was about 4 degrees and was 20 m long. There were no road works being carried out at this site at the time of the collision.

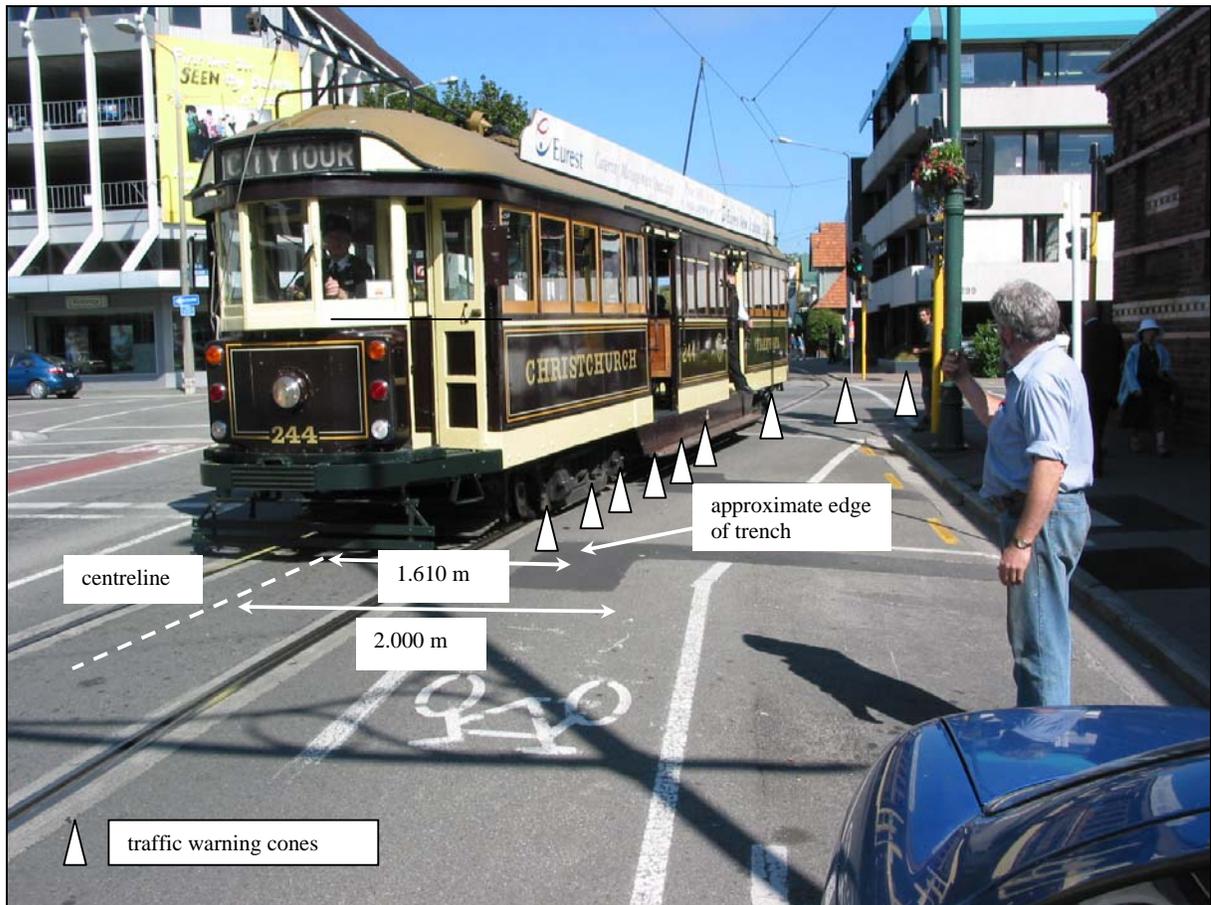
Figure 11
Tram 244 passing the worksite following completion of the work

- 1.4.6 Figure 11 shows Tram 244 passing the worksite after the work and resealing had been completed. The worksite consisted of 2 separate trenches from the duct adjacent to the tram line to the kerb. The first trench was 5 m from the intersection of Durham Street North and Armagh Street and the other about 6 m along Armagh Street.

- 1.4.7 The darker shade of grey shows the location of the trenches after resealing. The edge of the new seal was closer to the tram line than the edge of the trenches had been. At the closest point, the edge of the trench was 843 mm from the edge of the tram line (1.610 m from the centreline) (see Figure 11), which allowed for the traffic warning cones to be placed between the edge of the trench and the side of the tram. The cones were 944 mm high and extended 370 mm from the edge of the trench towards the tram line, at the base of the cone.

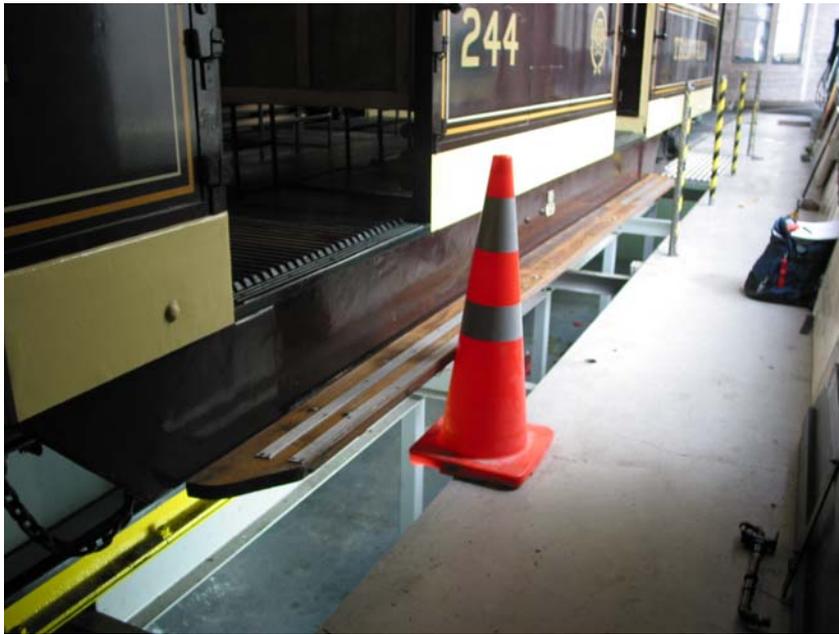
Figure 12
Traffic warning cone in the vertical position

- 1.5.1 A static post-incident examination of the position of the traffic warning cone against the running board of Tram 244 was undertaken at the tram depot. The measurement from the running board to the surface of the concrete walkway was confirmed as 300 mm, the same as at the worksite.
- 1.5.2 Figure 12 shows the traffic warning cone flush against the side of the running board, with the bevelled leading edge of the running board clearly visible.

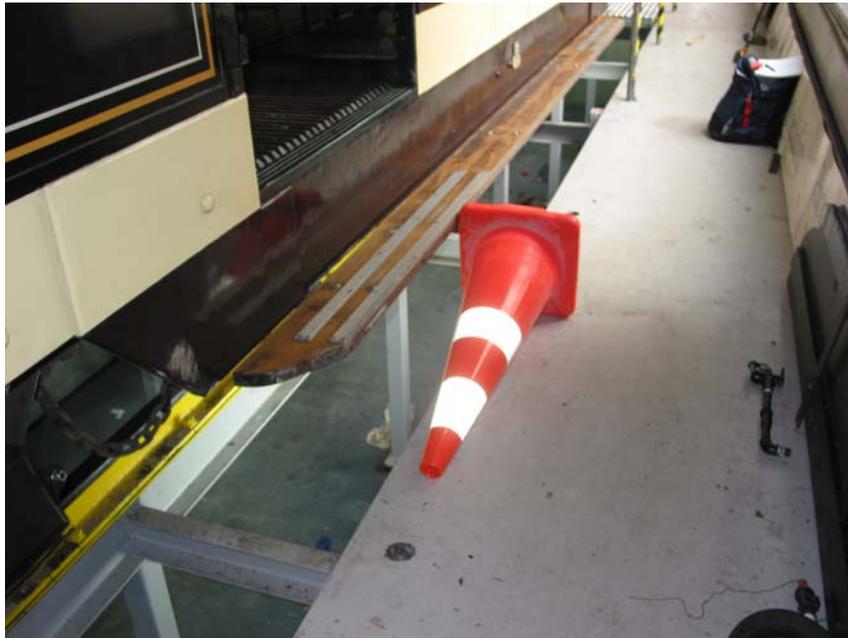
Figure 13
Traffic warning cone in the horizontal position

1.5.3 Figure 13 shows the traffic warning cone in the horizontal position alongside the running board.
