**Report 07-103, passenger express Train 200, collision with stationary passenger  
express Train 201, National Park, 21 March 2007**

### **Abstract**

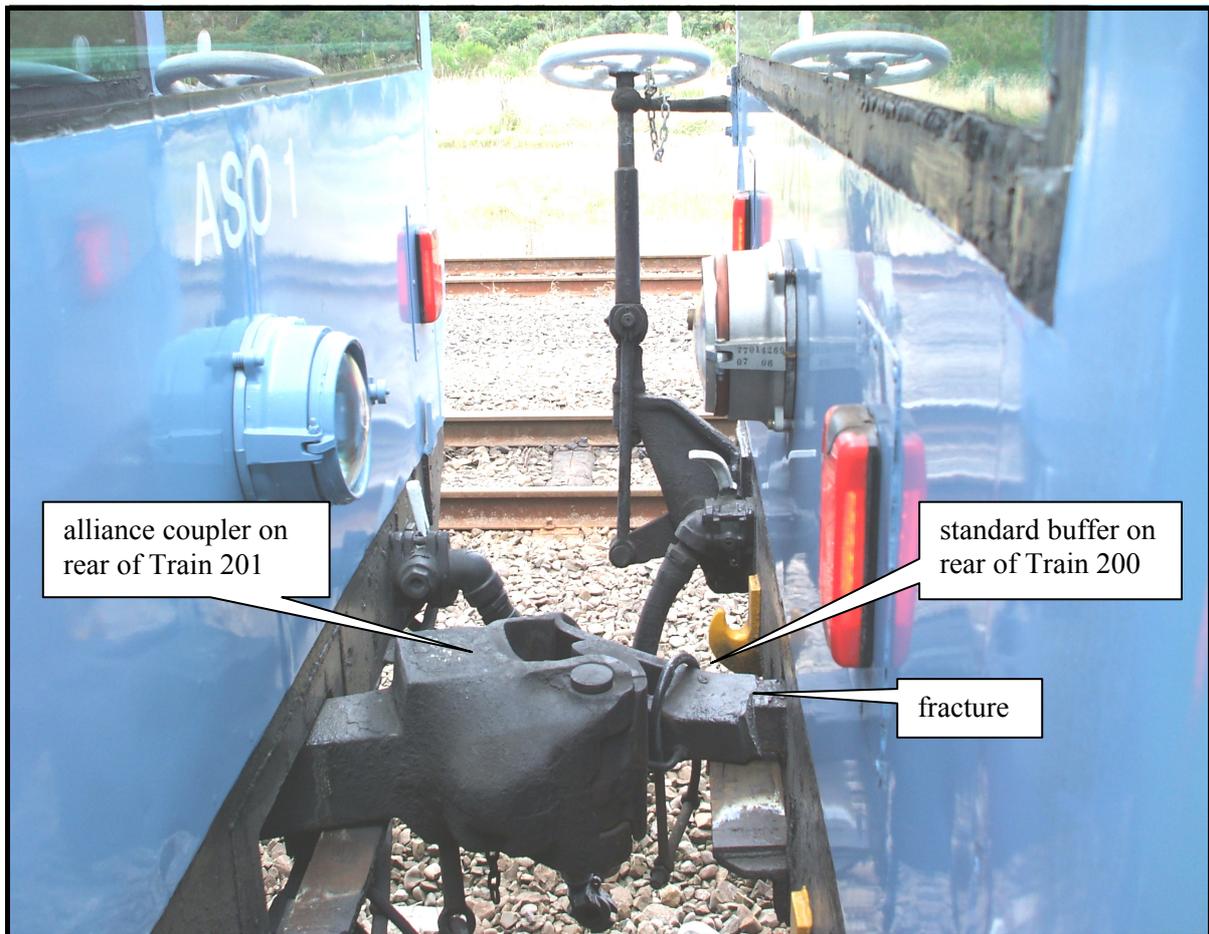
**Figure 4**  
**Impact damage to couplings (provided by Toll Rail)**

One passenger travelling in the rear passenger carriage on Train 200 received a minor injury. The buffer at the rear of the train was damaged.

- 1.1.17 On hearing the impact, the train attendant and locomotive engineer from Train 201 inspected the damaged couplings (see Figure 4) then went to the head of Train 200 to tell the locomotive engineer that there had been a collision. The locomotive engineer on board Train 200 radioed train control and reported the collision.
