Report 07-105: push/pull passenger train sets overrunning platforms, various stations within the Auckland suburban rail network, between 9 June 2006 and 10 April 2007

push/pull passenger train sets overrunning platforms

various stations within the Auckland suburban rail network

between 9 June 2006 and 10 April 2007

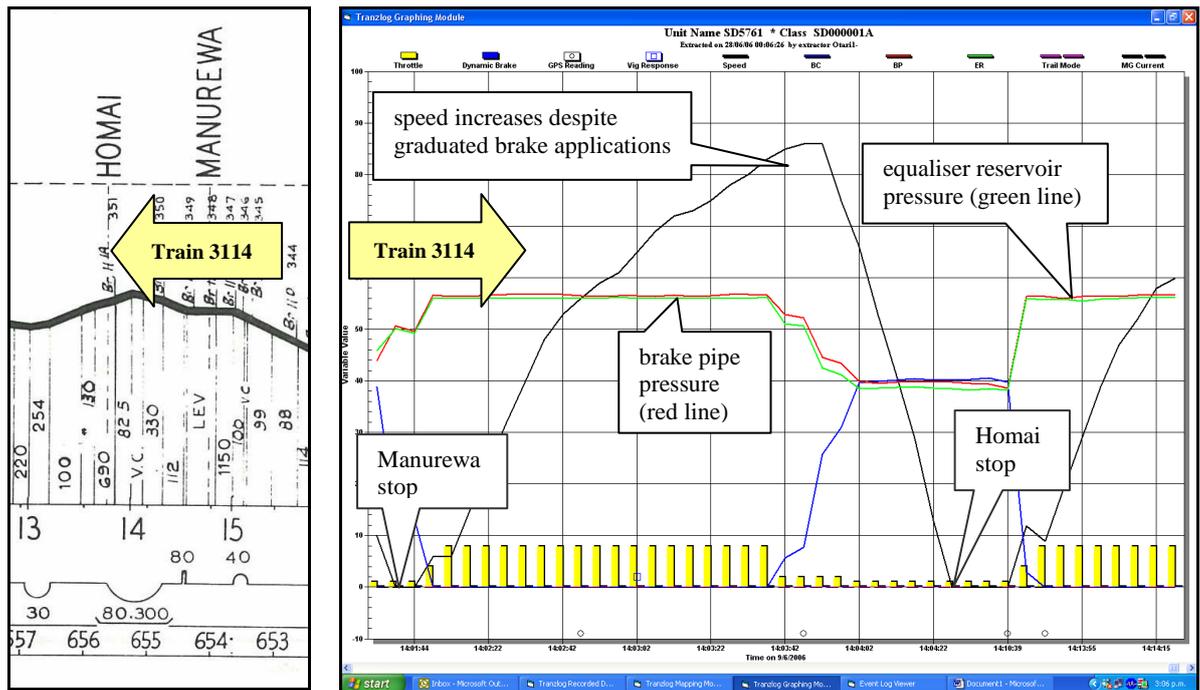
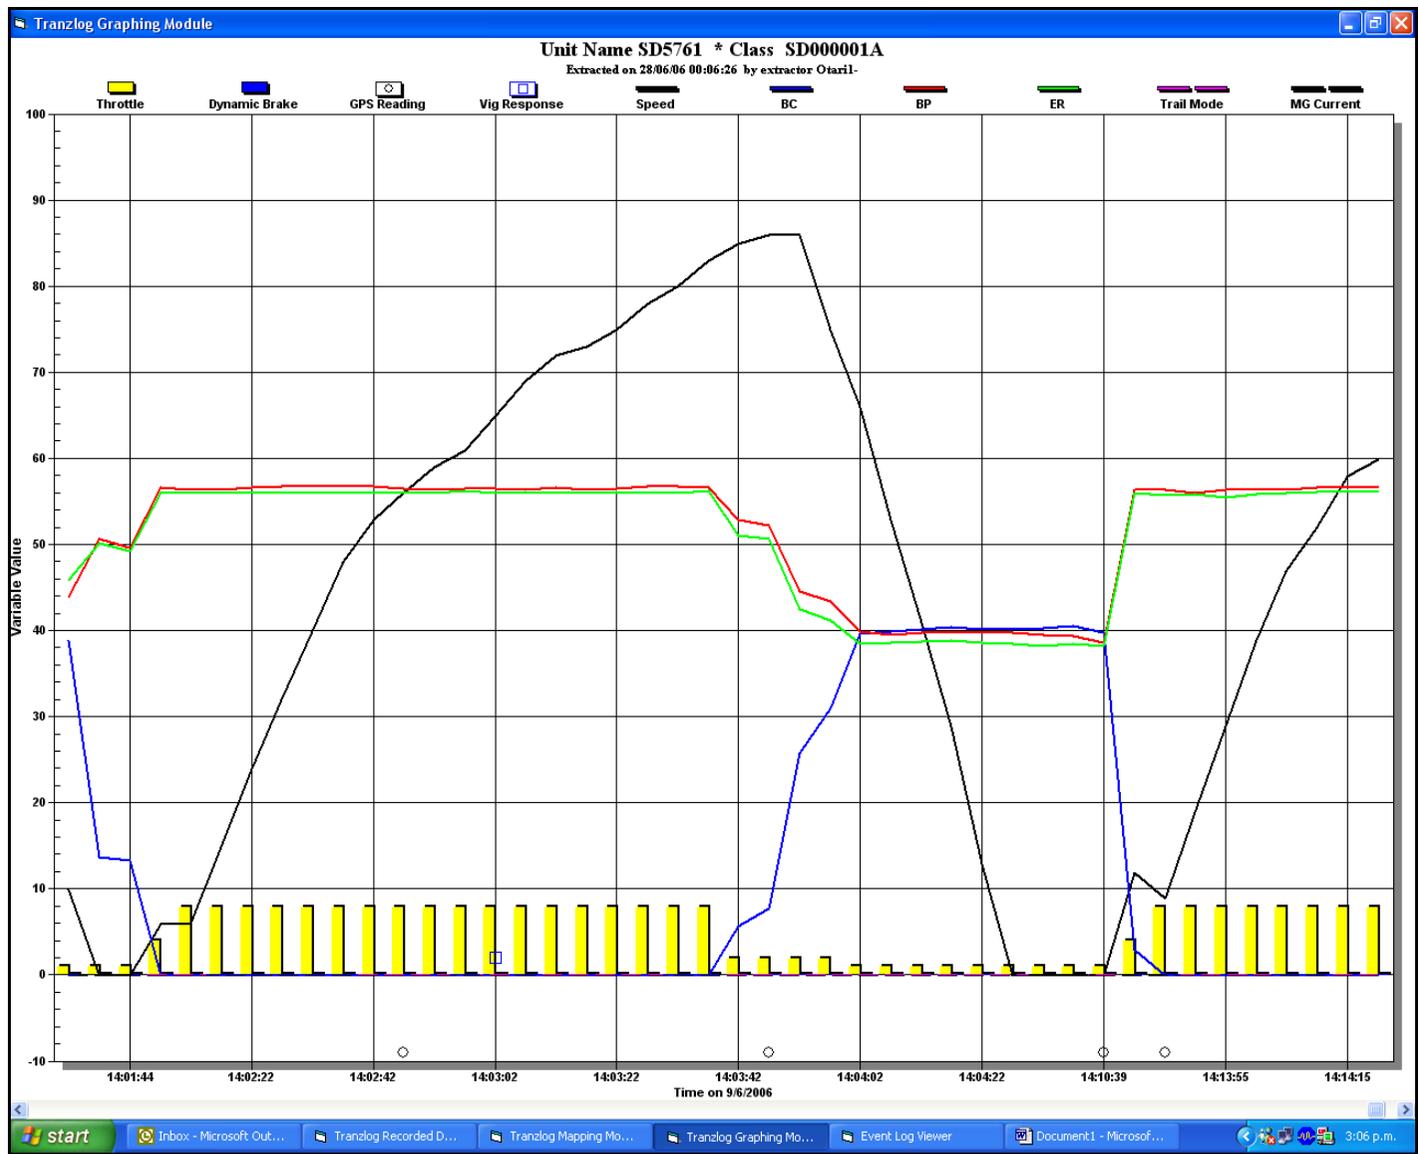
Figure 4
Homai station track alignment/gradient detail (left)
and (right) event recorder data from SD5761 (neither graph is to scale)
(refer appendix section 6.6 for a larger scale of the event recorder data)

Homai station had a 138 m long island platform. The Up main line through the station was contained within a 1111 m radius right-hand curve on the 1 in 690 descending gradient (see Figure 4).

- 1.2.10 On the same date (29 May 2006) another locomotive engineer had also reported poor brake performance on the same set when operating in the pull mode. The nature of the failure was described as “poor brakes on this train which required full service to bring the speed down at all, on approach to platforms”. Maintenance staff reported that adjustments had been made to the travel of brake pistons on DC4922 and some brake blocks on the SA/SD vehicles had been replaced where necessary.

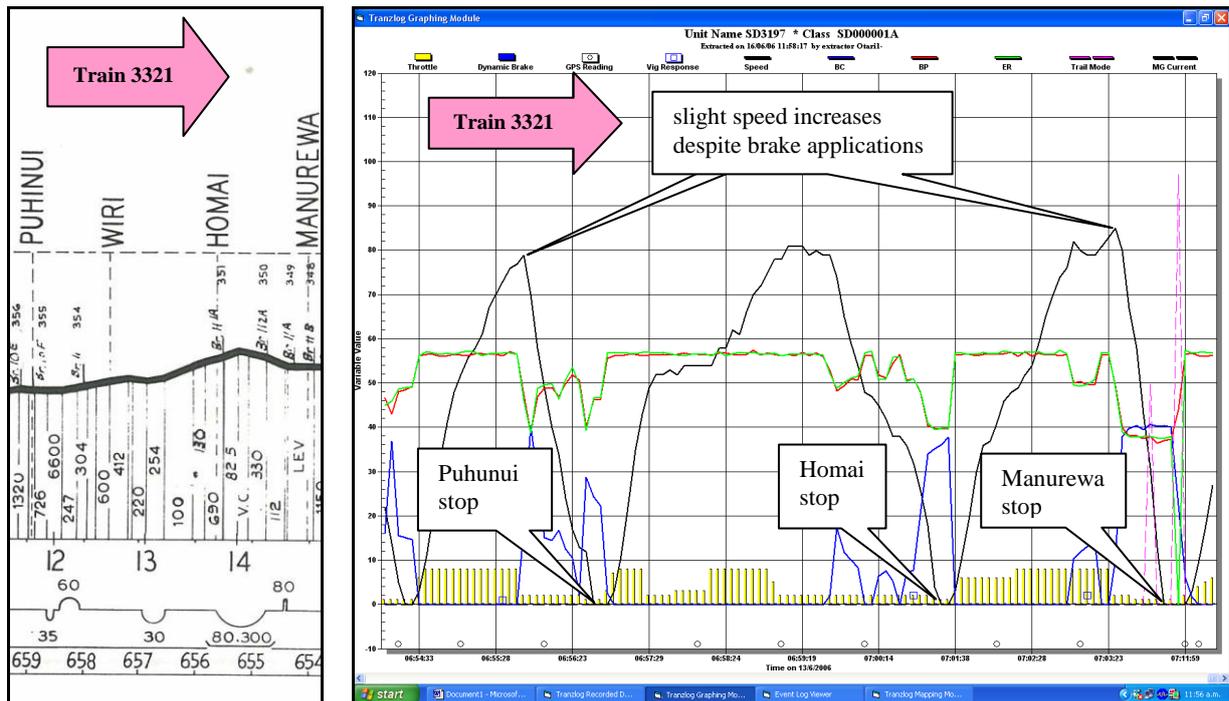
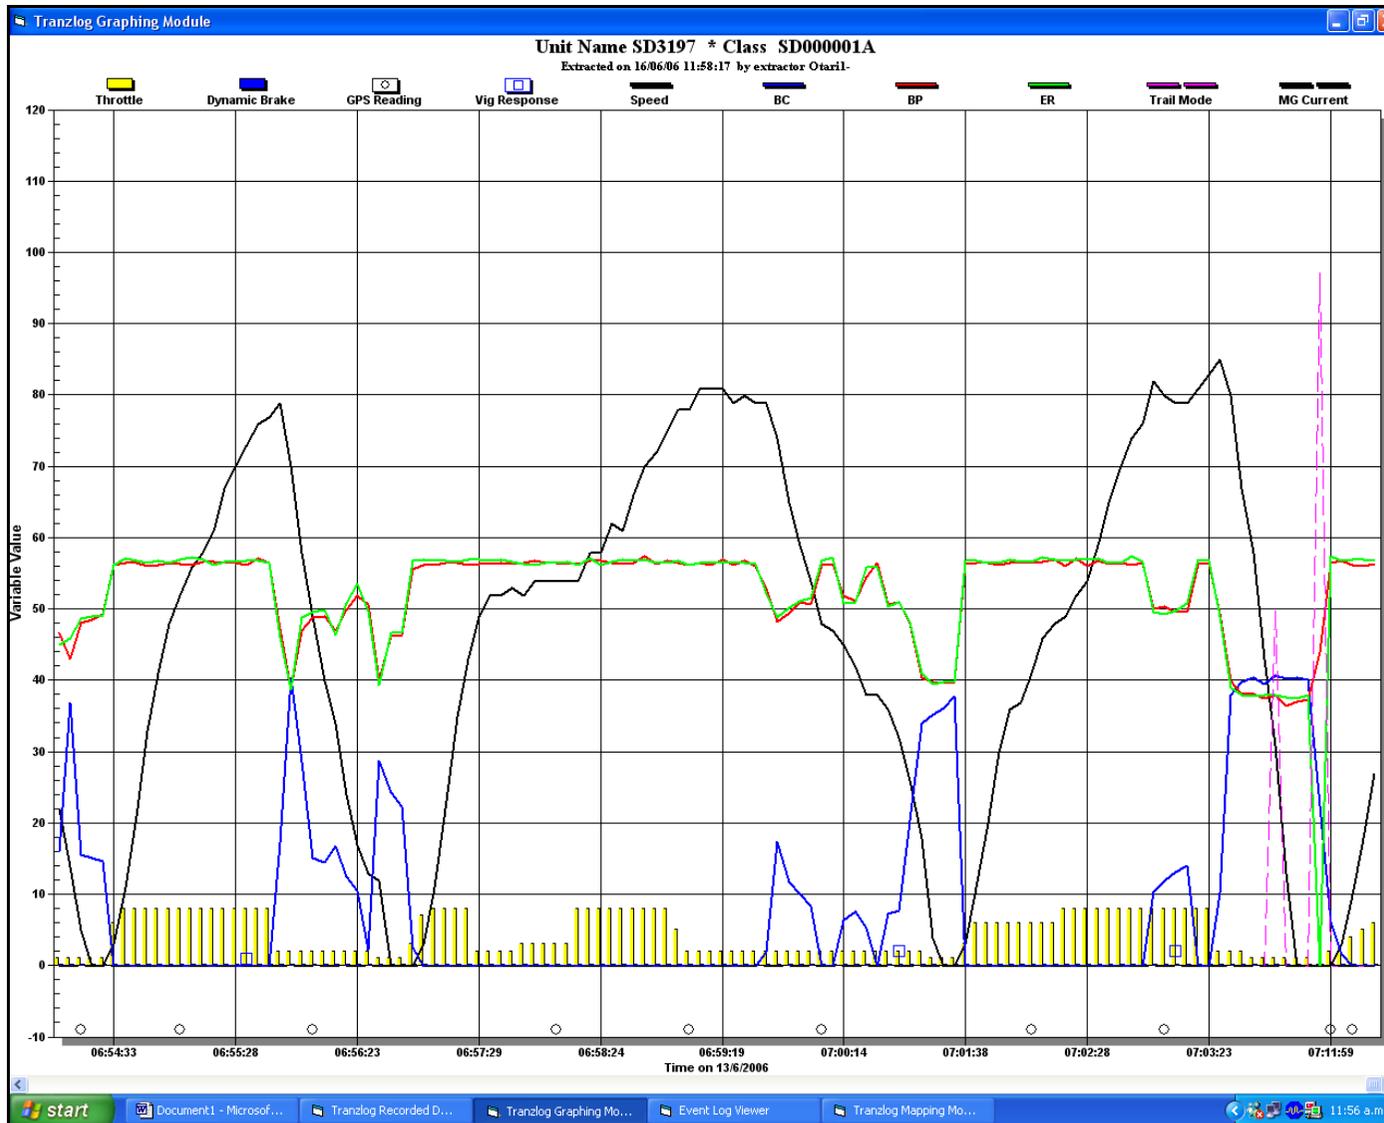
Figure 5
Manurewa station track alignment/gradient detail (left)
and (right) event recorder data from SD3197 (neither graph is to scale)
(refer appendix section 6.6 for a larger scale of the event recorder data)

1.3.2 Manurewa station had a 79 m long island platform. The Down main line through the station was contained within straight and level track (see Figure 5). Note: Wiri station was closed to passenger traffic.

1.3.4 The minder driver noticed that the train was travelling at about 80 km/h approaching Manurewa station in continuous heavy rain. The minder driver said that he had earlier discussed with the train locomotive engineer the need for him to adjust his braking technique when approaching platforms under such conditions.

1.3.7 Fifteen days previously on 29 May 2006, a locomotive engineer had reported that the brakes on SD3197 were operating less than optimally. TAMM depot staff reported that brake blocks on the locomotive had been replaced, the brake blocks on all passenger carriages had been inspected and adjustments made to the length of some of the brake cylinder piston travel.

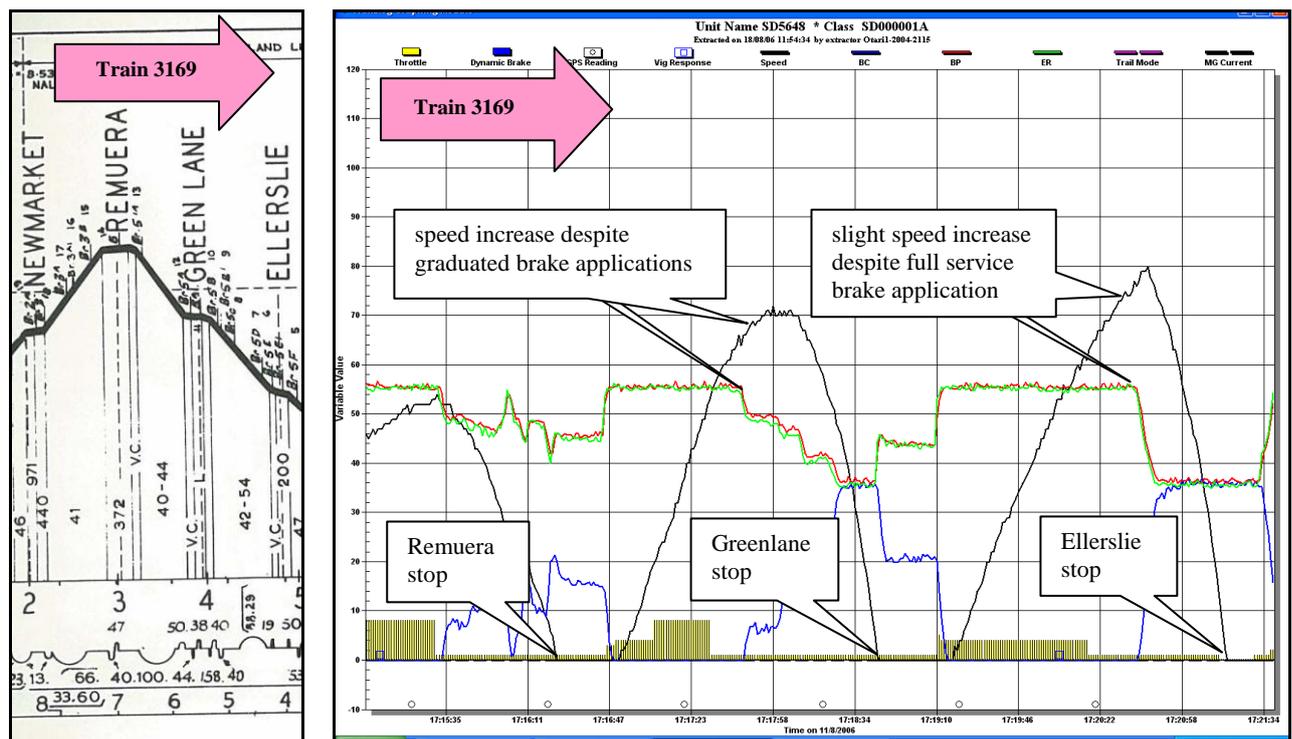
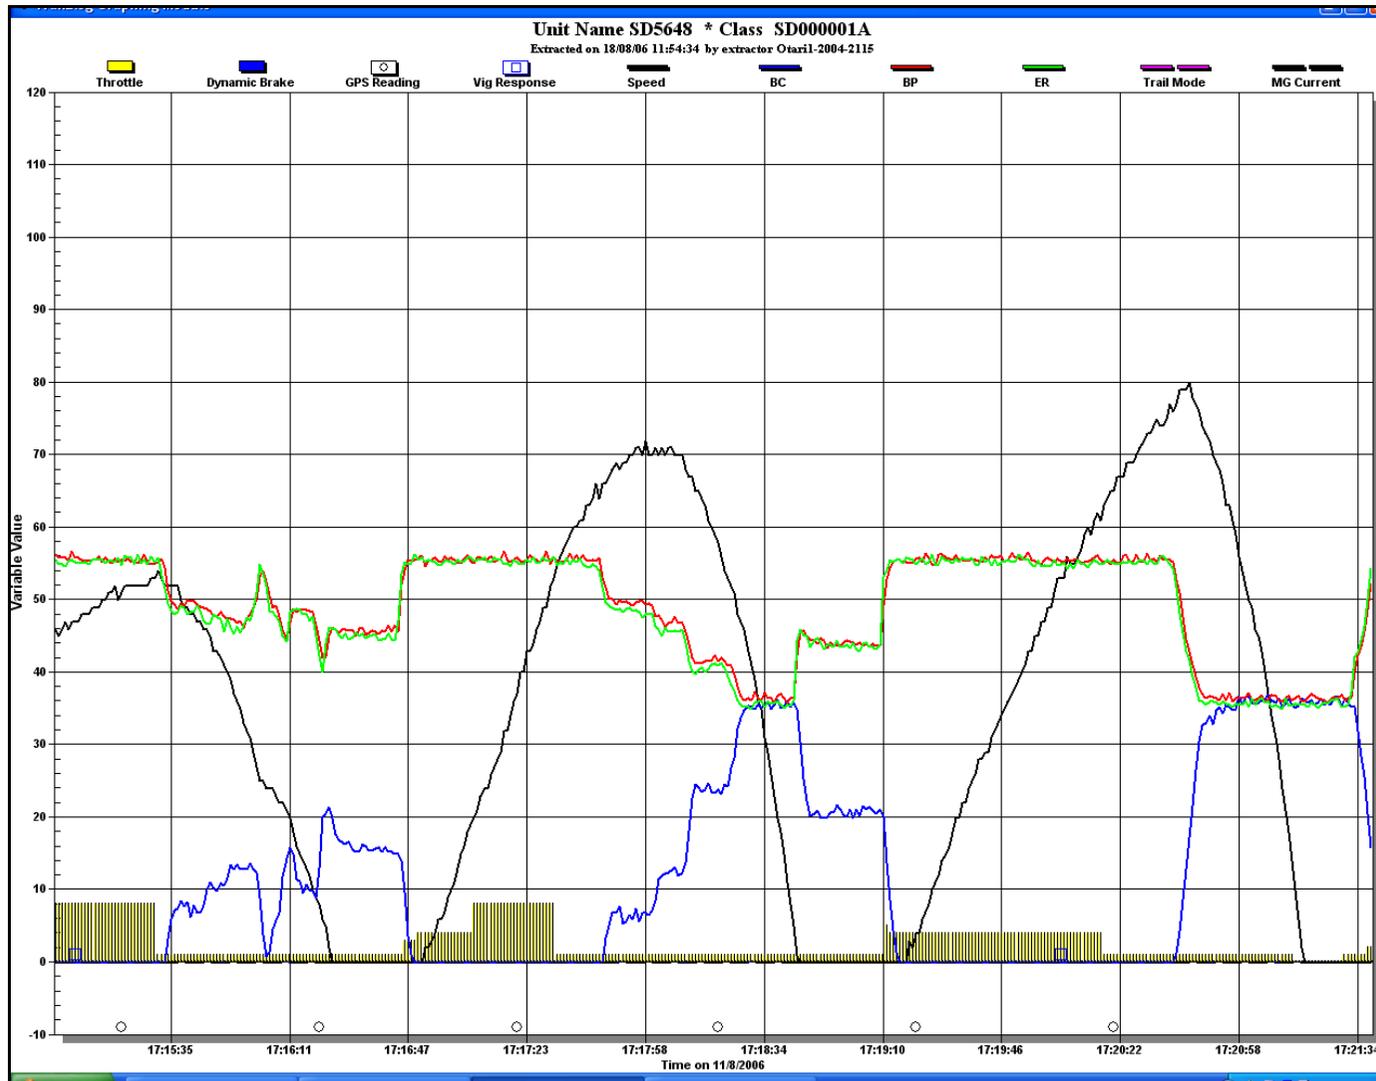
Figure 6
Ellerslie station track alignment/gradient detail (left)
and (right) event recorder data from SD5648 (neither graph is to scale)
(refer appendix section 6.6 for a larger scale of the event recorder data)

1.4.2 Ellerslie station had a 71 m long island platform. The Down main line platform was contained within straight track on a descending gradient of about 1 in 200 (see Figure 6).

- 1.4.9 The locomotive engineer said that he didn't have a predetermined location where he initiated his brake applications approaching Ellerslie. He varied his braking technique to account for brake performance, passenger loading and the prevailing weather conditions. He said that every train set had its own characteristics, but he usually got an early feel if it was a good braking train set or not. He thought the braking performance on the set was good on the day of the incident.

1.4.12 The 54D books from DC4536 and SD5648 for the 3 months leading up to the incident were examined to identify any entries relating to braking performance. On 1 August 2006, 10 days before the incident, a locomotive engineer had identified poor braking performance when driving from DC4536. The automatic brake valve had been replaced that day and subsequent testing confirmed that the braking system was code compliant. There were no reports in SD5648's 54D book relating to braking performance issues within the 3 months prior to the incident.

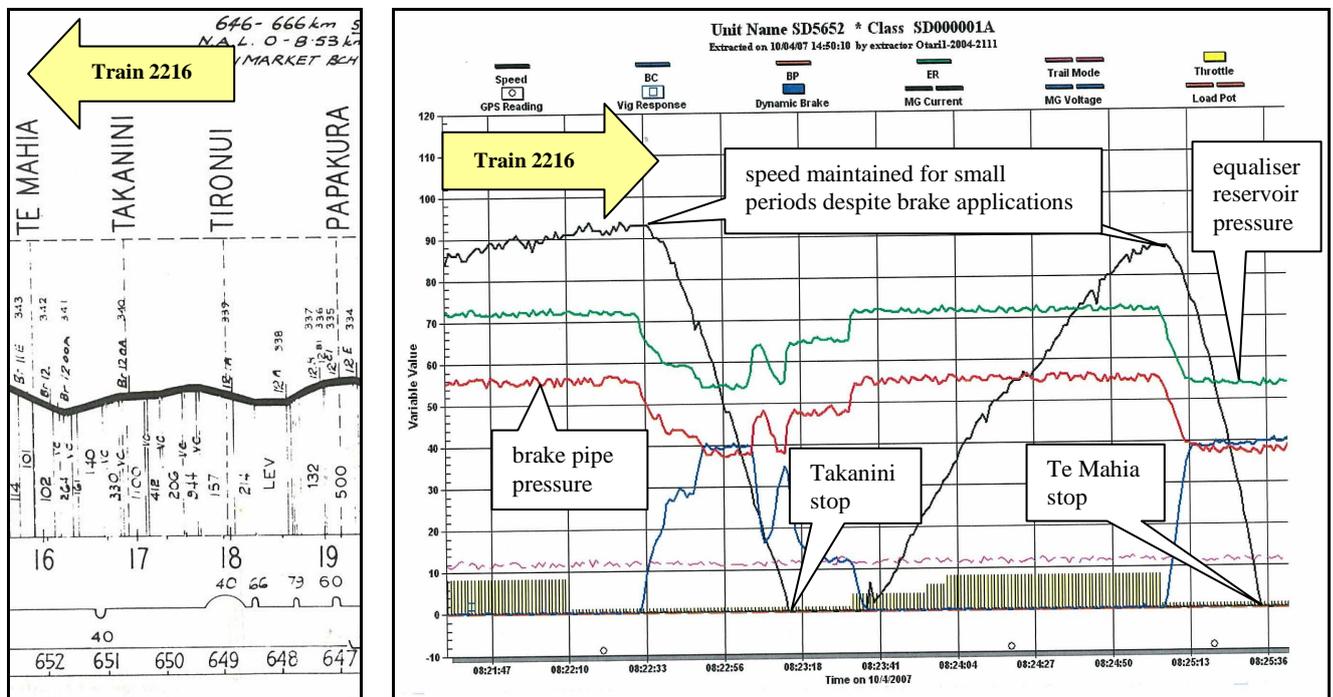
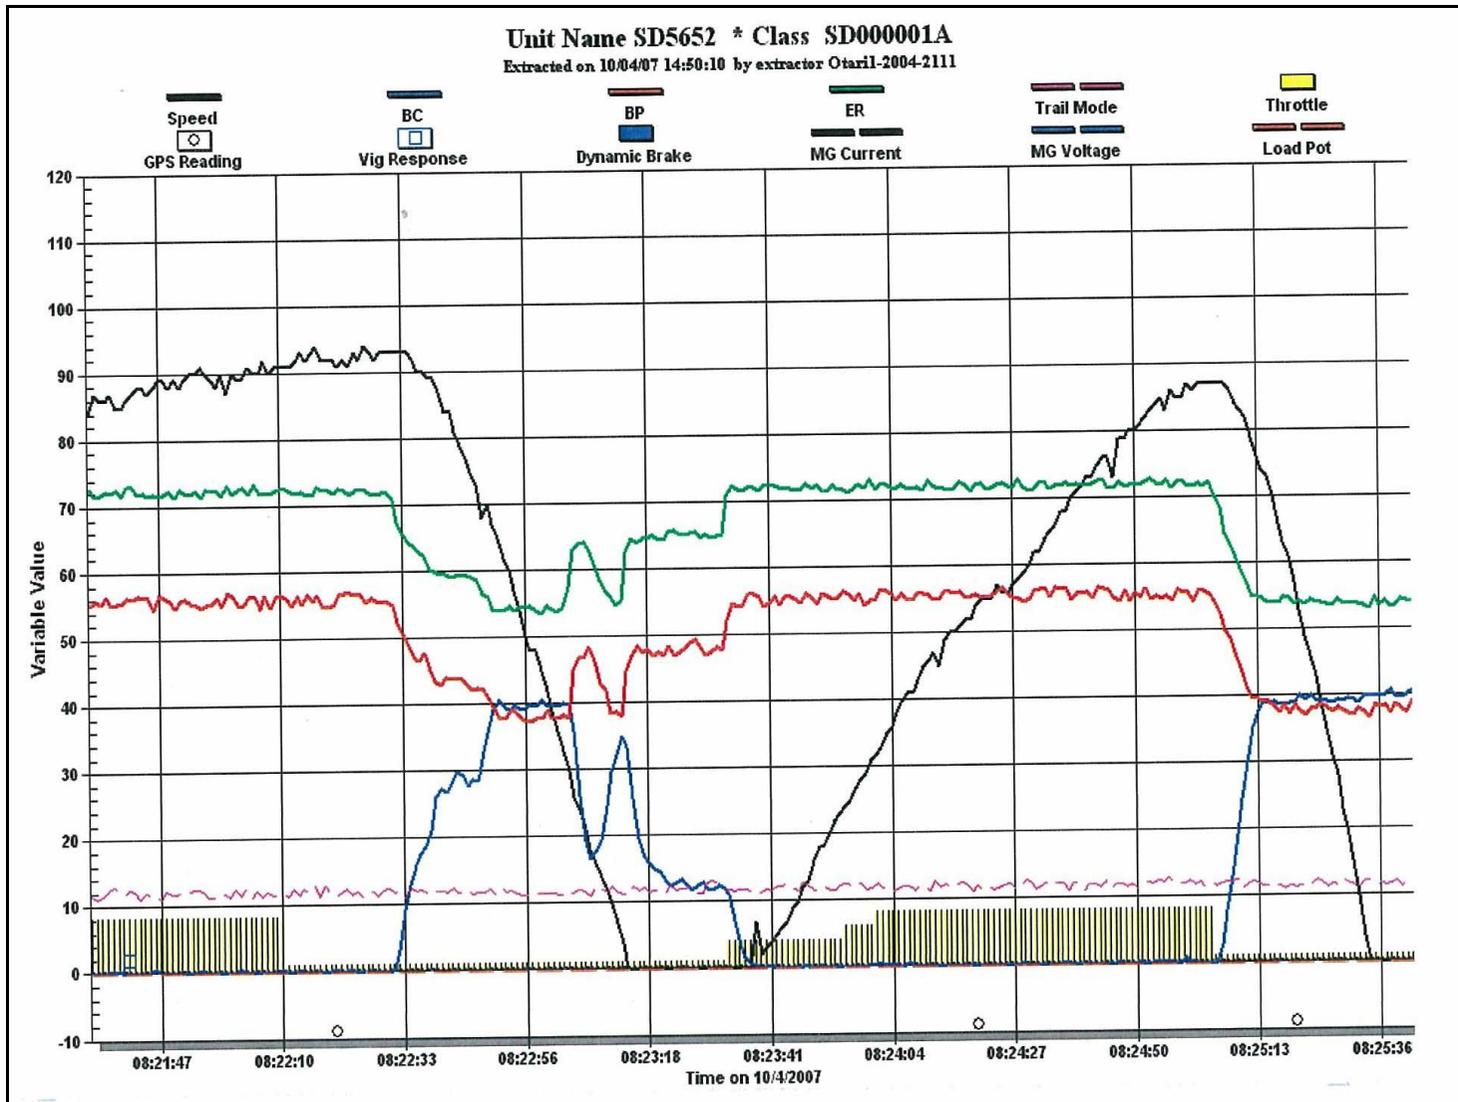
Figure 7
Te Mahia station track alignment/gradient detail (left)
and (right) event recorder data from SD5652 (neither graph is to scale)
(refer appendix section 6.6 for a larger scale of the event recorder data)

1.5.2 Te Mahia station had a 75 m long island platform. The Up main line platform was contained within a 1227 m radius right-hand curve on an ascending gradient of 1 in 100 (see Figure 7). Note: Tironui station was closed to passenger traffic.

- the overall stopping distance from the initiation of the brake application and the actual stop was 385.3 m.
- 1.5.6 The locomotive engineer said that after that incident he “took it a bit easier”. He said that further into the journey he reverted to his normal braking practices when he felt the train was responding normally to his brake applications. Having stopped at several stations after Te Mahia, the train approached Meadowbank.

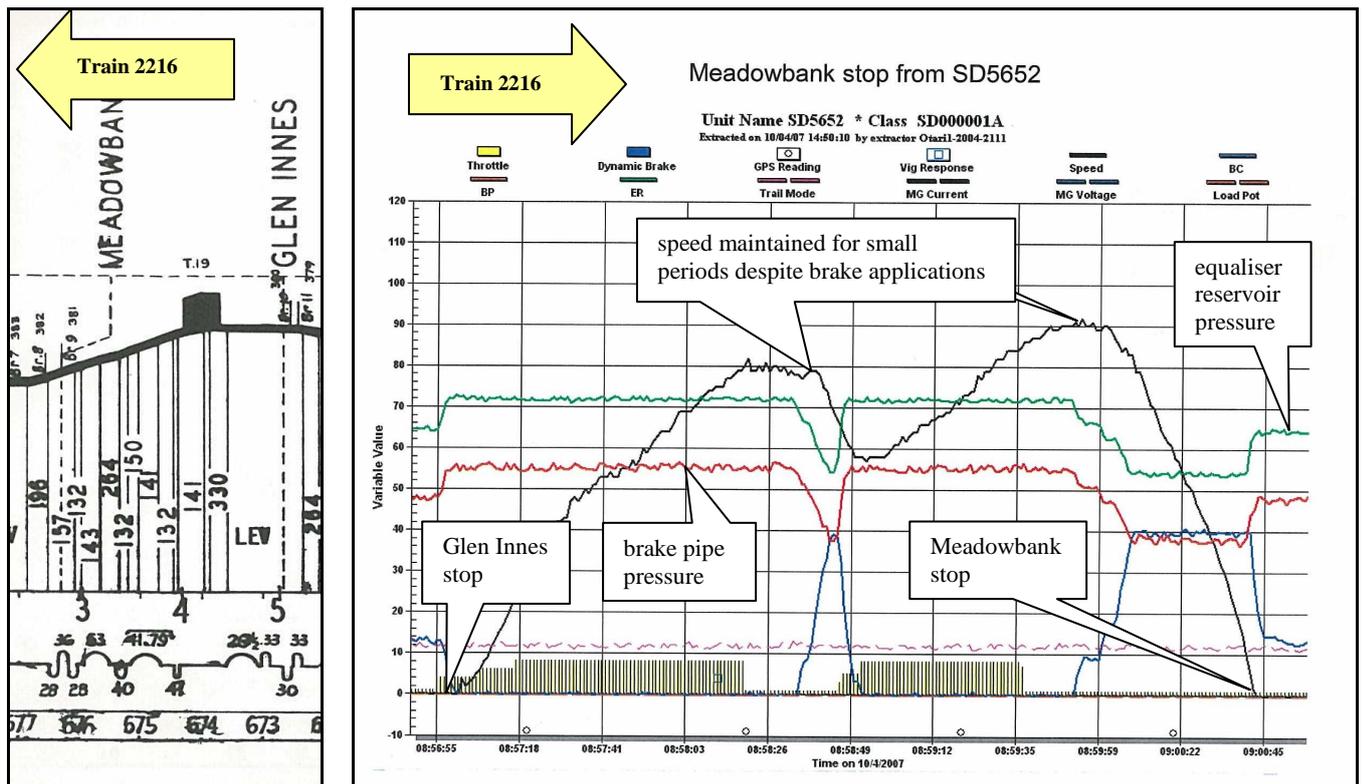
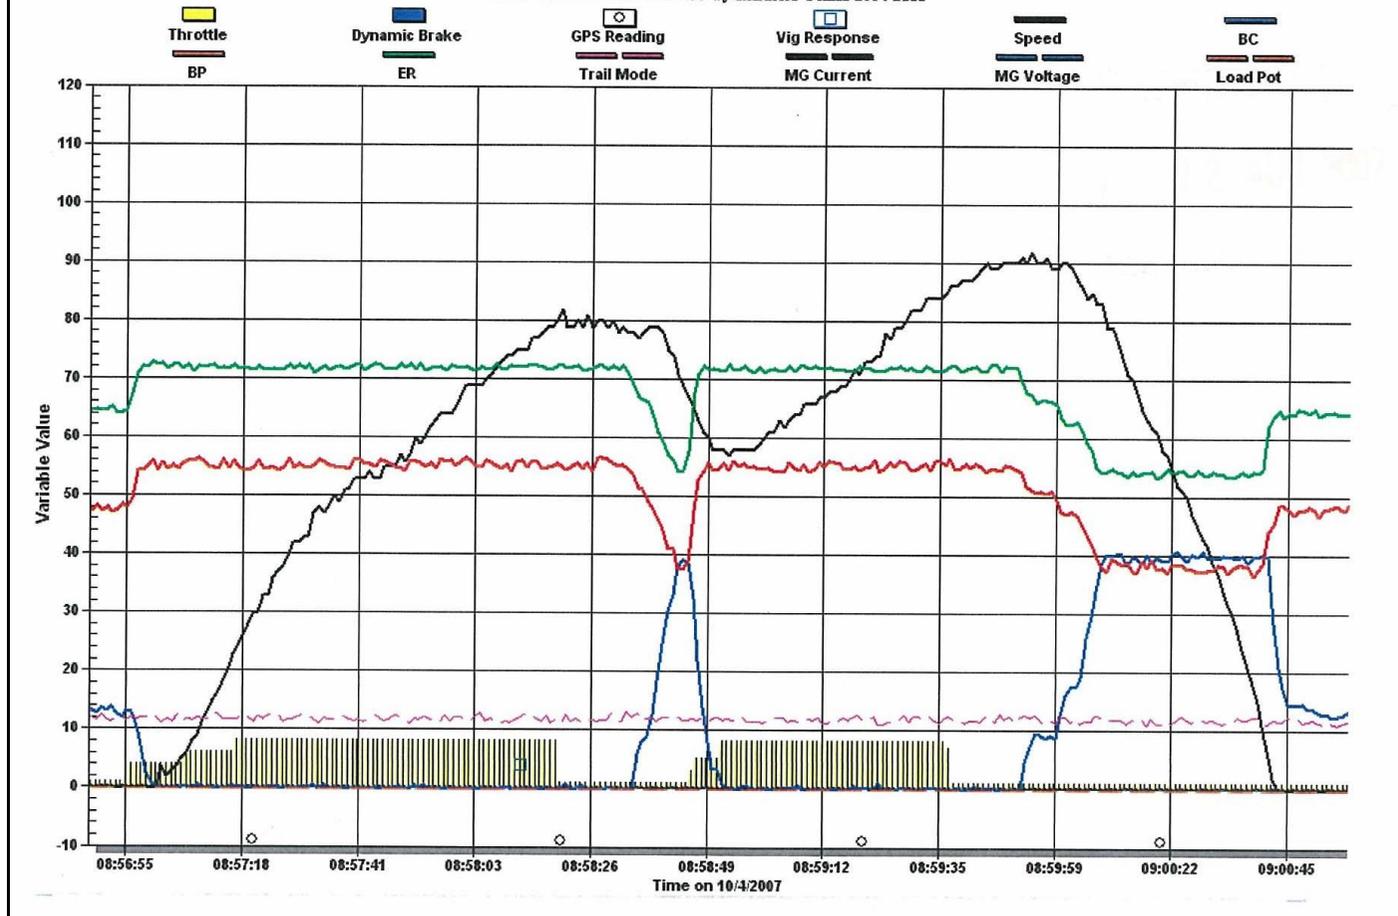
Figure 8
Meadowbank station track alignment/gradient detail (left)
and (right) event recorder data from SD5652 (neither graph is to scale)
(refer appendix section 6.6 for a larger scale of the event recorder data)

- 1.5.7 Meadowbank station had a 100 m long island platform. The Up main line was contained within a 563 m radius right-hand curve on a descending gradient of 1 in 157 (see Figure 8).

- 1.5.8 The locomotive engineer said that he made a normal brake application when the train approached Meadowbank station, followed by a full service application when he realised that the brakes were not responding as he expected. The train finally stopped 45 seconds later and had completely overrun the platform.
