**Report 07-108, express freight Train 720, track warrant overrun at Seddon,
Main North Line, 12 May 2007**

Report 07-108
express freight Train 720
track warrant overrun at Seddon
Main North Line
12 May 2007

On Saturday 12 May 2007, at 0400, northbound express freight Train 720 travelled past Seddon towards Vernon on the Main North Line without the authority of a track warrant issued from train control.

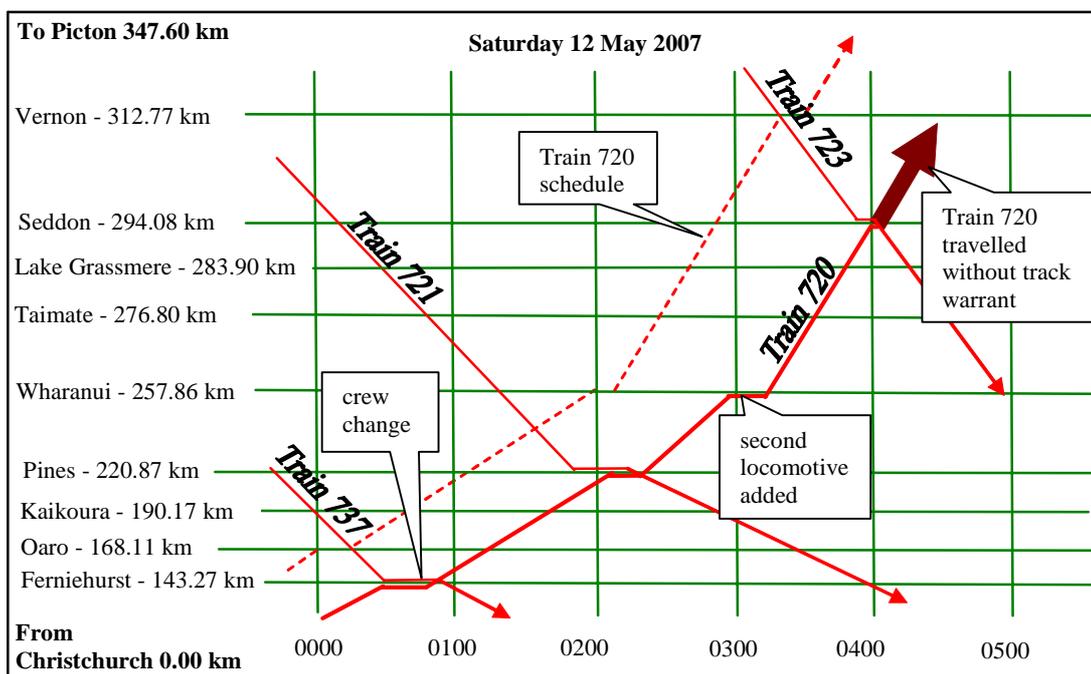
Figure 1

Details of train movements as recorded on the train control diagram (not to scale)

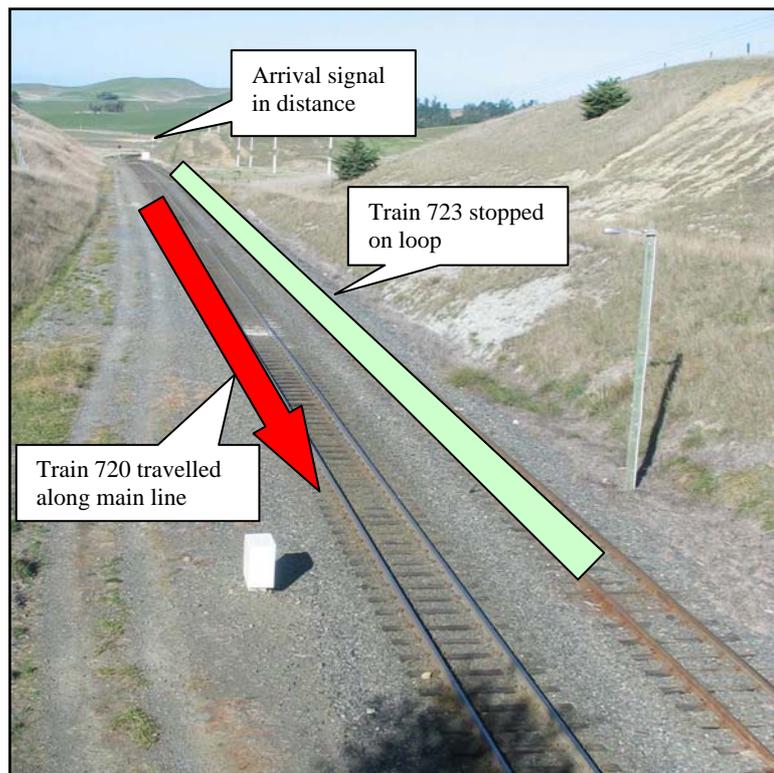
Figure 2
South end of Seddon

- 1.1.6 The locomotive engineer of Train 720 could not recall if he made his mandatory call when he sighted the station warning board⁴ approaching Seddon but recalled that he had waved to his colleague on Train 723 as the locomotives passed each other (see Figure 2).

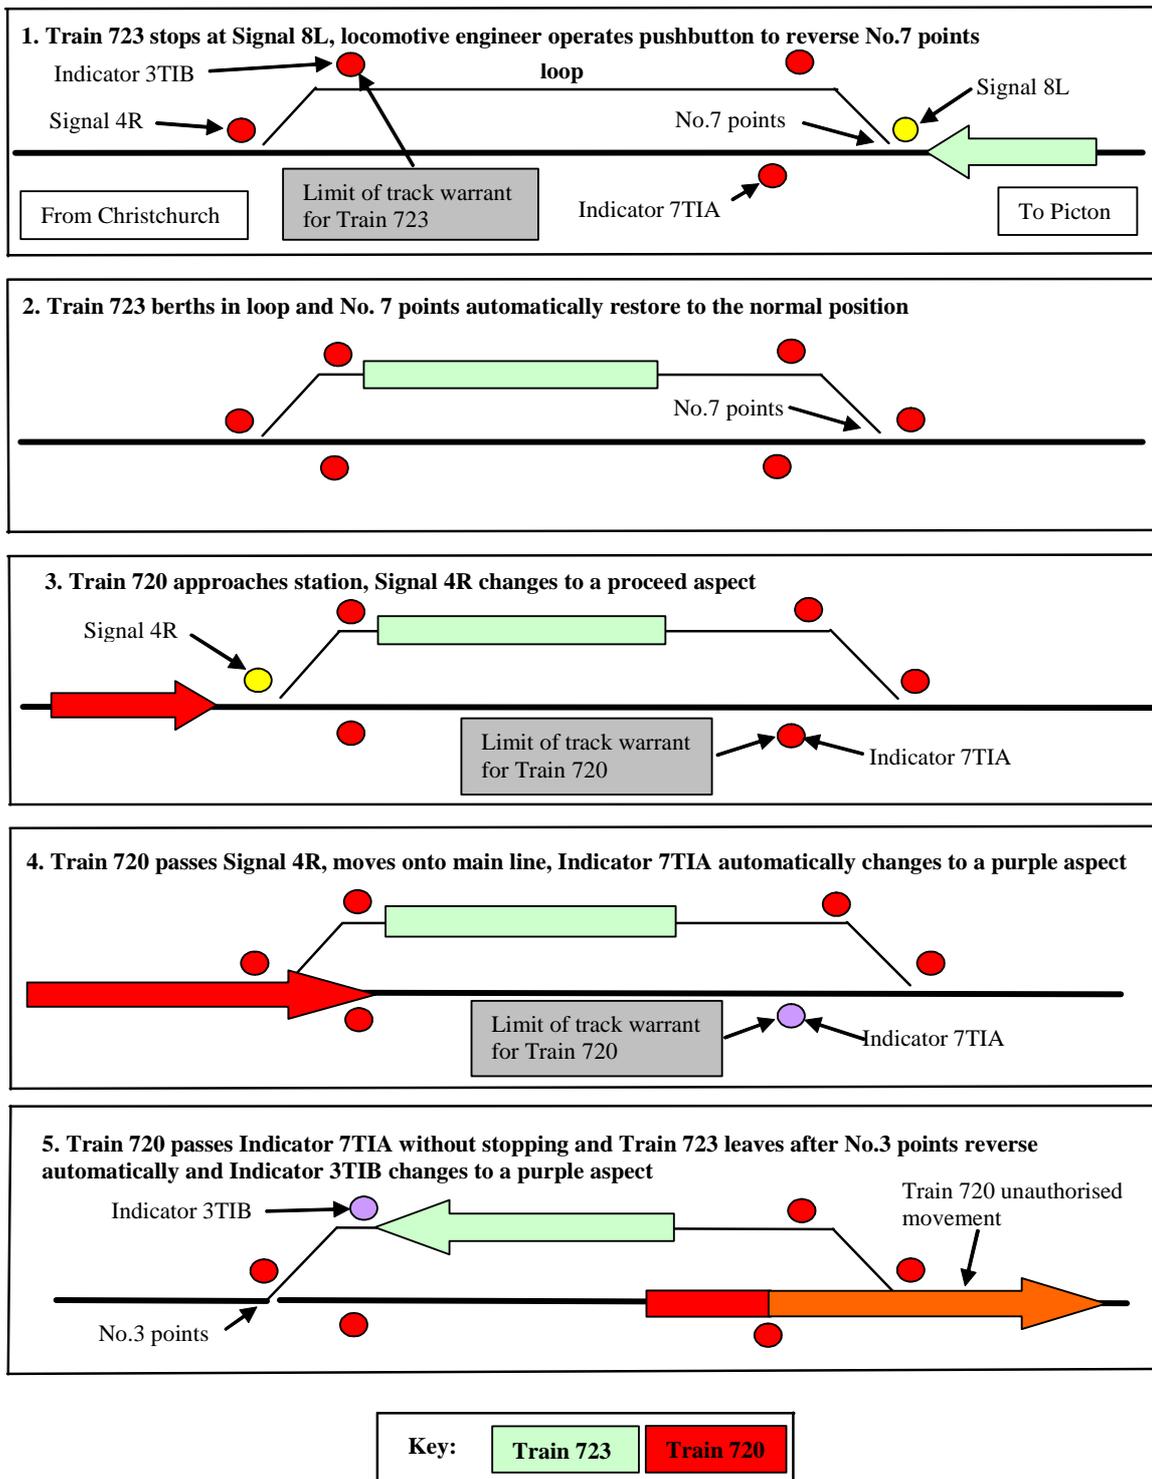
Figure 4
Crossing sequence for Train 723 and Train 720 at Seddon (not to scale)

1.3.14 The crossing sequence of Train 723 and Train 720 at Seddon is described in Figure 4.

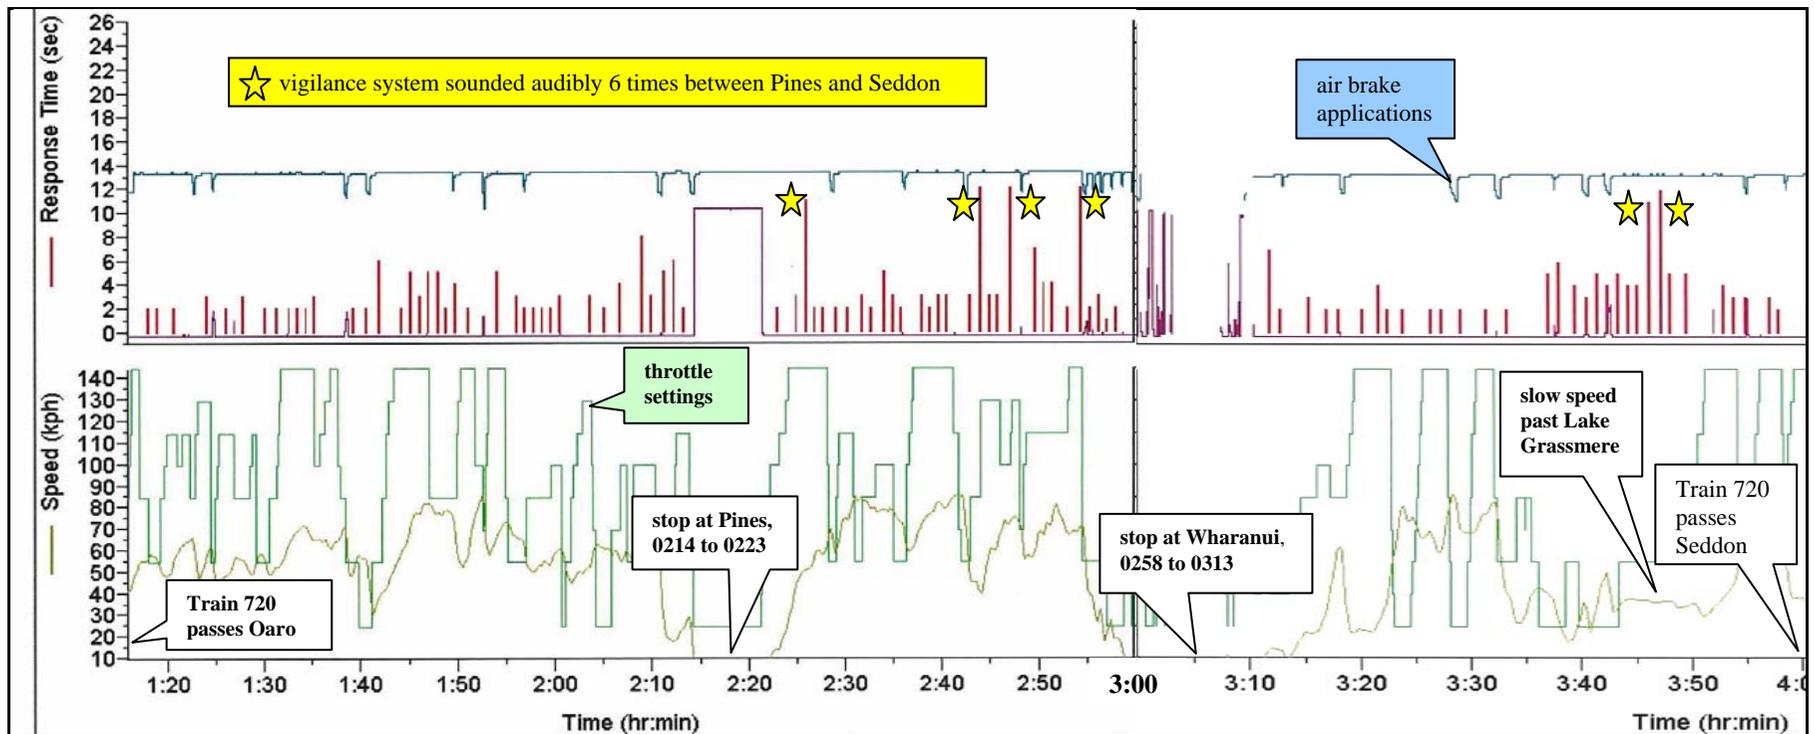
Figure 5
Train 720 event recorder data between Oaro and Seddon (not to scale)

1.4.1 The data from the event recorder system installed on DFT7077 on Train 720 was downloaded and made available for analysis. The vigilance response data for the journey segment from about the time the train was travelling through Oaro (south of Kaikoura) at about 0115 to Seddon showed the following (see Figure 5):

- 3.4 The event recorder on Train 720 clearly showed a pattern of low vigilance with the locomotive engineer over a distance of 85 km and for a period of 2 hours. Information of this type could have been used to alert train control of his condition had the equipment been used to its full potential.

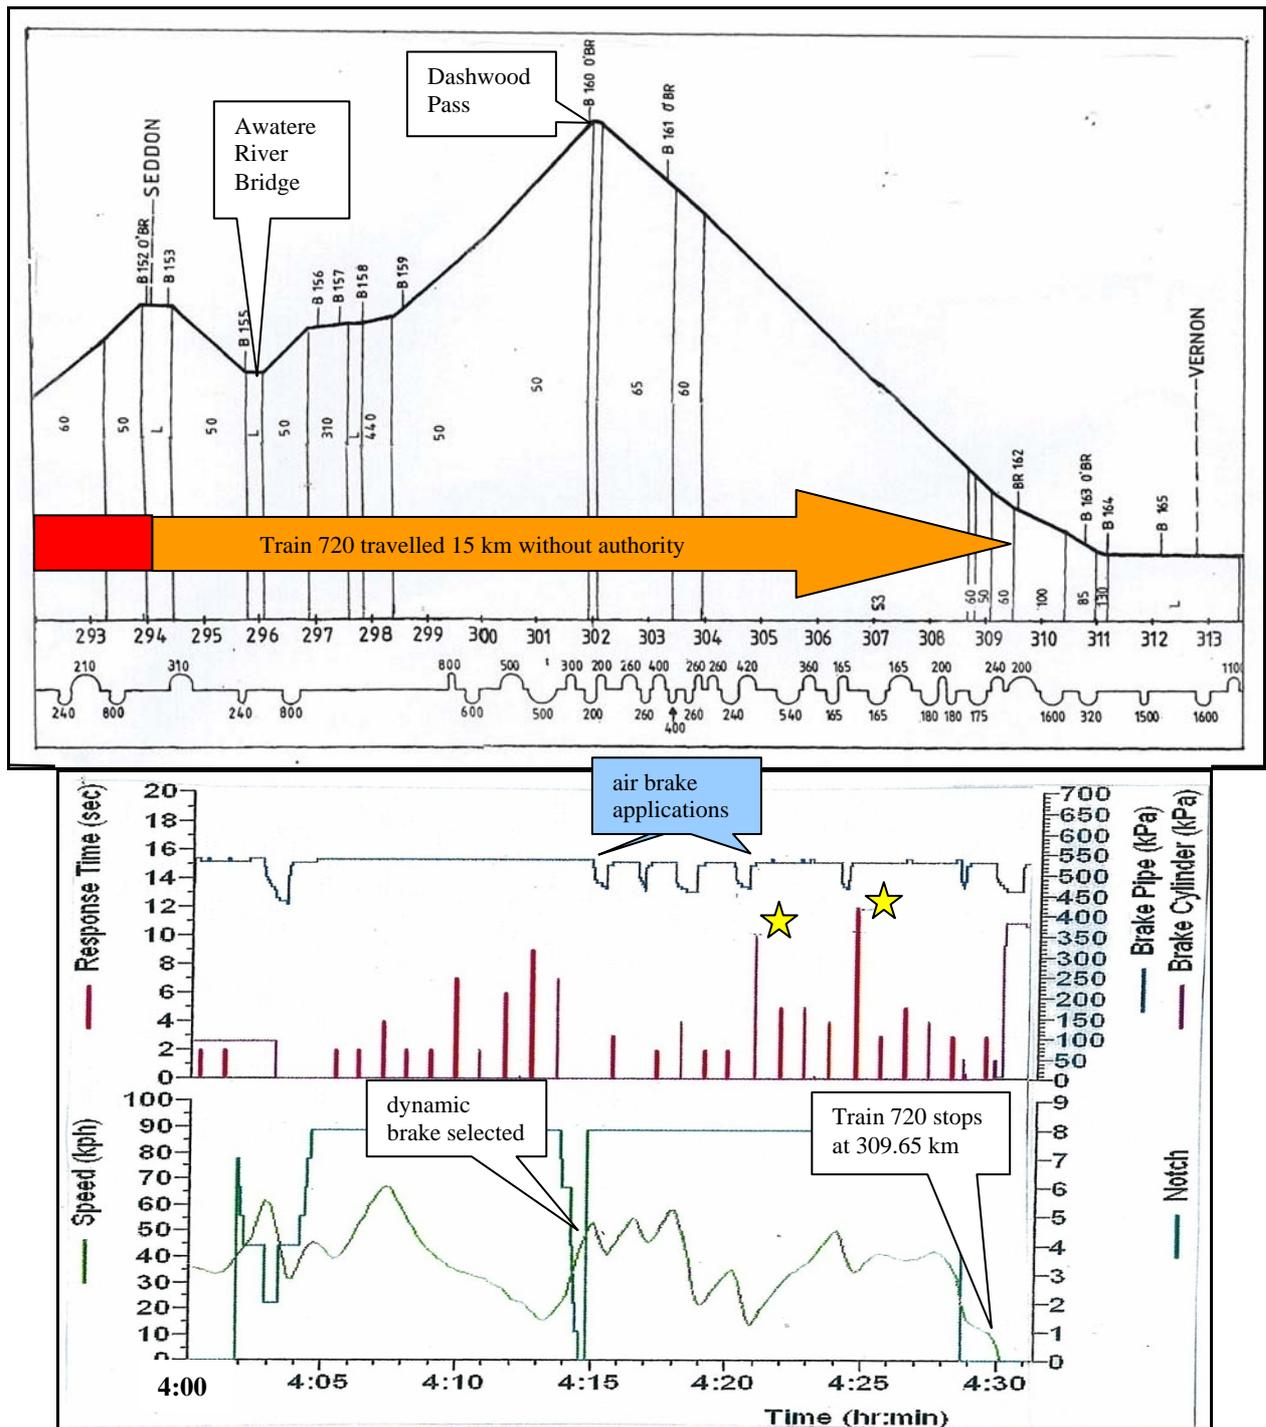
Figure 6
 Gradient and alignment profiles between Seddon and Vernon at top;
 Train 720 event recorder data compared over same distance at bottom (neither graph is to scale)

1.4.2 The vigilance response data for the journey segment from Seddon to Vernon showed the following:

- 2.27 In this instance the system was recording a pattern of deteriorating alertness, but alarms were not being transmitted outside the locomotive cab to say, train control where action could have been taken to address the matter. On 6 occasions prior to reaching Seddon, and one, possibly 2 occasions after leaving Seddon, the vigilance system had cycled into the audible alarm status.
