**Report 08-108, express freight Train 845, track warrant overrun,  
Reefton–Cronadun, 13 August 2008**

**Report 08-108**  
**express freight Train 845**  
**track warrant overrun**  
**Reefton-Cronadun**  
**13 August 2008**

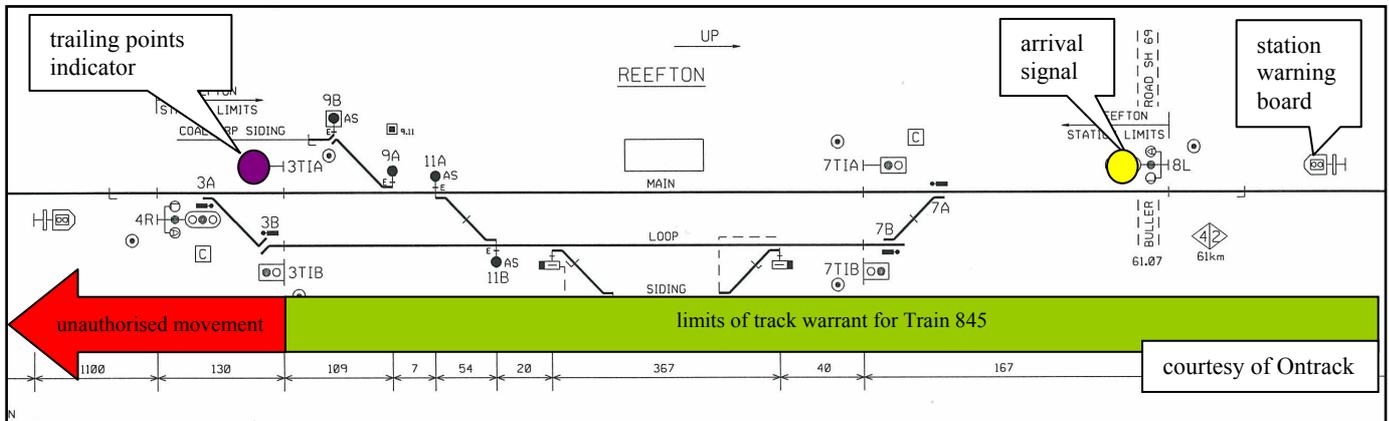
**Figure 3**  
**Signalling arrangements at Reefton with Train 845 movement (not to scale)**

1.2.11 The signalling arrangements at warrant stations, such as at Reefton, incorporate a limited signalling and track-circuiting system. The signalling system comprises an arrival signal located at the entrance to the station, with an associated set of motorised points, located inside the arrival signal (see Figure 3 for the signalling arrangements at Reefton).

1.2.12 The limited length of track circuiting generally starts about 800 metres before the arrival signal and extends along the main line (only) to the opposite point at the other end of the station. The 2 arrival signals are interlocked with the track circuits. If the circuiting is unoccupied and both motor points are in the normal position, the arrival signal displays a caution, normal speed aspect on a train's approach. The arrival signal can be passed, without stopping, if the track warrant includes specific instructions to berth on, or travel along, the main line.

- 2.5 The arrival signal at Reefton displayed a proceed aspect for the main line, and the trailing points indicator showed a purple aspect meaning that the points were set for a movement along the main line. This indicator was not authority for the train to proceed, but simply showed that the points were correctly set for the train to continue once proper authority from train control had been received.
