Report 08-109: Passenger express Train 9113, platform overrun resulting in signal passed at danger, Fruitvale Road Station, North Auckland Line, 4 September 2008

Rail inquiry 08-109
Passenger express Train 9113,
platform overrun resulting in signal passed at danger,
Fruitvale Road Station, North Auckland Line,
4 September 2008

Approved for publication: November 2010

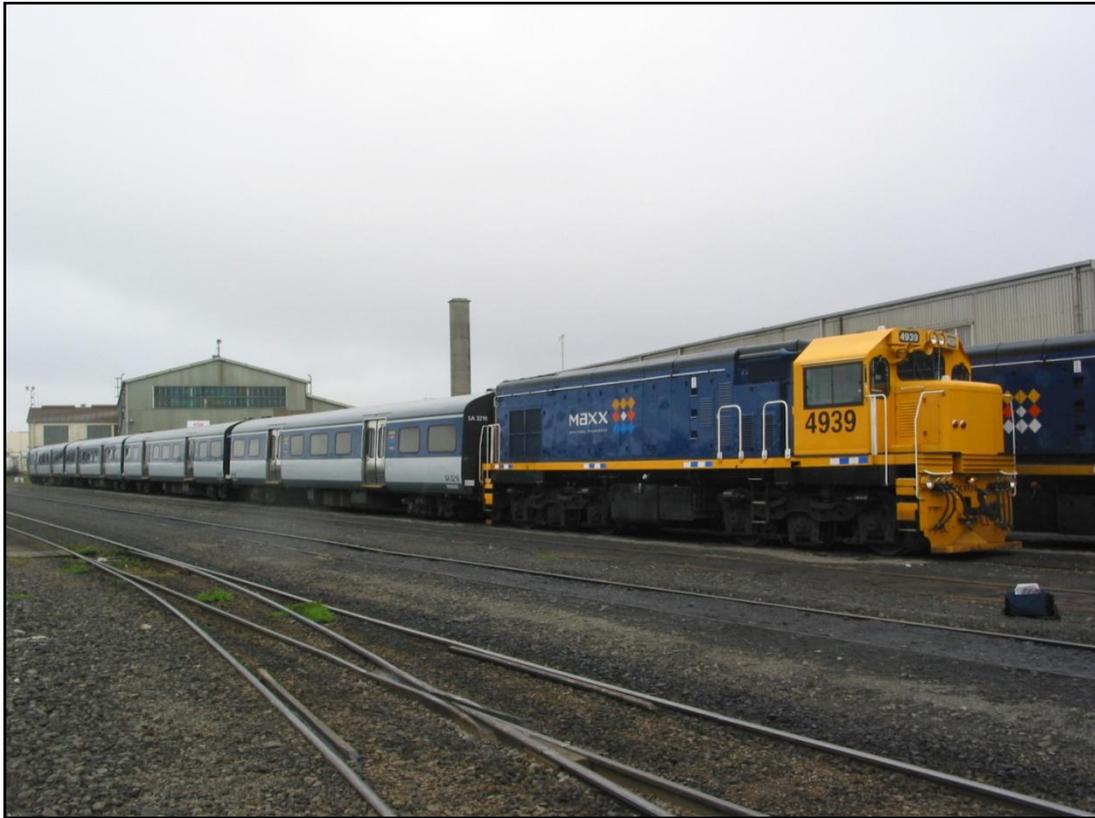
Figure 2
Consist of Train 9113

- 3.1.1. On Thursday 4 September 2008 at 0805, Train 9113, a Veolia commuter passenger train, departed from Waitakere on the North Auckland Line to Britomart. The train consisted of locomotive DC4939 pulling passenger cars SA3216, SA3263, SA322 and driver trailer SD3199. The train had a total tare weight of 206 tonnes (t) and was 95.60 m long (see Figure 2).

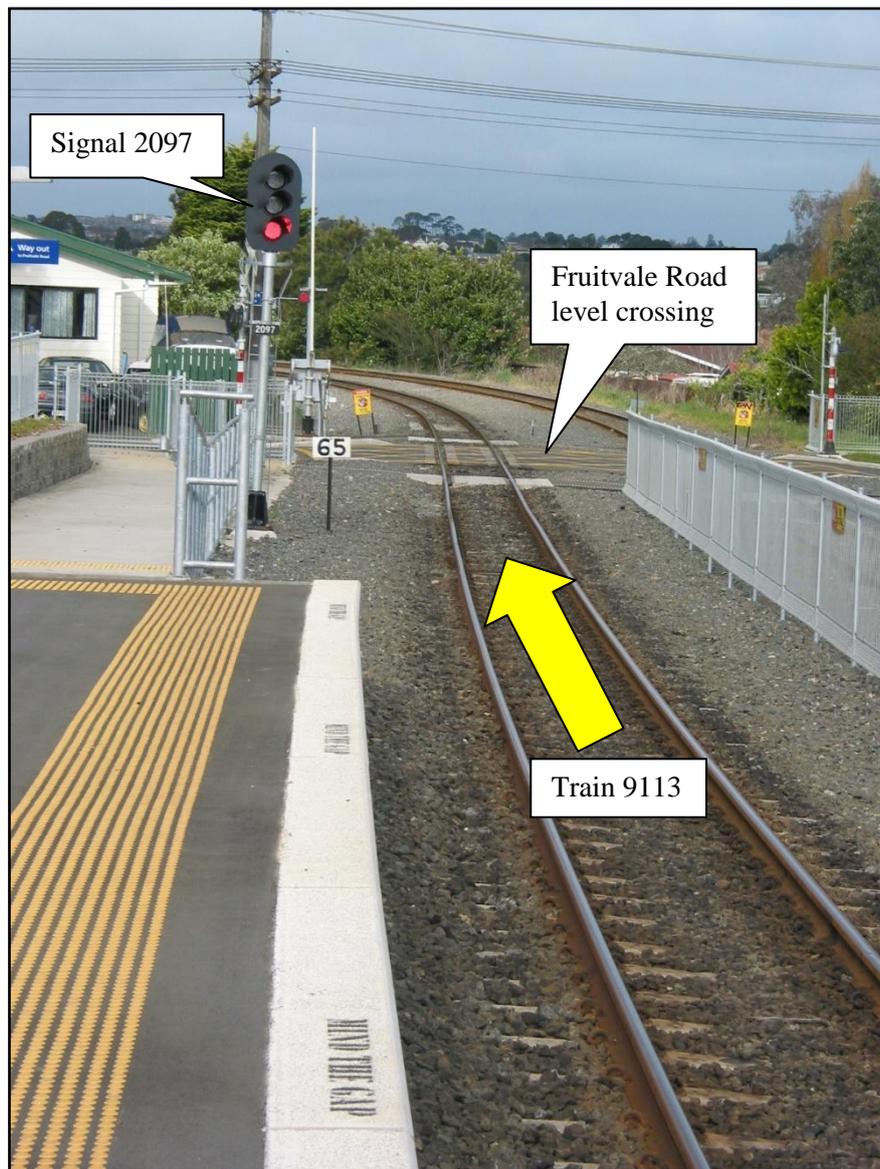
Figure 3
Signal 2097 at Fruitvale Road Station

- 3.1.4. The locomotive engineer said that after making the initial brake application he felt what he thought was the train sliding; he released the brakes, applied the independent brake, released the train brake and made a full service brake application (refer table in 3.7.2). The full service application was made as the train passed Signal 2097 displaying a red aspect (see Figure 3).

- 3.1.6. Train 9113 passed Signal 2097 displaying a red aspect at 0826:57 (referred to as a SPAD). The barrier arms protecting the level crossing descended to the horizontal position at the same time the train entered the level crossing. There were motor vehicles waiting on both road approaches when the train entered the level crossing.

- 3.1.7. At 0827:10 Train 9113 stopped with the front of the locomotive 66 m past Signal 2097 and 93 m past the end of the station platform. The second passenger car was straddling Fruitvale Road with the rear 30 m of the train (about one and a half passenger cars) ahead of Signal 2097. The rear door on the rear carriage was the only door alongside the station platform.

- 3.2.10. Signal 2097 had been positioned 27 m past the end of the platform, in line with international practice (see Figure 3). This was done so that the driver of a train stopped at the platform could always see the signal. There was not enough space to provide a standard overrun distance of 150 m from the signal at the end of the platform to the level crossing. In this case only 11 m were available between Signal 2097 and the near kerb line on Fruitvale Road.

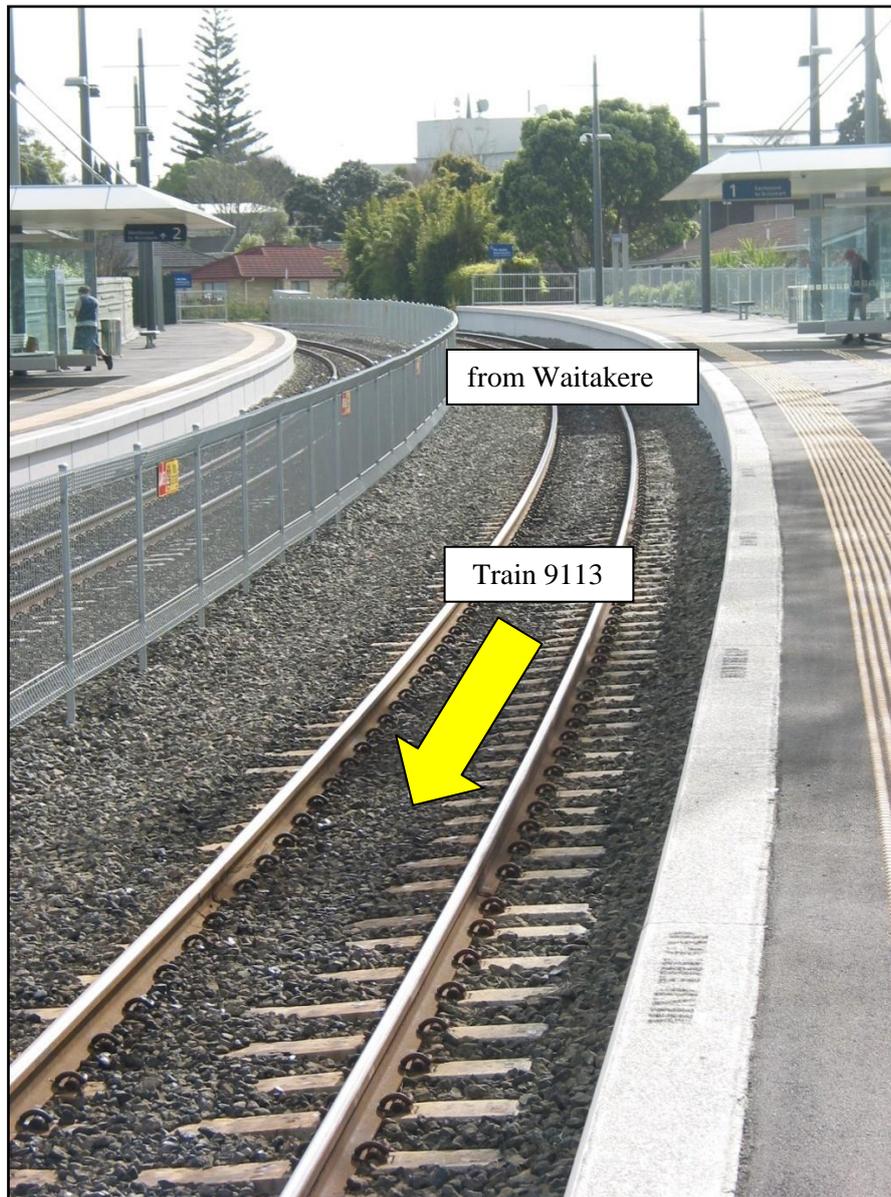
Figure 4
Fruitvale Road Station Down Main line platform

- 3.2.8. The 140 m long Fruitvale Road Station platforms were on compound 600 m and 305 m radius curves, with a shelter positioned centrally on each platform (see Figure 4). The platforms were designed to accommodate 6-carriage passenger trains. Because of the track curvature, the maximum train speed was restricted to 65 km/h.

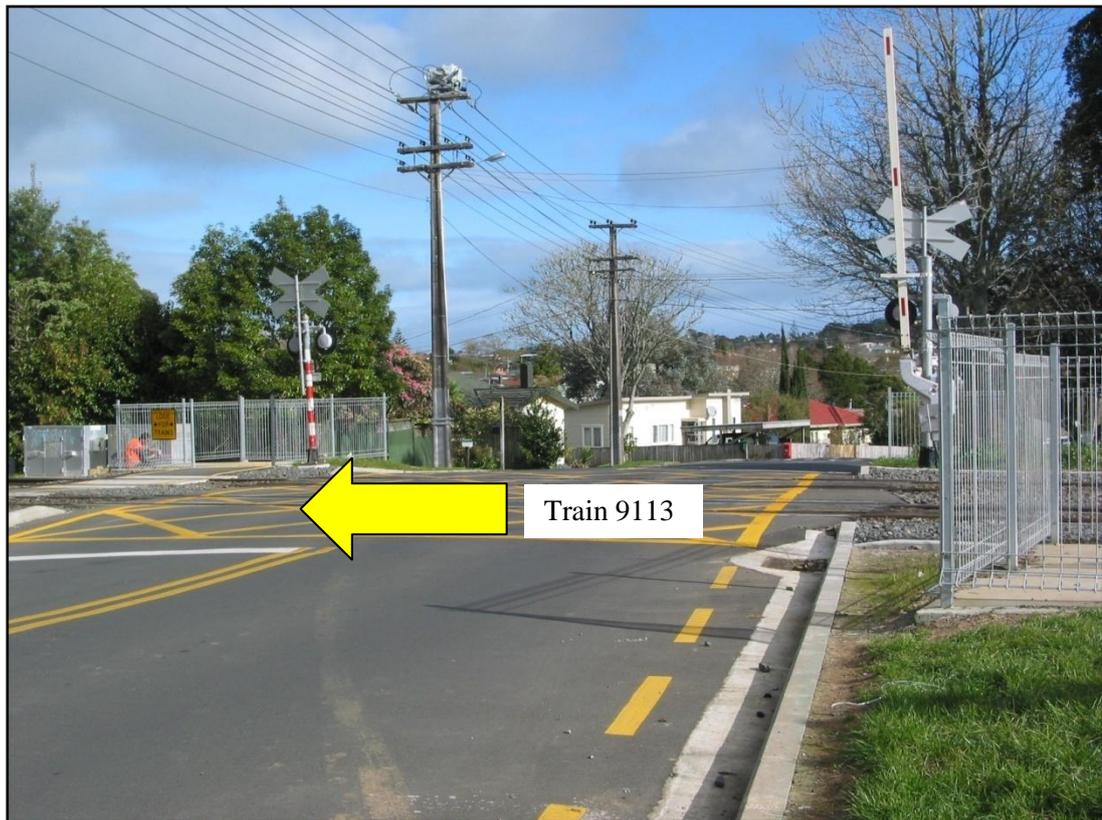
Figure 5
Fruitvale Road level crossing

3.3.2. Level-crossing alarm installations close to where trains regularly stop on the approach, such as at Fruitvale Road Station, created a design dilemma for signalling systems. In such situations the following had to be considered:

- 4.13. The compromise between reducing undue delays to road traffic and providing adequate protection at level crossings is not an easy one to manage. Because the overlap distance from Signal 2097 to the kerb line of Fruitvale Road was 11 m only, rather than the recommended 150 m, there was a risk that the level crossing active protection would not be fully operational (barrier arms down) if a "stopping train" overran the platform and signal. One method of reducing the risk created by an overrunning train would be to reduce the delay caused by the vital timer so that the level crossing protection started sooner, but this creates another risk: road driver impatience leading to their driving around the barriers, particularly if they can see a train stopped at the station platform. The risk is increased at double-track level crossings because the protection can be activated by a train coming from the other direction as well, a point that could be easily missed by motorists, particularly those not familiar with the level crossing.

The Commission recommends that the Chief Executive require KiwiRail Network to review the Fruitvale Road Station and associated arrangements for protecting the adjacent level crossing, to see if speed restrictions or other changes to the signalling system can be made to minimise the possibility of an overrunning train entering an unprotected level crossing, without compromising the waiting time for motorists using the level crossing. This review should be extended to other stations where the distance between the stations and level crossings is less than the recommended 150 metres. (044/10)

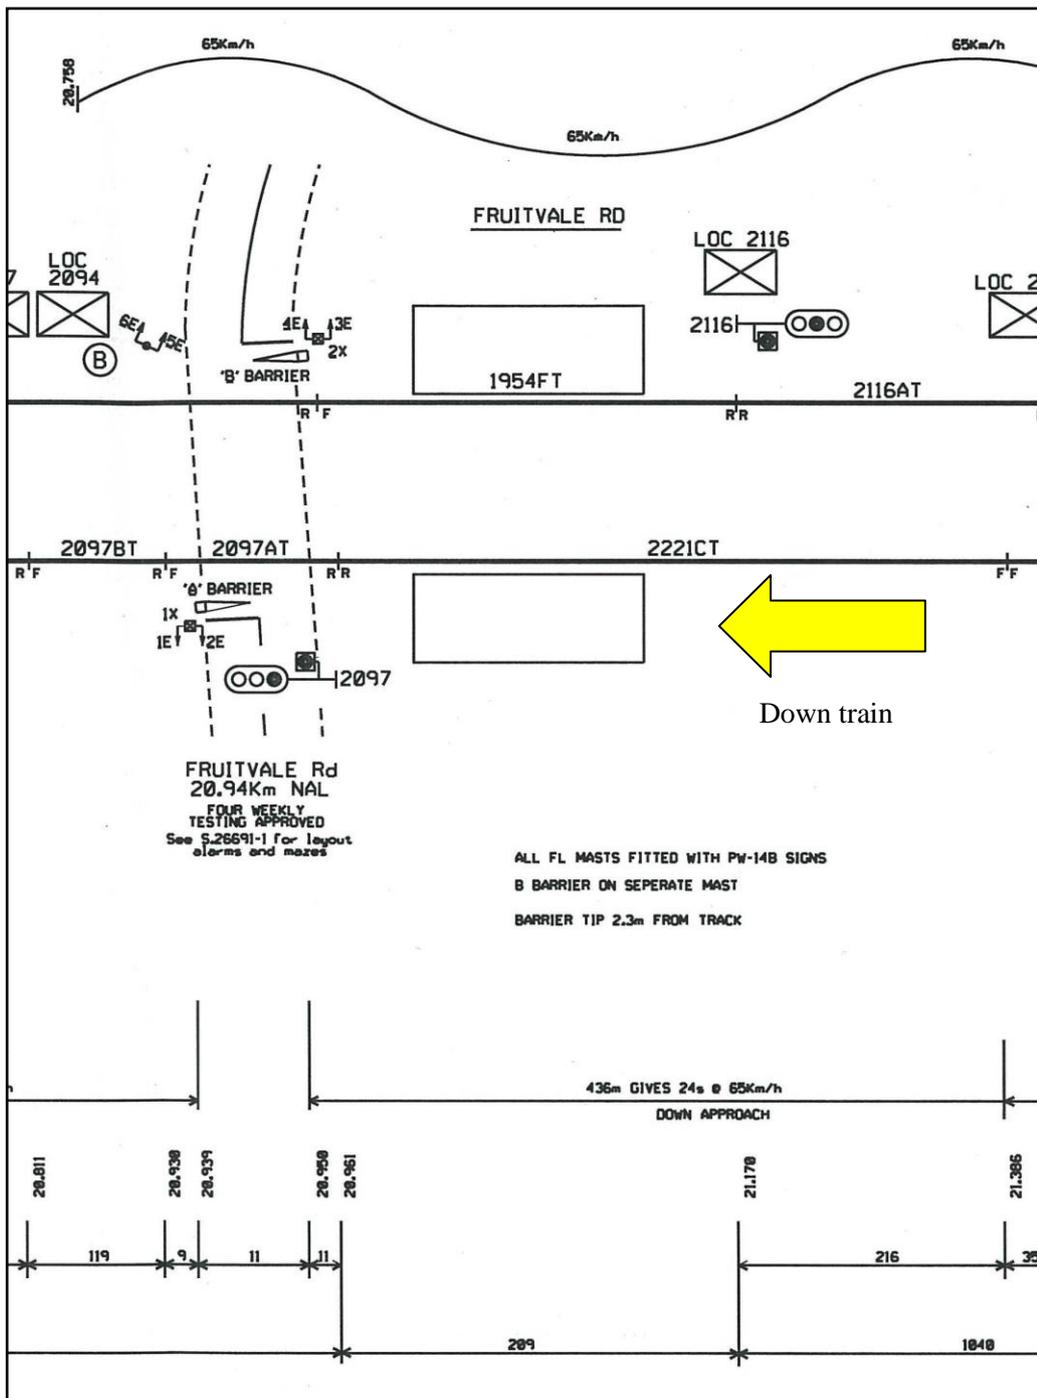
Figure 6
 Fruitvale Road signals layout (not to scale)
 (provided by KiwiRail Network)

- 3.3.3. KiwiRail's standard warning time for a level crossing equipped with active protection was 22 seconds for a train travelling at the maximum line speed, plus 2 seconds for every additional line protected. In the case of Fruitvale Road with 2 lines, the warning time was therefore 24 seconds; enough time for a non-stopping train restricted to a maximum of 65 km/h travelling on the Down Main line to travel a distance of 436 m (see Figure 6).

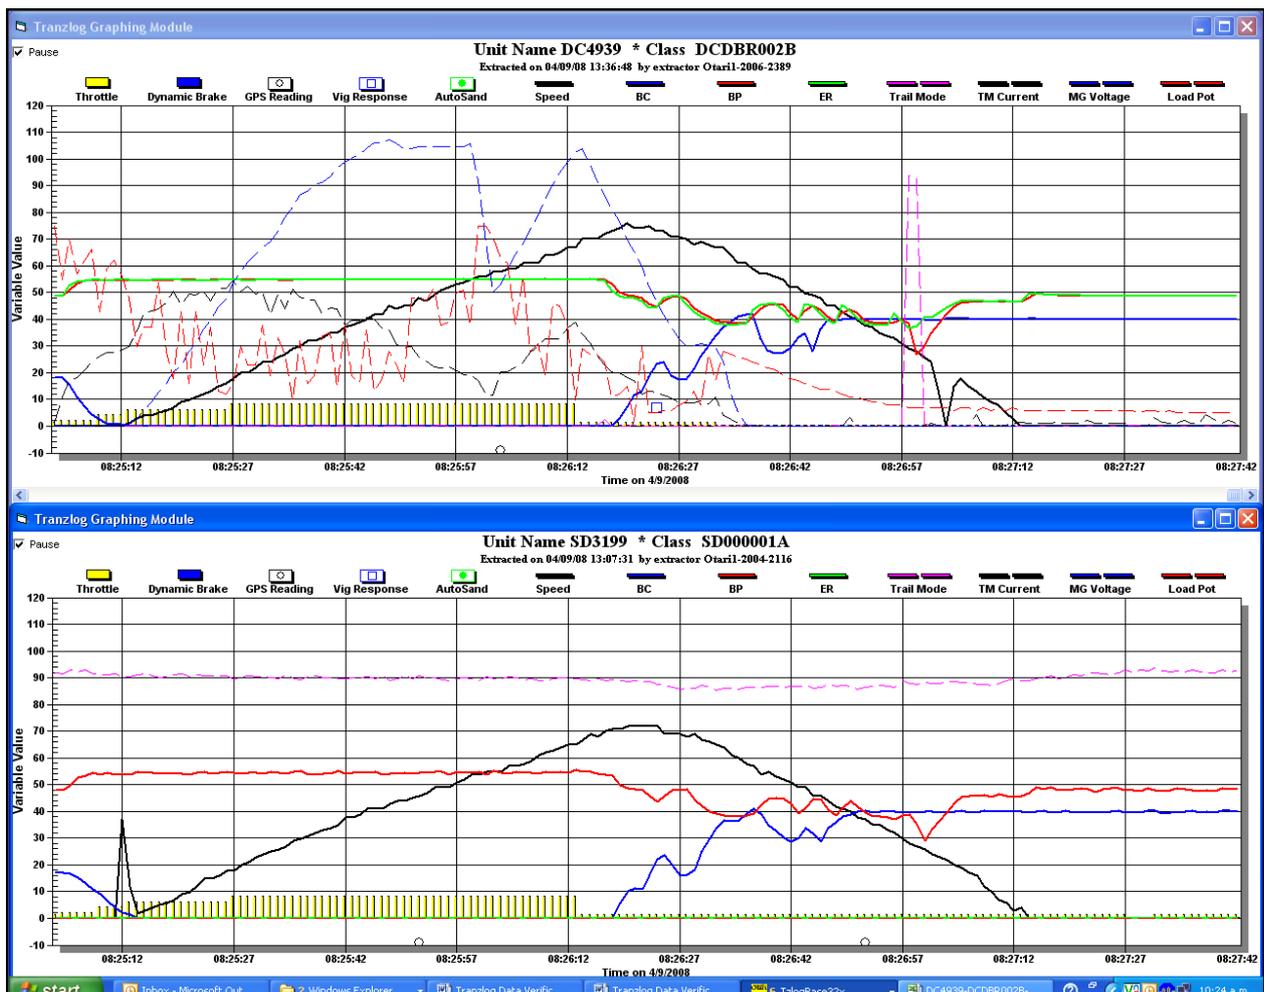
Figure 7
Tranzlog outputs for Train 9113 approaching Fruitvale Road Station

3.7.1. Data was downloaded from the Tranzlog event recorder fitted to locomotive DC4939 and SD3199 following Train 9113 overrunning Fruitvale Road Station platform and the subsequent passing of Signal 2097 at Stop. The downloaded data confirmed:

- the Tranzlog event recorder was working correctly at the time of the overrun
- the Tranzlog global positioning system was working correctly to update the clock to New Zealand Standard Time at one-minute intervals
- an average of 8 speed system messages from the logged data showed that the radar speed was 0.4% faster than true speed, while the locomotive speedometer gauge was 0.2% faster than true speed. Radar speed is used in the Tranzlog output graph (see Figure 7 and Appendix 1).
