Report 08-112: safe working irregularity resulting in a collision and derailment at Cass crossing station on the Midland Line, 8 November 2008

Final Report

Rail inquiry 08-112: safe working irregularity resulting in a collision and derailment at Cass crossing station on the Midland Line, 8 November 2008

Approved for publication: February 2011

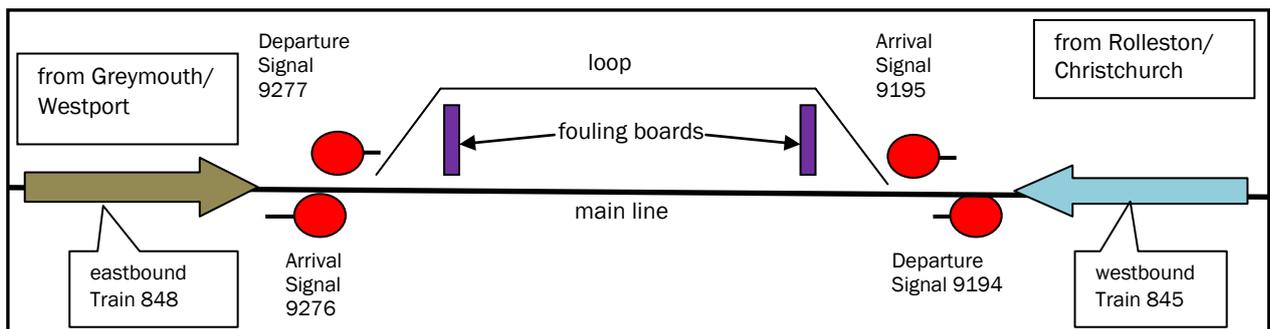
Figure 3
Train 848 and Train 845 approaching Cass crossing station (not to scale)

- 3.1.4. At about 0400, Train 848 and Train 845 approached Cass Station from opposite directions to conduct the crossing in accordance with KiwiRail's operating rules and procedures (see Figure 3). The locomotive engineer on Train 845 made a radio call to the locomotive engineer of Train 848 to confirm the berthing sequence. It was agreed that because both sets of main-line points were set in the normal position, Train 848 would enter the station first and berth on the main line.

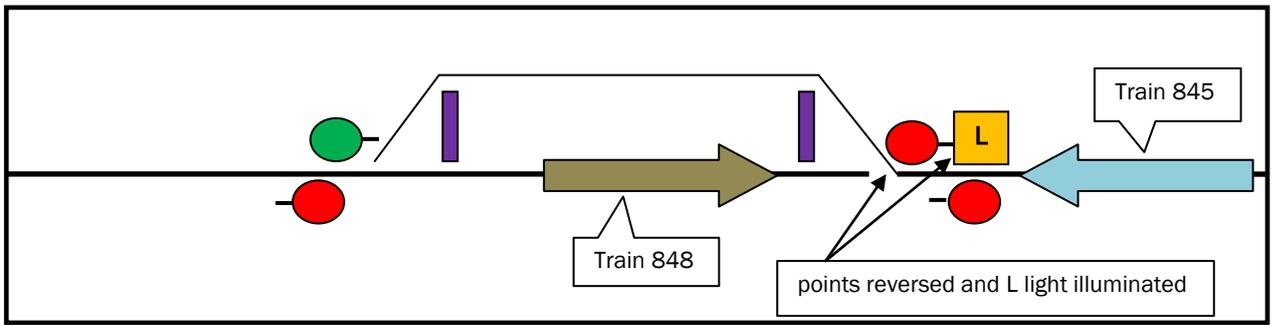
Figure 4
Signal aspects before Train 845 entered the crossing loop (not to scale)

- 3.1.5. Train 848 stopped at "Stop and Proceed" Arrival Signal 9276 for 22 seconds then proceeded to the main line. In the meantime, the locomotive engineer on Train 845, stopped at Arrival Signal 9195, left his cab to set the points for the crossing loop. After returning to his cab he saw that the "L" light on Signal 9195 was illuminated and he saw in the distance the aspect on Departure Signal 9277 change from red to green. The change of aspect confirmed to him that the rear of Train 848 was clear inside Cass Station main line (see Figure 4).

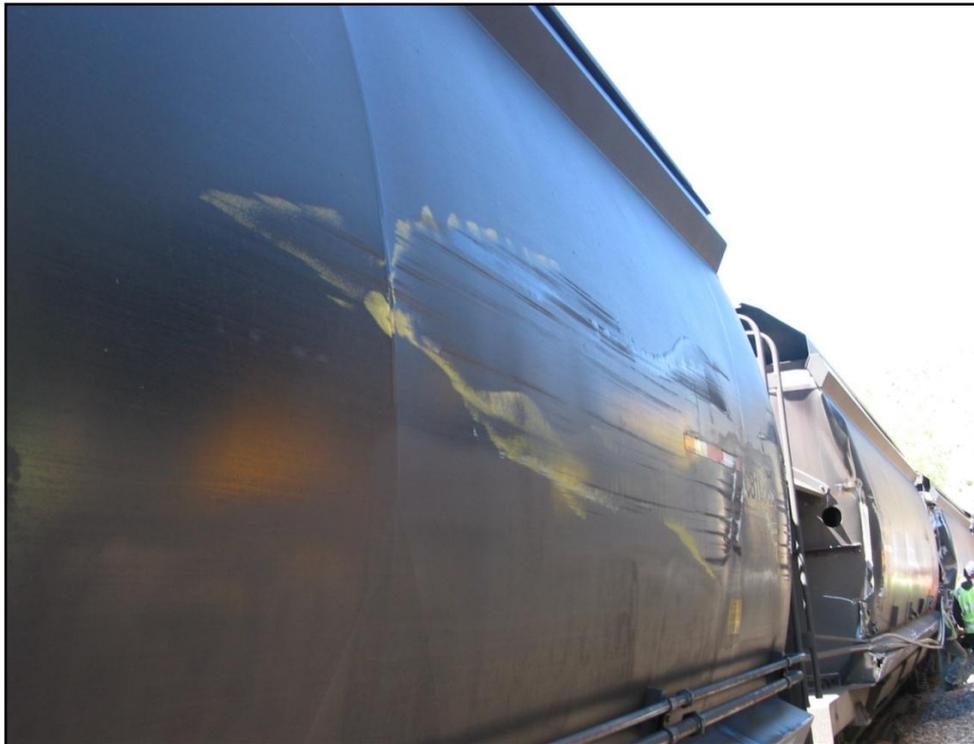
Figure 5
Impact marks on wagon CB10685

- 3.1.6. Train 845 entered the crossing loop before it had been established that Train 848 was stationary. The locomotive engineer on Train 848 said he gave the other driver a wave when the locomotives crossed. Seated on the right of the cab, his peripheral vision caught the movement of wagons going past on his left side. He was looking at the bright red light from Departure Signal 9194 and didn't realise exactly where he was on the main line, but thought he had some distance before reaching the fouling board. When he saw the wagons getting closer he moved the throttle to idle and made an emergency brake application.
- 3.1.7. A few seconds later, the lead locomotive on Train 848 struck wagon CB10685, the second wagon on Train 845 and the following 3 wagons (see Figure 5).

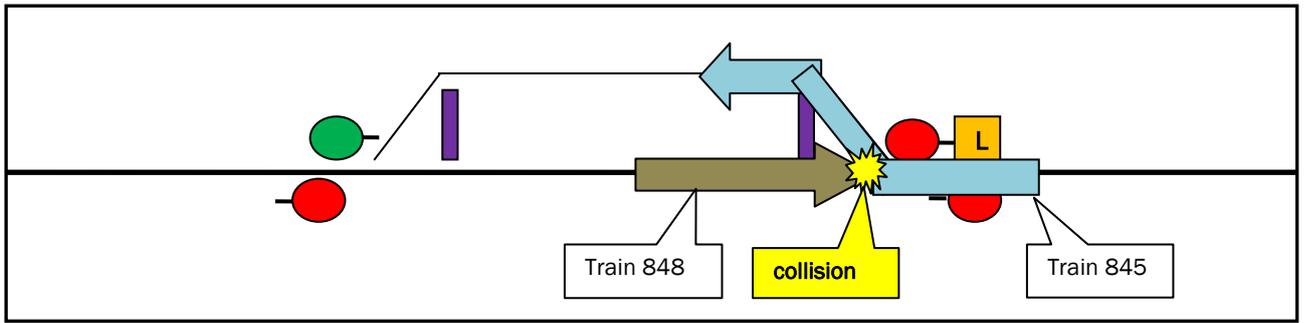
Figure 6
Train 845 crossing Train 848 at Cass (not to scale)

- 3.1.8. The locomotive engineer on Train 845 felt his train lurch then noticed an air loss from the brake valve pressure indicator, so he radioed Train 848 and said that he may have burst a brake hose, but was told that there had been a collision (see Figure 6).

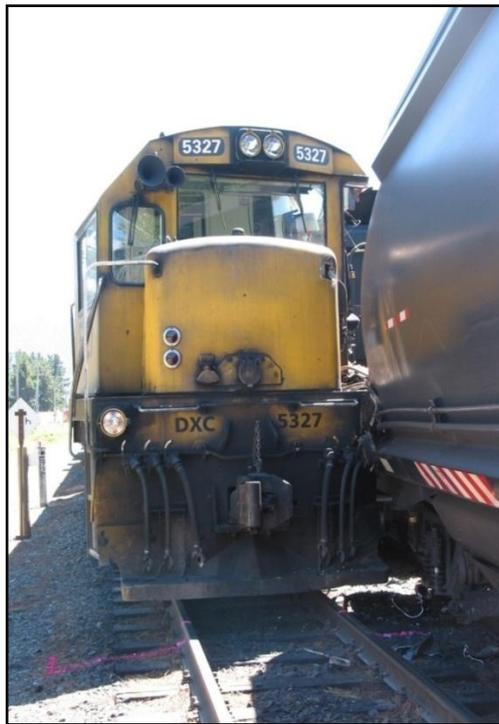
Figure 7
Lead locomotive of Train 848 wedged against Train 845

- 3.1.9. Train 848 stopped 15.6 m past the fouling board with DXC5327 wedged against Train 845 (see Figure 7). The collision resulted in the trailing bogies on wagons CB10224 and CB11177, the fourth and fifth wagons on Train 845, to derail.

- 3.2.5. The first evidence of sand application⁵ from Train 848 was 33.4 m before the fouling board. The initial point of impact occurred when Train 848 had overrun the fouling board by 8 m.

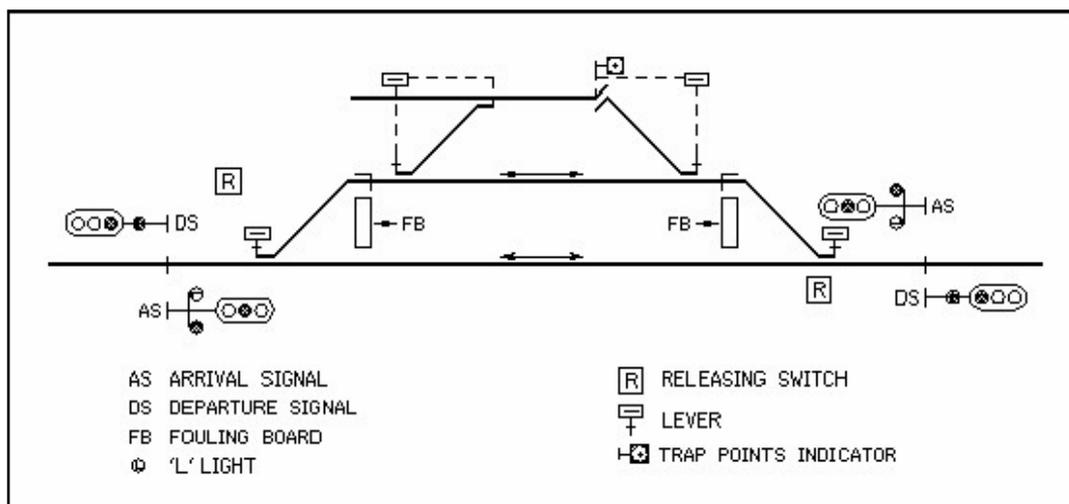
Figure 8
Typical layout of a crossing station in SLAS territory (not to scale)

- 3.3.3. In SLAS territory, an arrival signal was a “Stop and Proceed” signal and was sited at the entrance to a crossing station (see Figure 8). When such a signal was displaying a red aspect (“Stop” indication) and the train was not required to cross another at the station, the train had to be stopped and the next main line points restored to normal if needed. If after 10 seconds the signal was still at “Stop”, the train could proceed cautiously past the signal with the locomotive engineer examining all other main-line points to ensure they were correctly set for the main line, so that the train could pass safely over them, being prepared to stop if the line ahead was occupied or obstructed.

3.3.7. A departure signal controlled the exit from a crossing station and the entrance to the next single-line block section⁶. In SLAS territory, there was only one departure signal at each end of a crossing station and this signal controlled the departure of a train from either the main line or the crossing loop (see Figure 8).
