Report RO-2013-106:
Track occupation irregularity, leading to near head-on collision,
Otira-Arthur's Pass, 10 June 2013

Final Report

Rail inquiry RO-2013-106
Track occupation irregularity
leading to near head-on collision
Otira-Arthur's Pass
10 June 2013

Approved for publication: November 2014

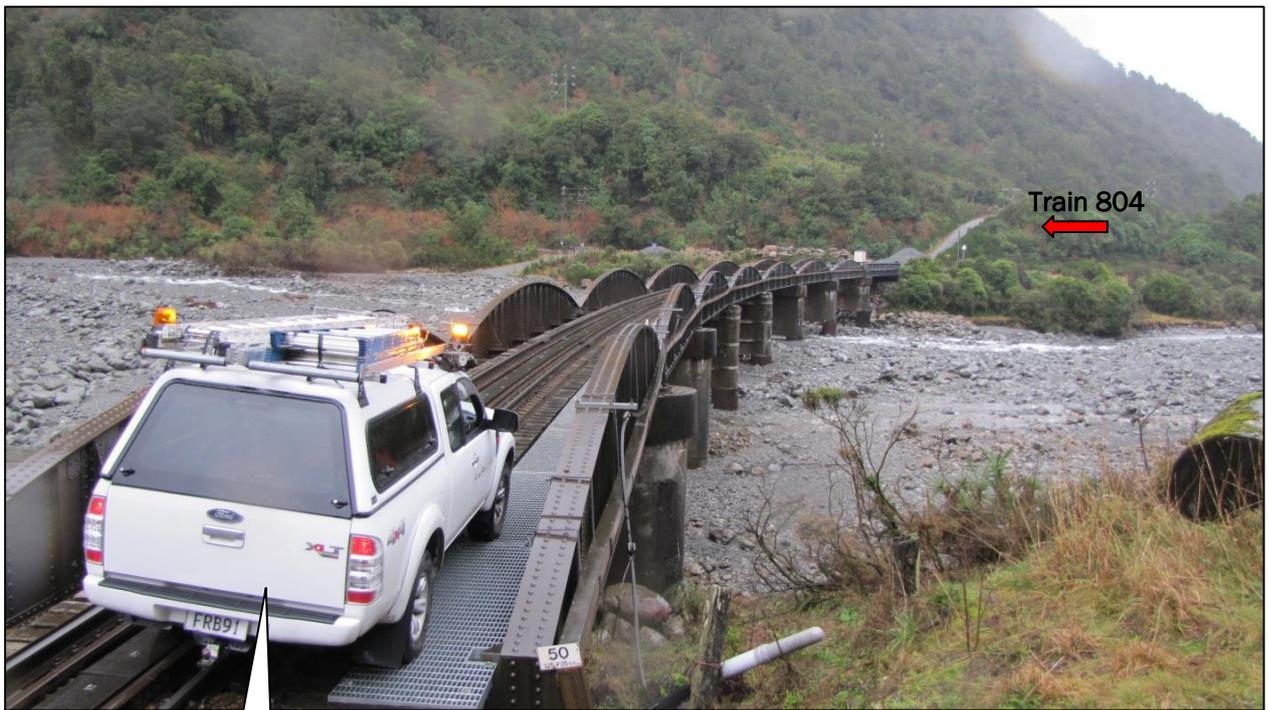
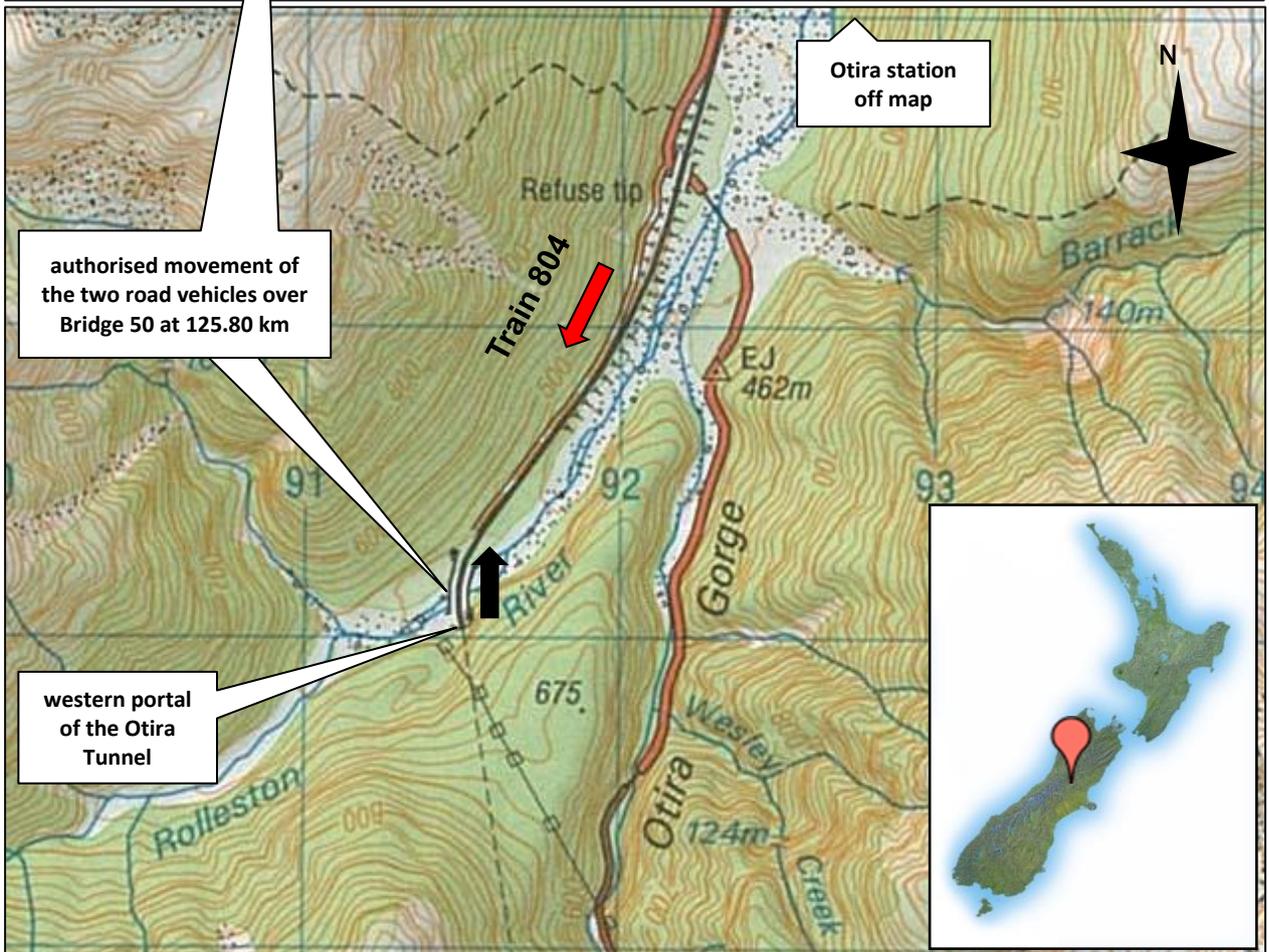
Opposing paths of the road vehicles and Train 804 between the Otira station and the western portal of the Otira Tunnel

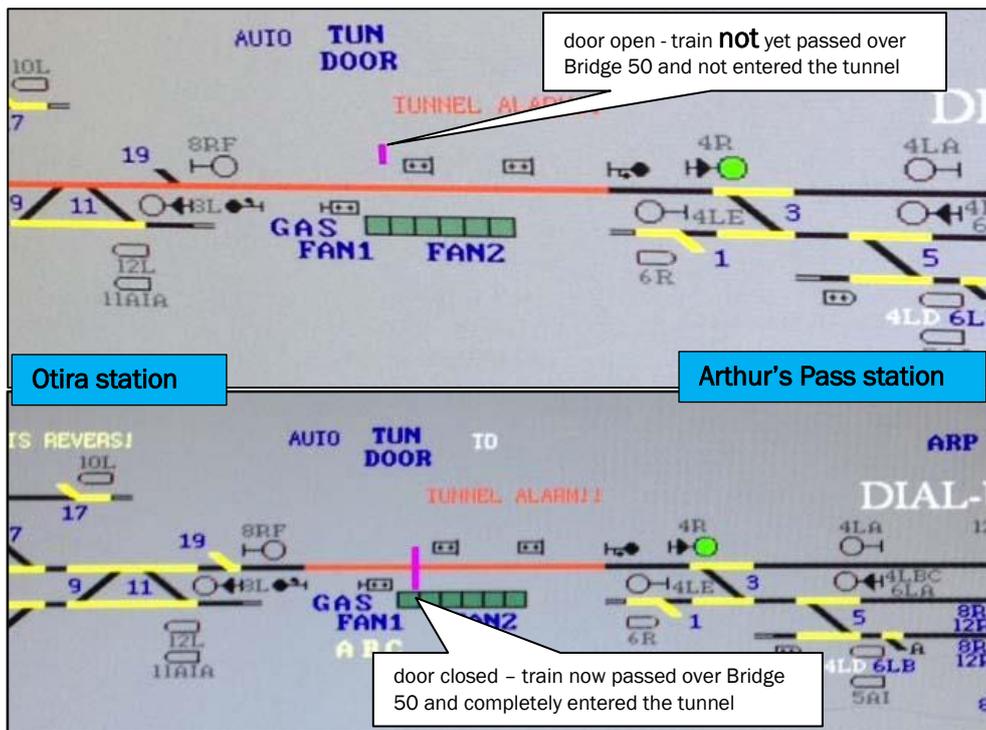
Figure 1
Train control mimic screen displays with a train moving from Otira to Arthur's Pass

- 3.1.6. During the authorisation process the train controller saw that the train was no longer at the Otira station when he looked at the signalling mimic screen (see Figure 1). The mimic screen included an additional display for a tunnel door operation at the western portal of the Otira Tunnel. The display used a crimson vertical marker that showed the door was open at the time the occupation was authorised. This meant that the train had not entered the tunnel and therefore had not passed over the bridge.

- 3.1.7. The train controller said that he concluded in his mind "that it had already passed over Bridge 50 and had proceeded to go through the adjacent [Otira] tunnel". The occupation was authorised at 1530.
