Inquiry RO-2013-108: Near collision between 2 metro passenger trains
Wellington, 9 September 2013

Final Report

Rail inquiry RO-2013-108

Near collision between 2 metro passenger trains
Wellington

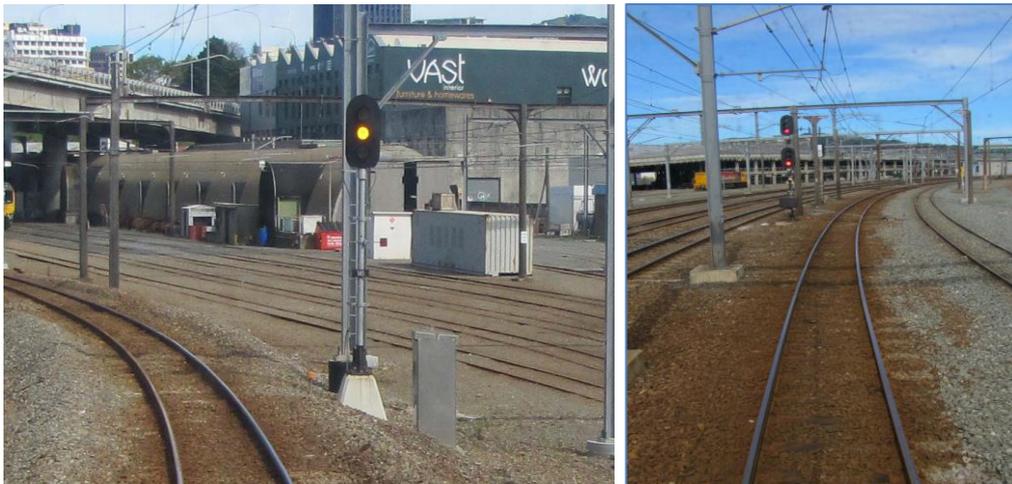
Figure 1
Signal 145 at yellow (left) and Signal 38 at red (right)

- 2.1.4. The train driver and train manager both said that their conversation continued until the time of the incident.
- 2.1.5. The passenger train was travelling at 53 kilometres per hour (km/h)³ when it passed Signal 145 at 1324:03. Signal 145 was showing a yellow aspect at that time (see Figure 1). The yellow aspect was a warning to the driver that the next signal was displaying red (stop). The next signal was Signal 38, which was 714 metres (m) ahead and out of clear view at the time of passing Signal 145.

- 2.1.6. The driver remembered noticing that Signal 145 was showing yellow, but he did not use the signal alert device installed in his cab. The signal alert device was designed to remind the driver that the previous signal was showing yellow. The system sounds an audible alarm and a flashing light appears in the driving cab after the train has travelled 400 m from where the driver has activated it. The train manager said that he could not recall seeing Signal 145 because he was turned towards the driver while they talked.

- 3.1.2. The driver of the passenger train acknowledged that he had not seen Signal 38 displaying red. Trains from the Johnsonville Line almost always berthed at platform 1, and for arriving movements Signal 38 was almost always showing green – at least that was the driver’s expectation in this instance. He also acknowledged that the reason for his not noticing the red signal was his becoming engrossed in his conversation with the train manager.

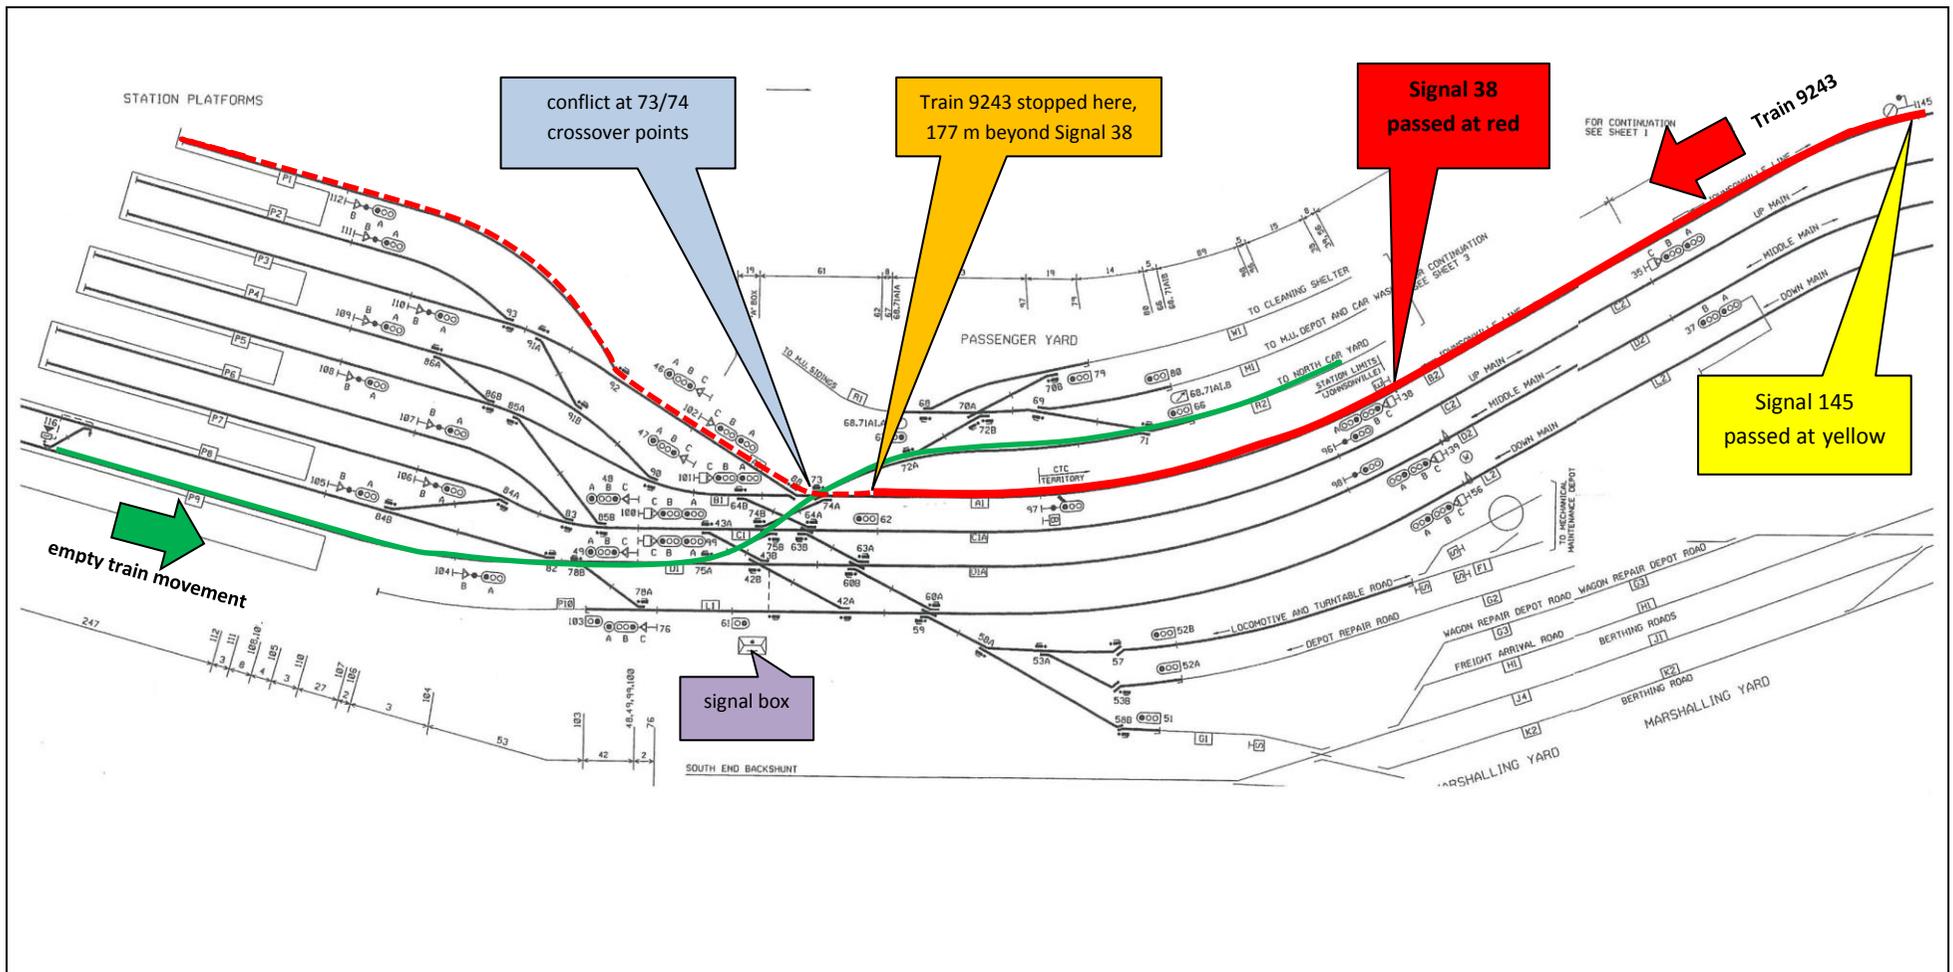
Figure 2
Track and signalling layout at Wellington showing the movement of the 2 trains
(not to scale)

- 2.1.7. Meanwhile a signaller in the Wellington signal box had set the route for an empty passenger train to go from platform 9 and through the 73/74 crossover points to the maintenance depot in the Wellington yard, a distance of 620 m. The 73/74 crossover points were the same ones over which the passenger train needed to travel in order to reach platform 1. Signal 38 was set at red so that the empty train could cross ahead of the passenger train (see Figure 2).

- 2.1.8. The empty train approached the 73/74 crossover points at 1324:32, travelling at about 17 km/h. Twenty seconds later the passenger train passed Signal 38 at red while travelling at 42 km/h with 15% braking applied. The passenger train driver was slowing his train to transit through the 73/74 crossover points. He had completely missed seeing that Signal 38 was displaying red. The 2 trains were travelling towards each other on an intersecting path at a then closing speed of 59 km/h.

- 2.1.9. Meanwhile the signaller saw on his mimic screen that the passenger train had failed to stop at Signal 38. He immediately broadcast an urgent message over the local radio channel for the passenger train driver to stop his train. The driver heard the signaller's radio call and applied full service braking from a speed of 27 km/h. The train stopped in 35 m, with the front of the train 42 m back from the crossover points (an overrun of 177 m past Signal 38). It was calculated that the rear of the empty train had cleared the crossover points 7 seconds earlier.

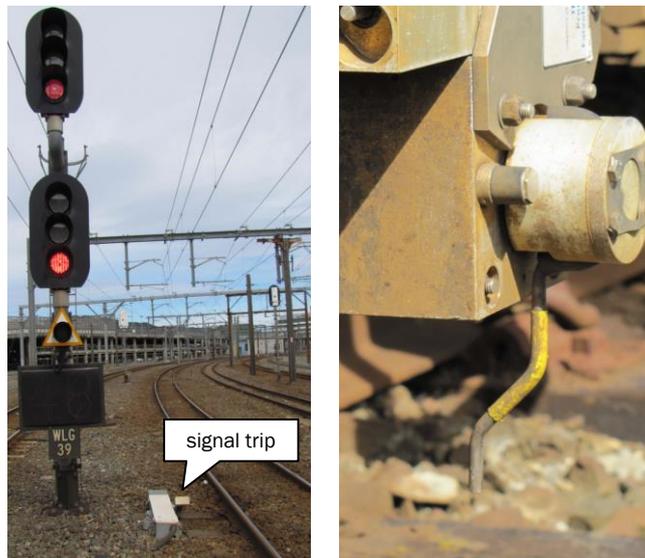
Figure 3
 A signal trip installed at Signal 39 (left) and the trip lever on a Matangi train (right)

- 3.2.3. The equivalent signals on the other 2 lines are Signal 39 and Signal 56. These 2 signals are equipped with signal trip devices at ground level (see Figure 3). The signal trip catches on a brake trip lever mounted low down on an electric train which automatically applies the train’s air brakes if the signal is passed at red.

3.2.4. Signal 38 was not equipped with a signal trip device, so in the event of an overrun there was no automatic means of stopping a train before it reached the crossover points. The Commission has recommended that such a device be installed.

On 23 October 2013, the Commission recommended that the Chief Executive of KiwiRail install some form of protection that will automatically stop a train that has overrun Signal 38 in the Wellington Station area, and that he reviews other signalling arrangements in busy, high risk metro passenger areas to ensure the same arrangements are in place to minimise the risk of train collisions for the same or similar reasons (O22/13).

A program to install a Signal trip at 38 Signal has been agreed. Design is programmed for completion by end of January 2014, and final commissioning by end of March 2014. Concurrently the Signals Engineering team will be undertaking a qualitative risk review of signalling arrangements in the Wellington Metro area. This will also be expected to be completed by end of March 2014.
