NO. 94-108
PLEASANT POINT RAILWAY
PLEASANT POINT
13 MARCH 1994

TRANSPORT ACCIDENT INVESTIGATION COMMISSION

RAIL ACCIDENT REPORT NO. 94-108

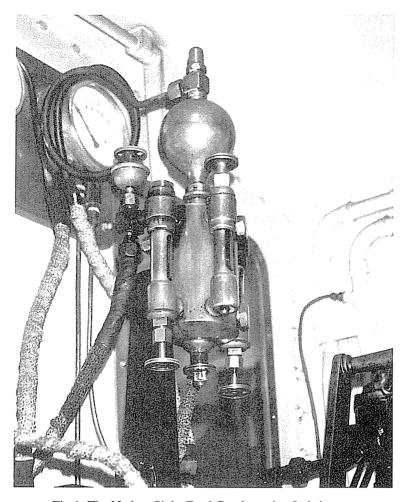
- 1.8 At 1325, when the train was about halfway towards Pleasant Point Station, the lubricator oil level sight glass on the fireman's side broke without warning. Steam and oily hot water blew into the cab, directly towards the upper chest and face of the fireman.

Fig 1: The Nathan Sight-Feed Condensation Lubricator.

- 1.17 This model of the Nathan lubricator has tubular sight glasses but no external safety shield. No data was available on the frequency of sudden failure of the glasses in service, but no anecdotal evidence of any unexplained breakage could be found.

- 1.28 The parts of the broken tubular sight glass were recovered from D16. It was apparent that the ends of the tube had not been fused, and the maker of the glass could not be identified.

- 2.6 The sight glass failure was probably due to an undetected crack or flaw of unknown origin.
- 2.7 The fireman fell from the cab, probably as a result of the fright or start caused by the sudden discharge from the lubricator, and was seriously injured.

- 3.1 As a result of this investigation, it was recommended to the Pleasant Point Railway that they:
 - 3.1.1 Replace the tubular sight glasses in the Nathan lubricator of locomotive D16 with borosilicate glass tubes that comply with or a similar to the specifications contained in NZS5301:1977, and have been heat treated to relieve the stresses caused by cutting (048/94); and
 - 3.1.2 Install a screen in front of the tubular sight glasses on the Nathan lubricator similar in design to the screen provided for boiler water level sight gauges on most steam locomotives (049/94).

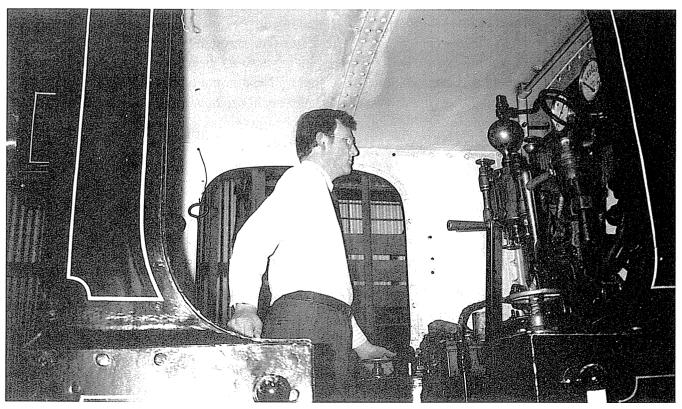
Fig 2: The normal position of the Fireman in the cab of D16.
