No. 95-117

Train 600

Pukehou

12 November 1995

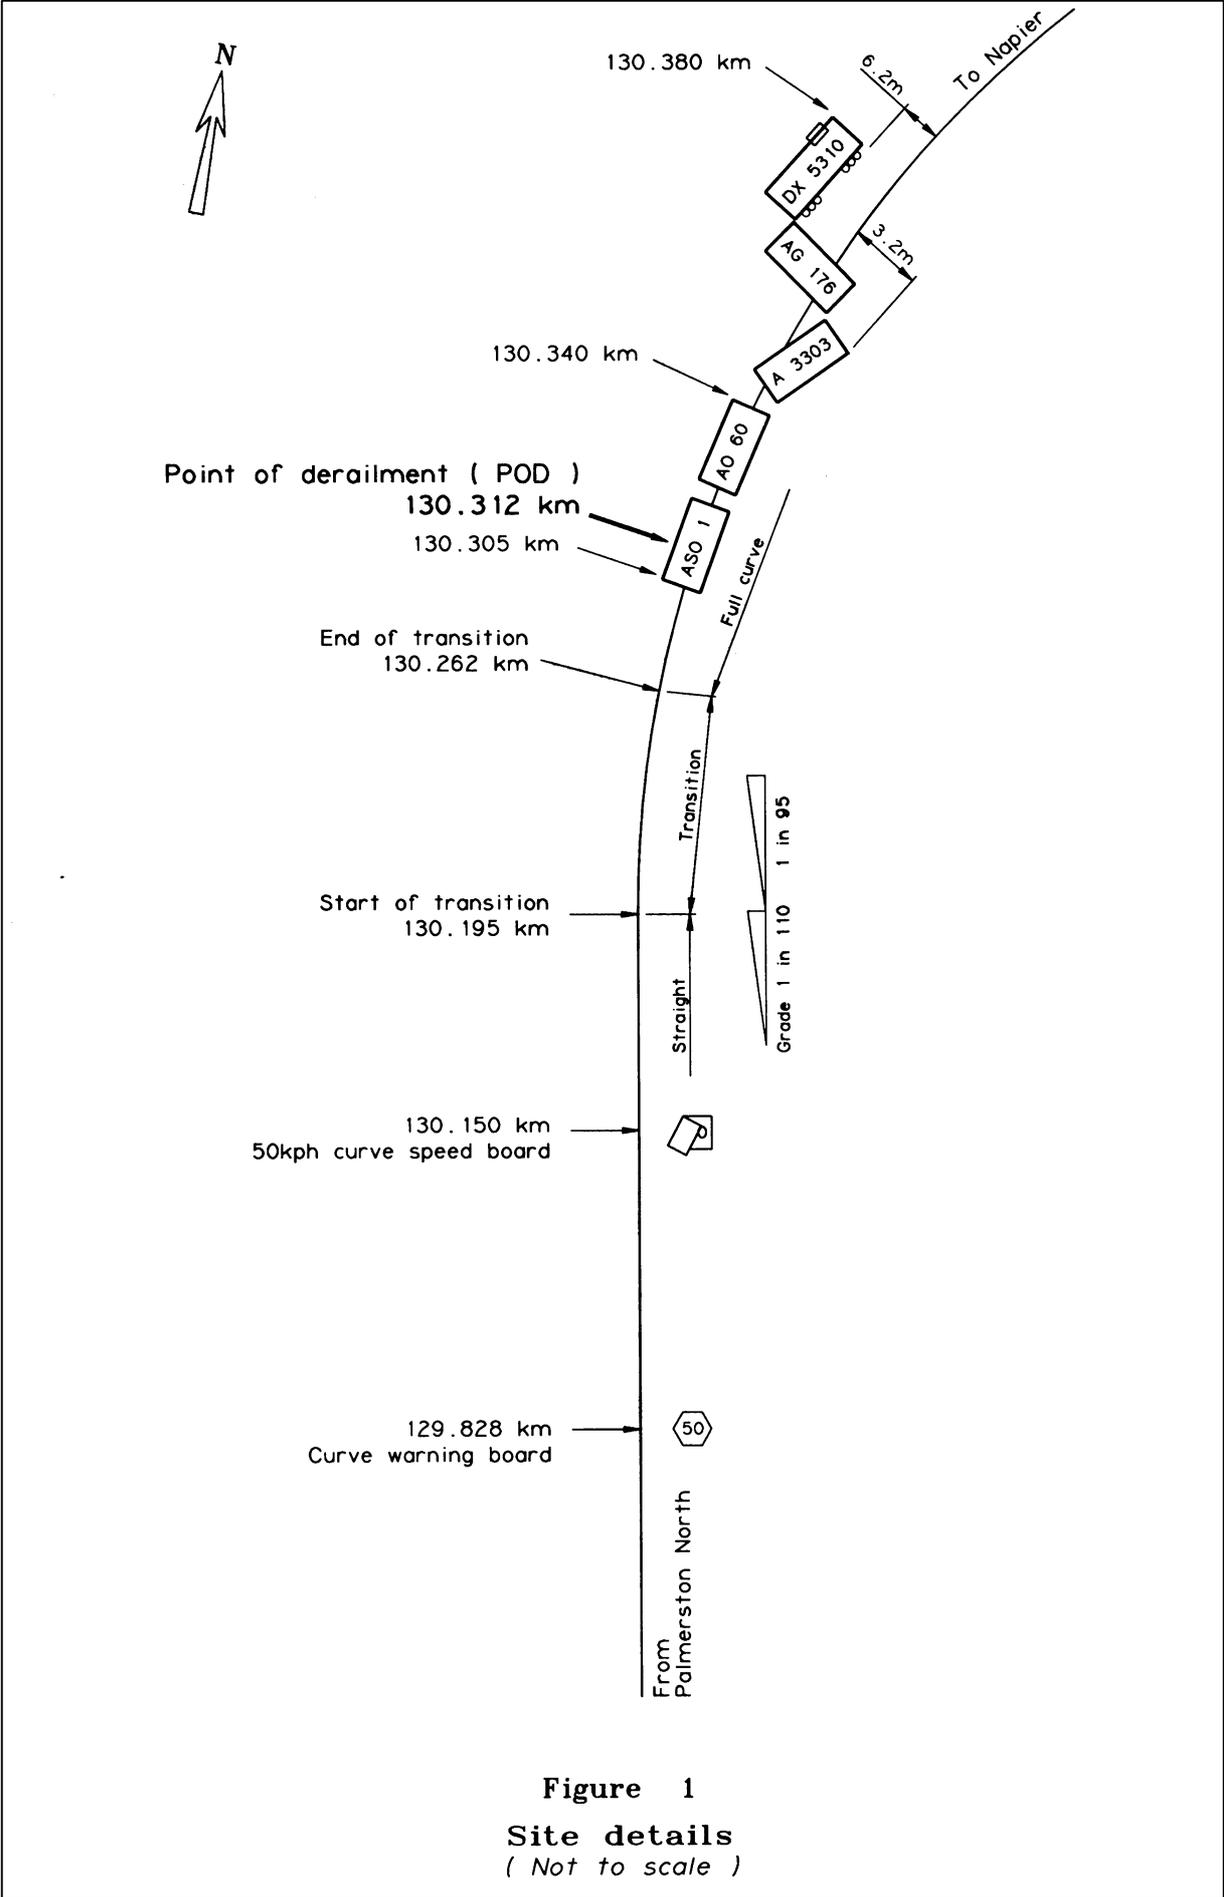
Figure 1
Site details
(Not to scale)

- 1.13 The LE's first indication of the approaching curve was looking up and seeing it some 75m ahead at which point he stated he applied emergency braking. Braking took effect progressively as the train entered the curve transition at 130.195 km and an 8% speed reduction occurred before the locomotive derailed at approximately 130.312 km, 50m into the body of the curve. (TRL curves include a transition length from curve entry to full curve radius over which radius and cant are progressively applied. In the case of the derailment curve this transition was 67m in length from 130.195 km to 130.262 km, refer Figure 1).

- 1.15 The locomotive overturned onto its left hand side and slid forward finally coming to rest 68m from the POD with its leading end opposite 130.38 km and in the position indicated in Figure 1. The locomotive was extensively damaged.

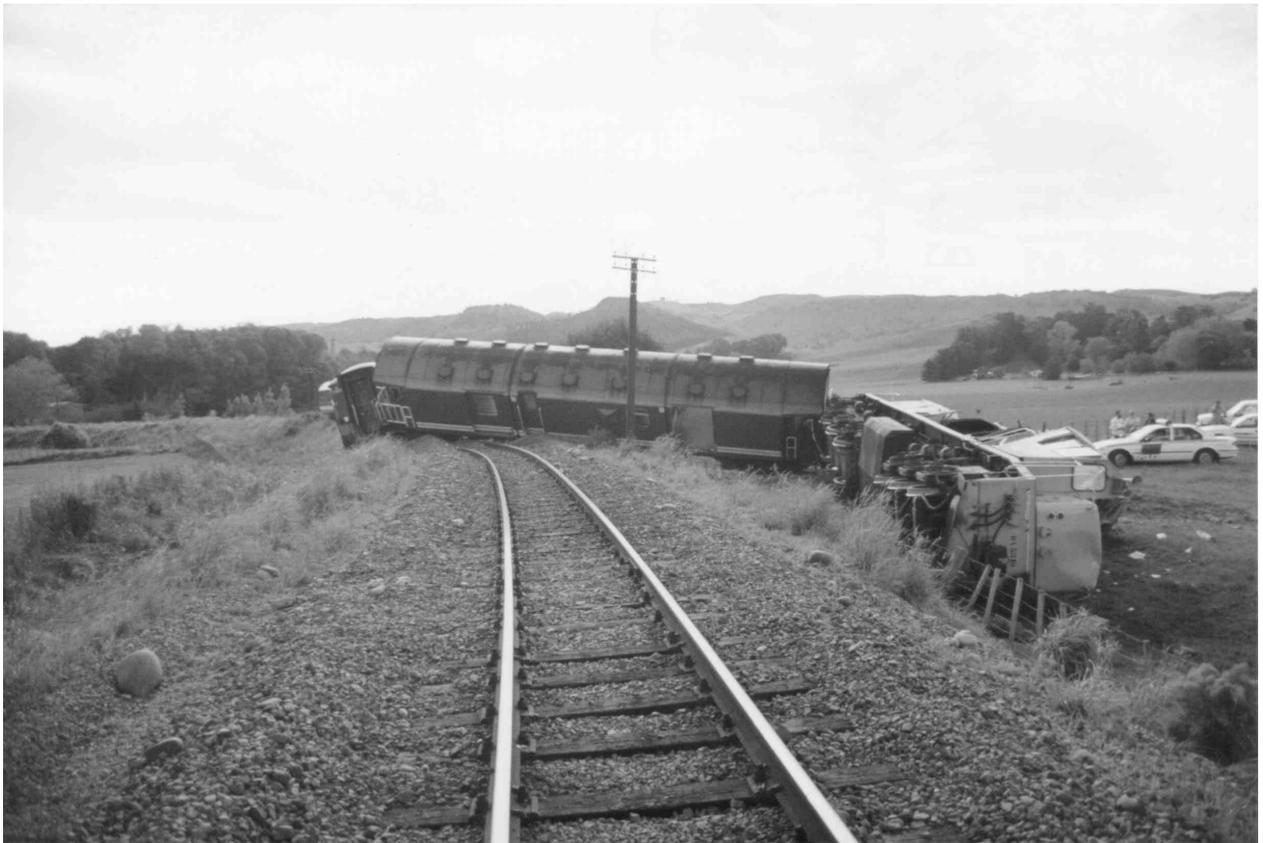
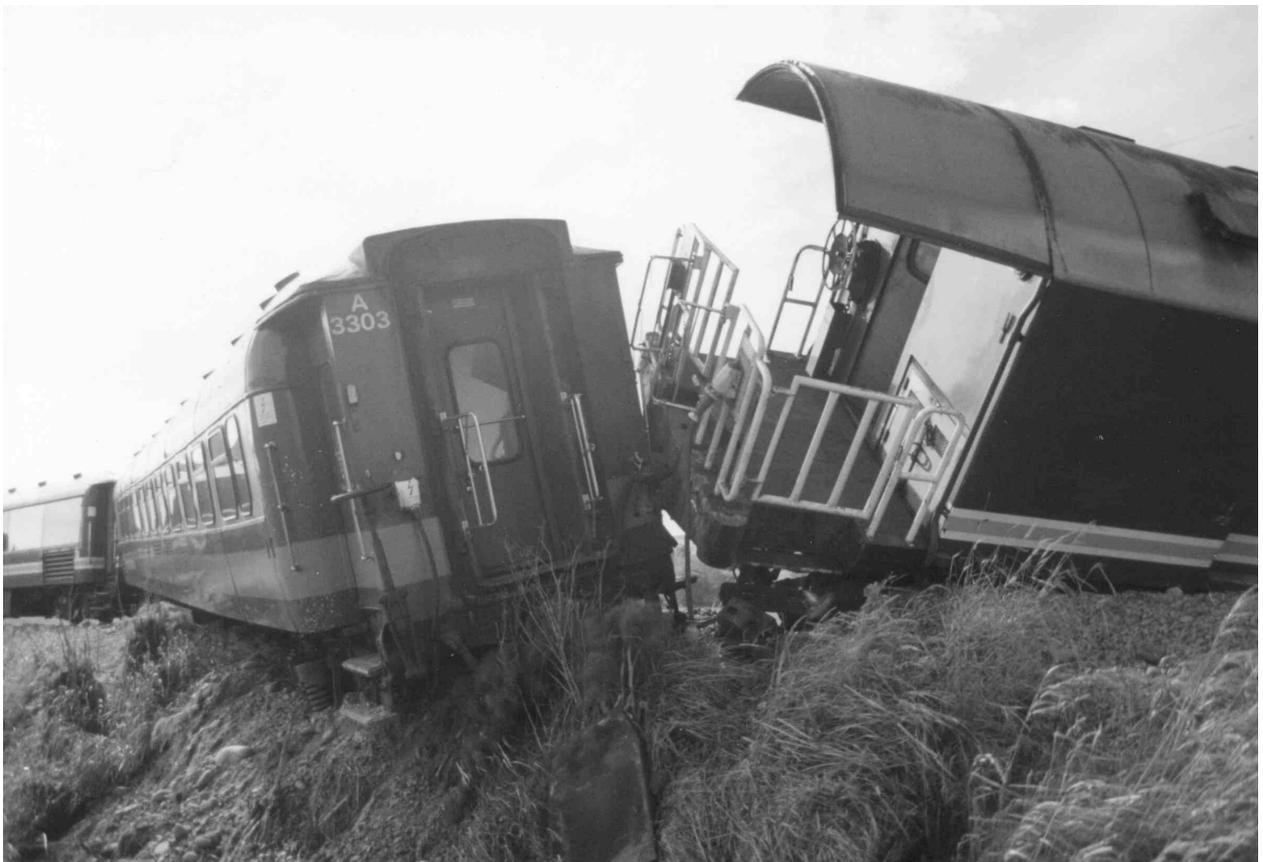
Figure 2
Position of Train 600 following derailment

- 1.17 The right hand curve was on an embankment with the ground level on the left hand side between two and three metres below rail level.
- 1.18 As a result of DX 5310 overturning van AG 176 attached to DX 5310 was derailed all wheels. A 3303 was attached to AG 176 and the leading bogie and trailing axle of the trailing bogie of this car were derailed. The two cars containing passengers and train crew at the rear of the train remained on the rails. The final position of all vehicles is shown in Figure 1. DX 5310 came to rest horizontally on its left hand side, AG 176 was leaning approximately 40° to the right in direction of travel, and A 3303 approximately 7° to the right in direction of travel, (Figure 2). Both AG 176 and A 3303 suffered minor damage.

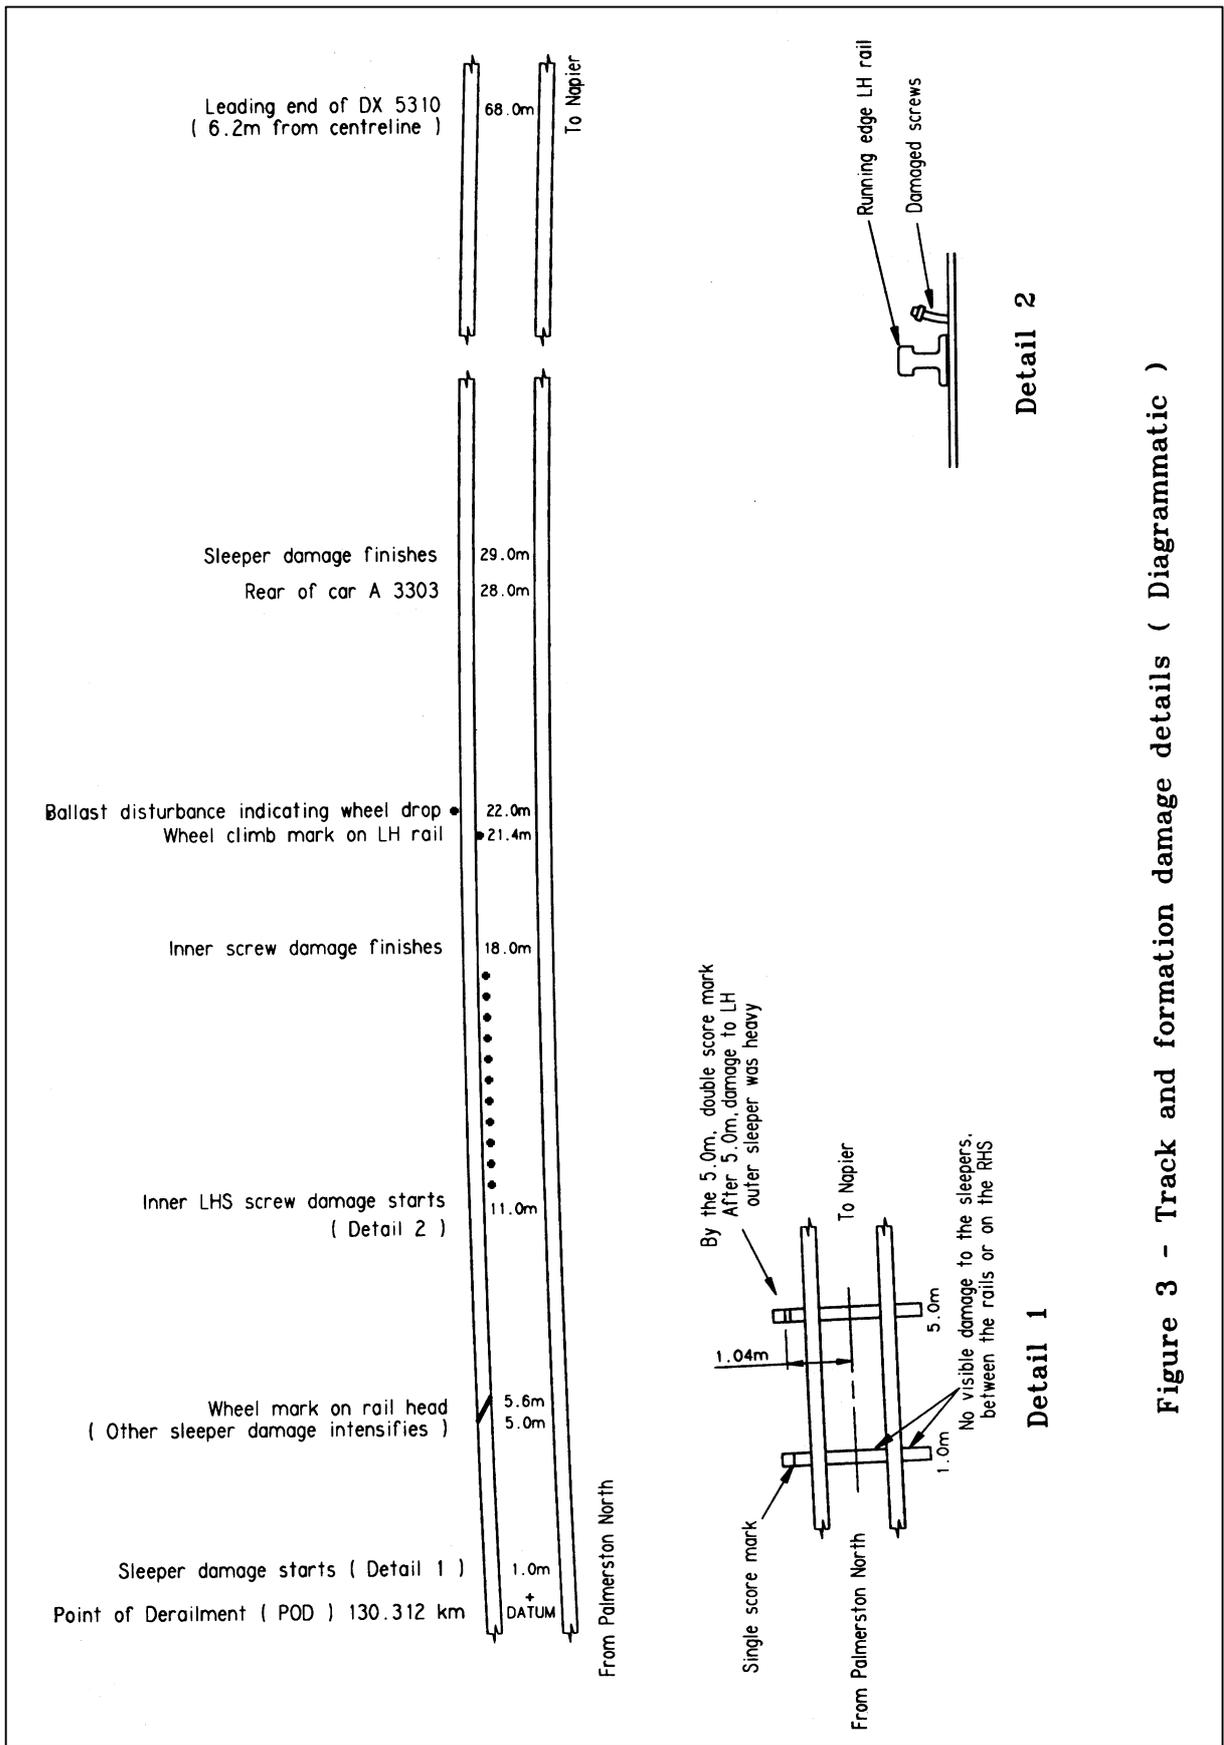
Figure 3 - Track and formation damage details (Diagrammatic)

- 1.32 Figure 3 details the relevant derailment marks on the track and formation in the vicinity of the assumed POD.

- 2.1 Score marks on the left hand side of the sleepers at 1.04 m from centreline between 130.313 km and 130.318 km were consistent with a contact made by the left hand side of the cowcatcher as the locomotive heeled, and indicated a POD at 130.312 km. The lack of any wheel markings climbing the left hand rail gauge face or crossing the rail head in the vicinity of the POD indicated derailment occurred when the locomotive heeled to the left as it entered the curve and all weight was transferred to the left hand wheels which then formed a fulcrum for over turning.

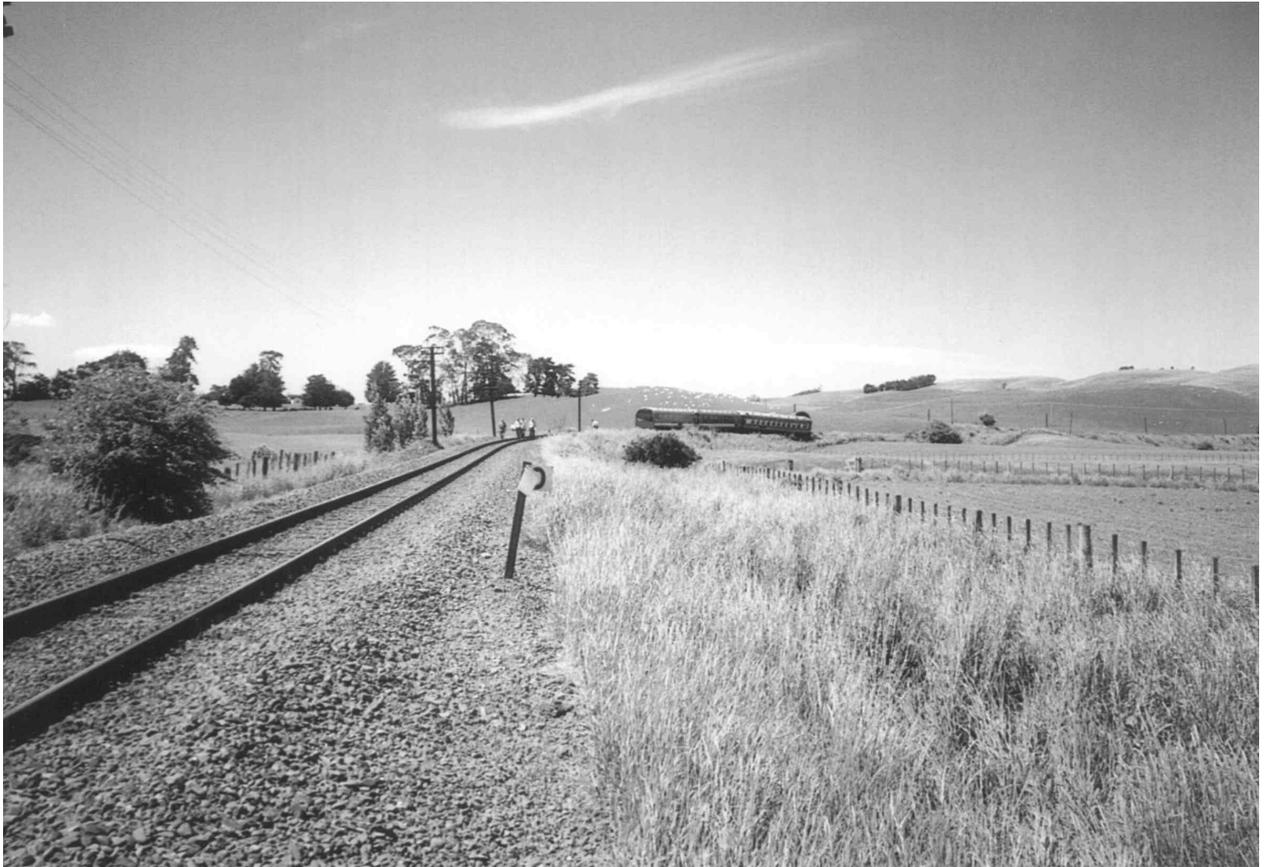
Figure 4
Curve Speed Board at 130.150 km as found following the derailment

- 2.19 The bent and obscured Curve Speed Board at 130.150 km was correctly sited 45 m before the entrance to the derailment curve. The LE stated he saw the approaching curve on looking up approximately 75 m before entry. If the Curve Speed Board had been in normal condition and displaying a 50 km/h authorised speed it is considered this would have had no effect on the end result. The key warning for the LE was the Curve Warning Board at 129.828 km, 367 m before the curve entrance. This was correctly sited and clearly visible but not noticed, or responded to, by the LE.

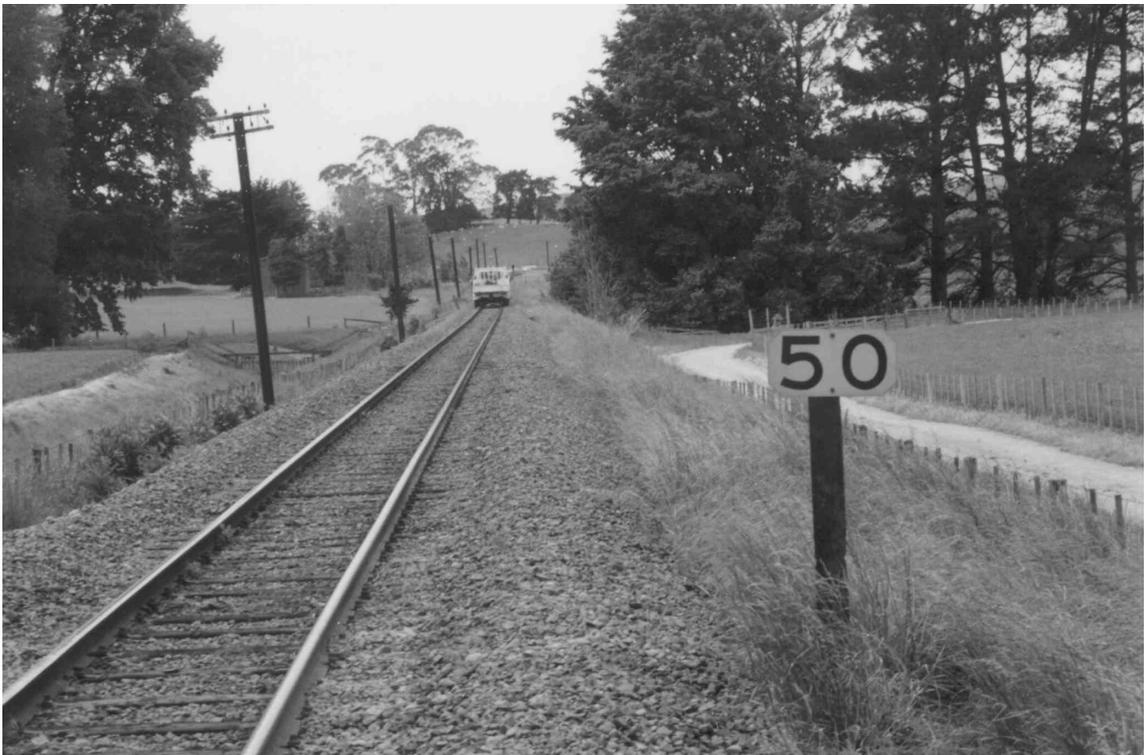
Figure 6
Curve Warning Board at 129.828 km

- 1.12 As the train traversed the Pukehou straight the LE stated he continued to refer to his Working Timetable with occasional glances up. He did not notice the Curve Warning Board for the approaching 200m radius curve which was sited on the right hand side of the track at approximately 129.828 km, or the Curve Speed Board which was sited on the right hand side of the track at approximately 130.150 km.

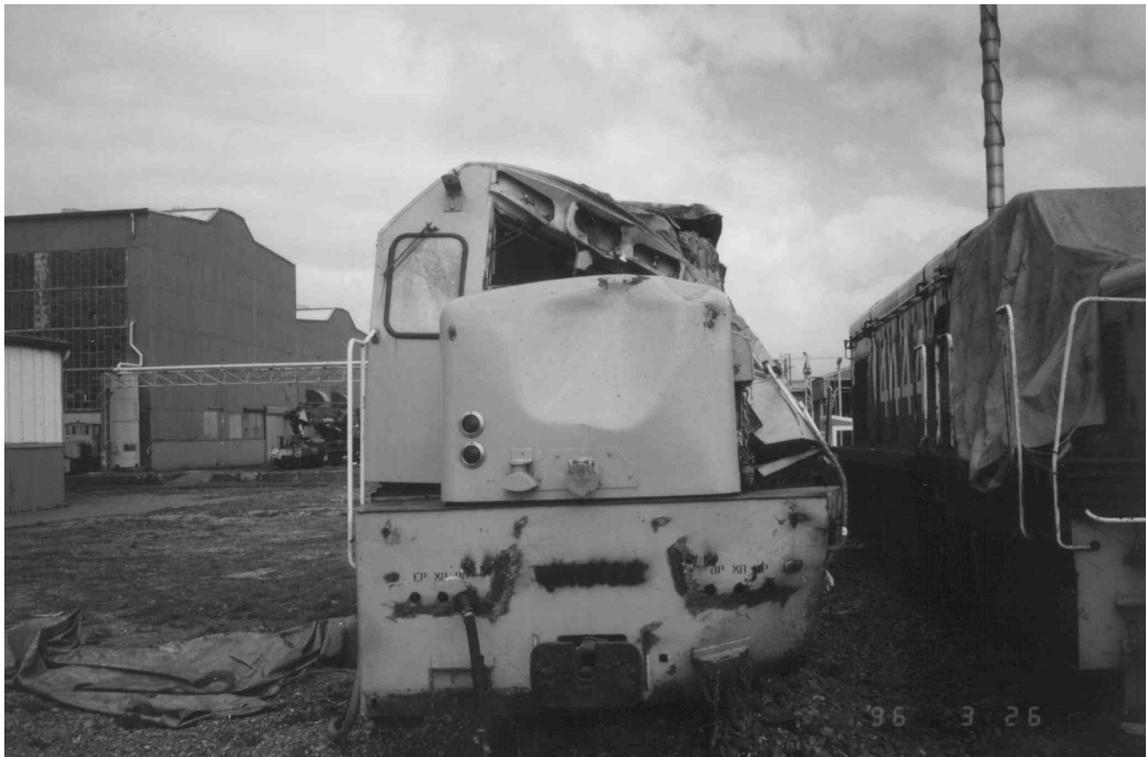
Figure 7
Damage to cab of DX 5310

- 1.45 Locomotive DX 5310 entered service in 1975 as part of an order from General Electric USA. The supply specification did not include any specific requirement for cab crashworthiness and no such details were submitted by General Electric to support their offer. The left hand side of the cab was crushed in the accident (Figure 7). This was the area occupied by the cab rider as the derailment occurred.

- 3.12 The damage to the cab of DX 5310 was consistent with that expected in a high speed derailment for a locomotive of this age and type.
