Report 99-109

Southerner passenger express Train 902

track warrant overrun

21 May 1999

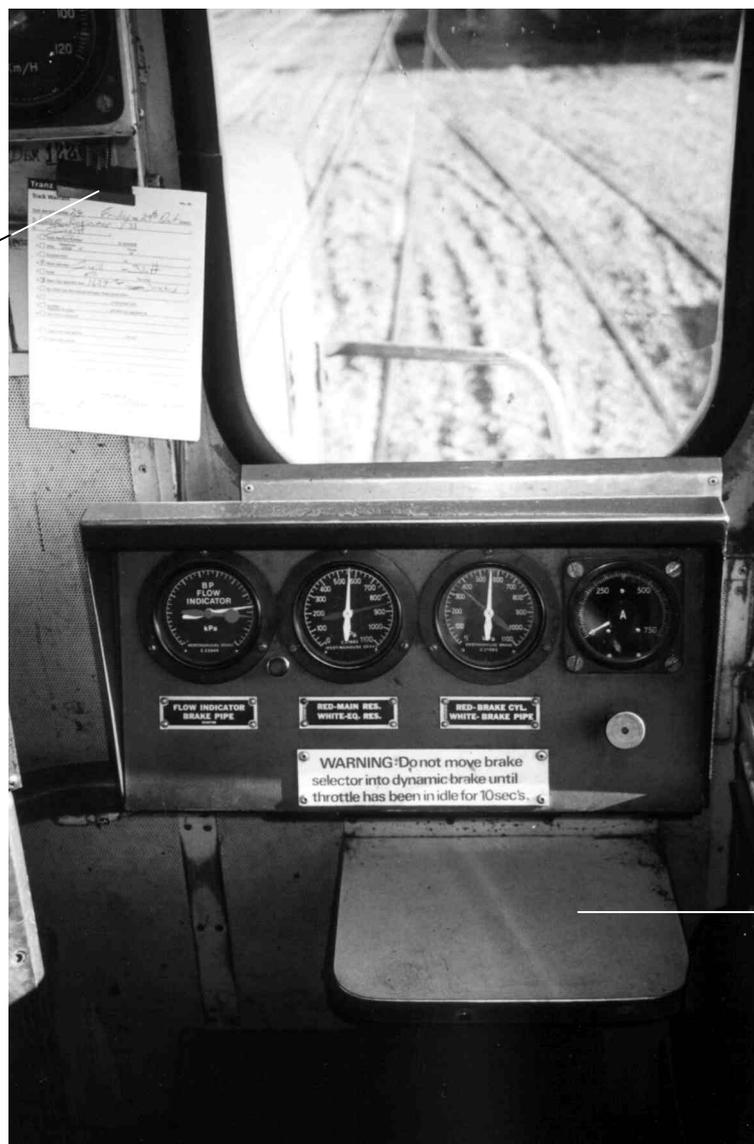
Figure 2
The position of the track warrant clip in a DBR class locomotive cab
(similar profile and configuration to a DC class locomotive cab)

1.4.1 A clip was provided in the locomotive cab in front of the LE. While there is no formal requirement to use the clip for track warrant purposes it is generally accepted that this is for the purpose of displaying track warrants or other operational documentation. On the day of the incident the track warrant was lying loose in the lunch tray. Figure 2 shows the relative positions of the clip and the tray.

Clip generally used
for track warrants

Lunch tray

- 2.4 The most significant factor likely to have contributed to the LE overrunning his track warrant was that of mindset; “the usual track warrant for this train over this section is to Dunedin therefore I must have a track warrant to Dunedin”. This situation can arise when the same LE on the same train operates on the same track warrant limits frequently and consistently. When he gets a different track warrant under these conditions there is a potential for repeat “conditioning” to override the awareness necessary to react to the changed circumstances. By having his track warrant on his lunch tray instead of in the clip provided, the LE deprived himself of an important visual reminder of his track warrant limit.

- 2.5 Although the existence of the clip was common knowledge, the requirements for its use were not formalised. There was evidence of LEs not using the clip for this purpose, preferring instead to use the lunch tray immediately in front of them.

- 3.1 Train 902 was being operated normally prior to the incident.
- 3.2 The LE was appropriately certified for the duties being carried out.
- 3.3 Train 902's overrun of its track warrant limits by approximately 2 km did not conflict with other train movements or track obstructions.
- 3.4 The LE's uncertainty as to the status of the level crossing protection resulted in him planning an unusual stop to obtain a new track warrant.
- 3.5 By leaving the track warrant lying on the lunch tray in front of him, instead of the on the clip provided in the locomotive cab, the LE may have deprived himself of an important visual cue for maintaining situational awareness.

- 4.1 On 3 April 2000, it was recommended to the managing director of Tranz Rail that he:
- 4.1.1 improve the resilience of the track warrant system to accommodate deviations from standard patterns, taking particular account of the need for:
- an improved method of providing an LE with a continuous and conspicuous visual display of his track warrant limit
 - introducing a system to identify the position of trains in track warrant territory which would increase the situational awareness of LEs as they approached the limit of their track warrant, and limit the possible consequence of any overrun which may occur (001/00); and
- 4.1.2 standardise and enforce relief arrangements for LEs involved in serious operating irregularities (002/00).
