## **Report 99-125**

### **Train 200**

**passed conditional stop board without authority**

**between Ohau and Levin**

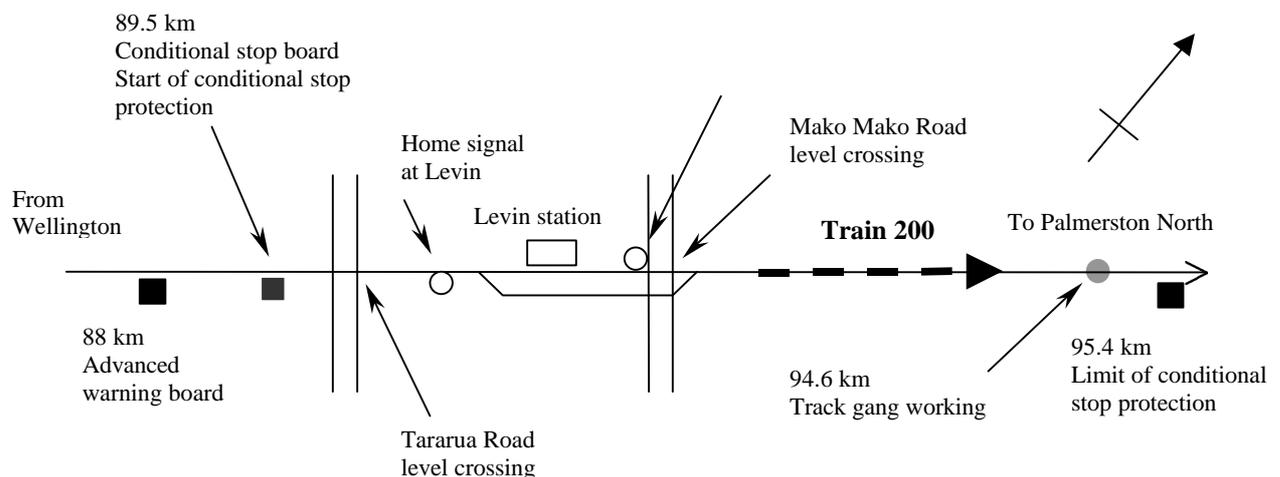
**Figure 1**  
**Plan of work area including conditional stop board protection area**  
 (not to scale)

- 1.1.22 The site at which the track gang was working at the time of the incident was approximately 5.1 km north of where the southern conditional stop board was erected. The conditional stop board marking the work area for southbound trains was a further 800 m north of the worksite (refer Figure 1).

- 3.3 The conditional stop boards had been placed in accordance with documented procedures but the south board had not been placed in the most appropriate position, which resulted in potential confusion for the LE and unnecessary delays to road traffic
