RAILWAY ACCIDENT

Report on the Derailment
that occurred on 20th May 1970
at Audenshaw Junction
near Guide Bridge

IN THE
LONDON MIDLAND REGION
BRITISH RAILWAYS

1971

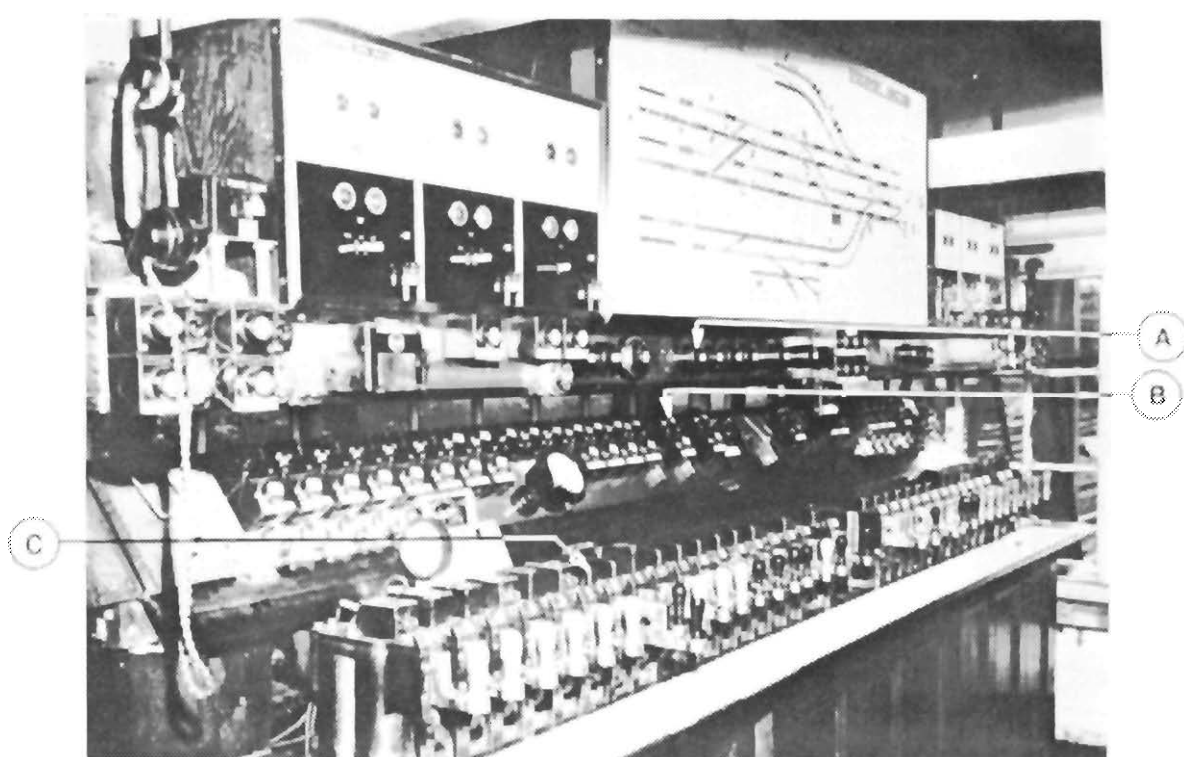
FIG.1 GENERAL VIEW OF FRAME.

of the frame with its electric lock dog on top of the slide, when Allman placed the signalbox electric Bardic handlamp across the economiser terminals of slides No. 5 and No. 6 and said "Try That". (This is shown in figure 1 at the front of this report).

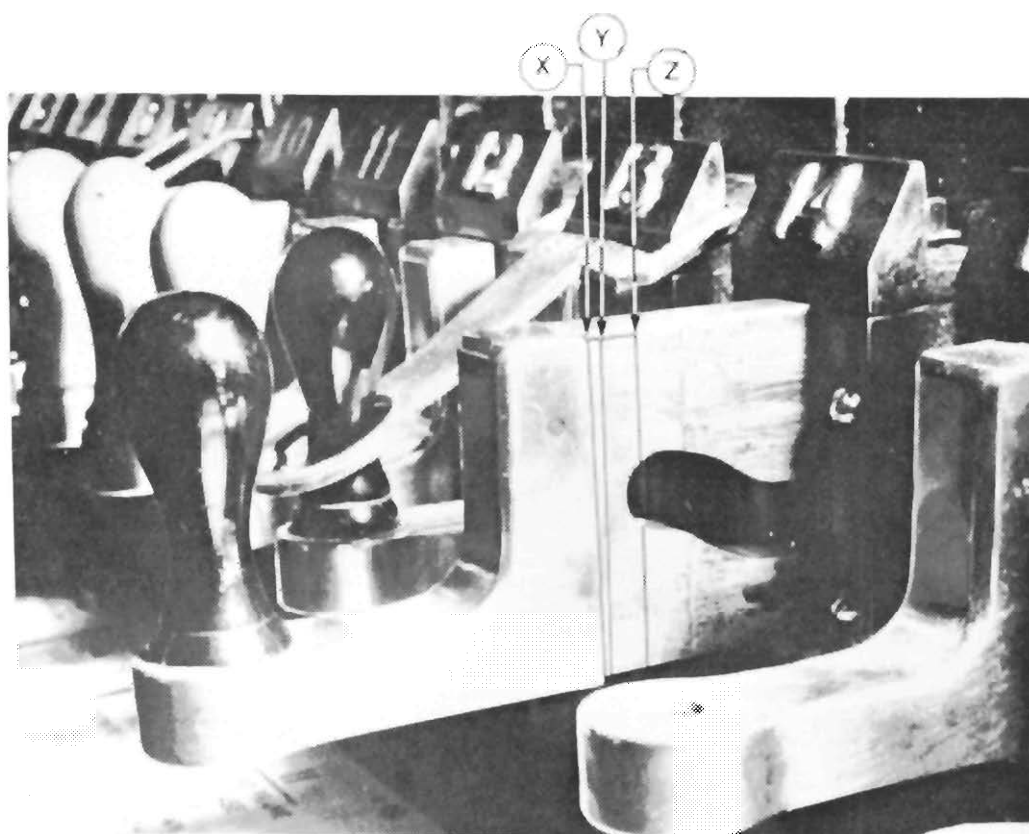
FIG.2 SLIDE No.14 (HANDLE OF No.15 REMOVED)

SHOWING POSITIONS:—

- X. SLIDE FULLY NORMAL
- Y. ELECTRIC LOCK EFFECTIVE
- Z. MECHANICAL LOCKING EFFECTIVE

36. He told me they were discussing the position with the signalman when Allman obtained a Line Clear Block Release from Ashton Junction so releasing signal slide No. 6. Mr. Blyth told me that at Allman's suggestion he pulled slide No. 6. and was trying to manipulate slide No. 5 with slide No. 14 pulled slightly out

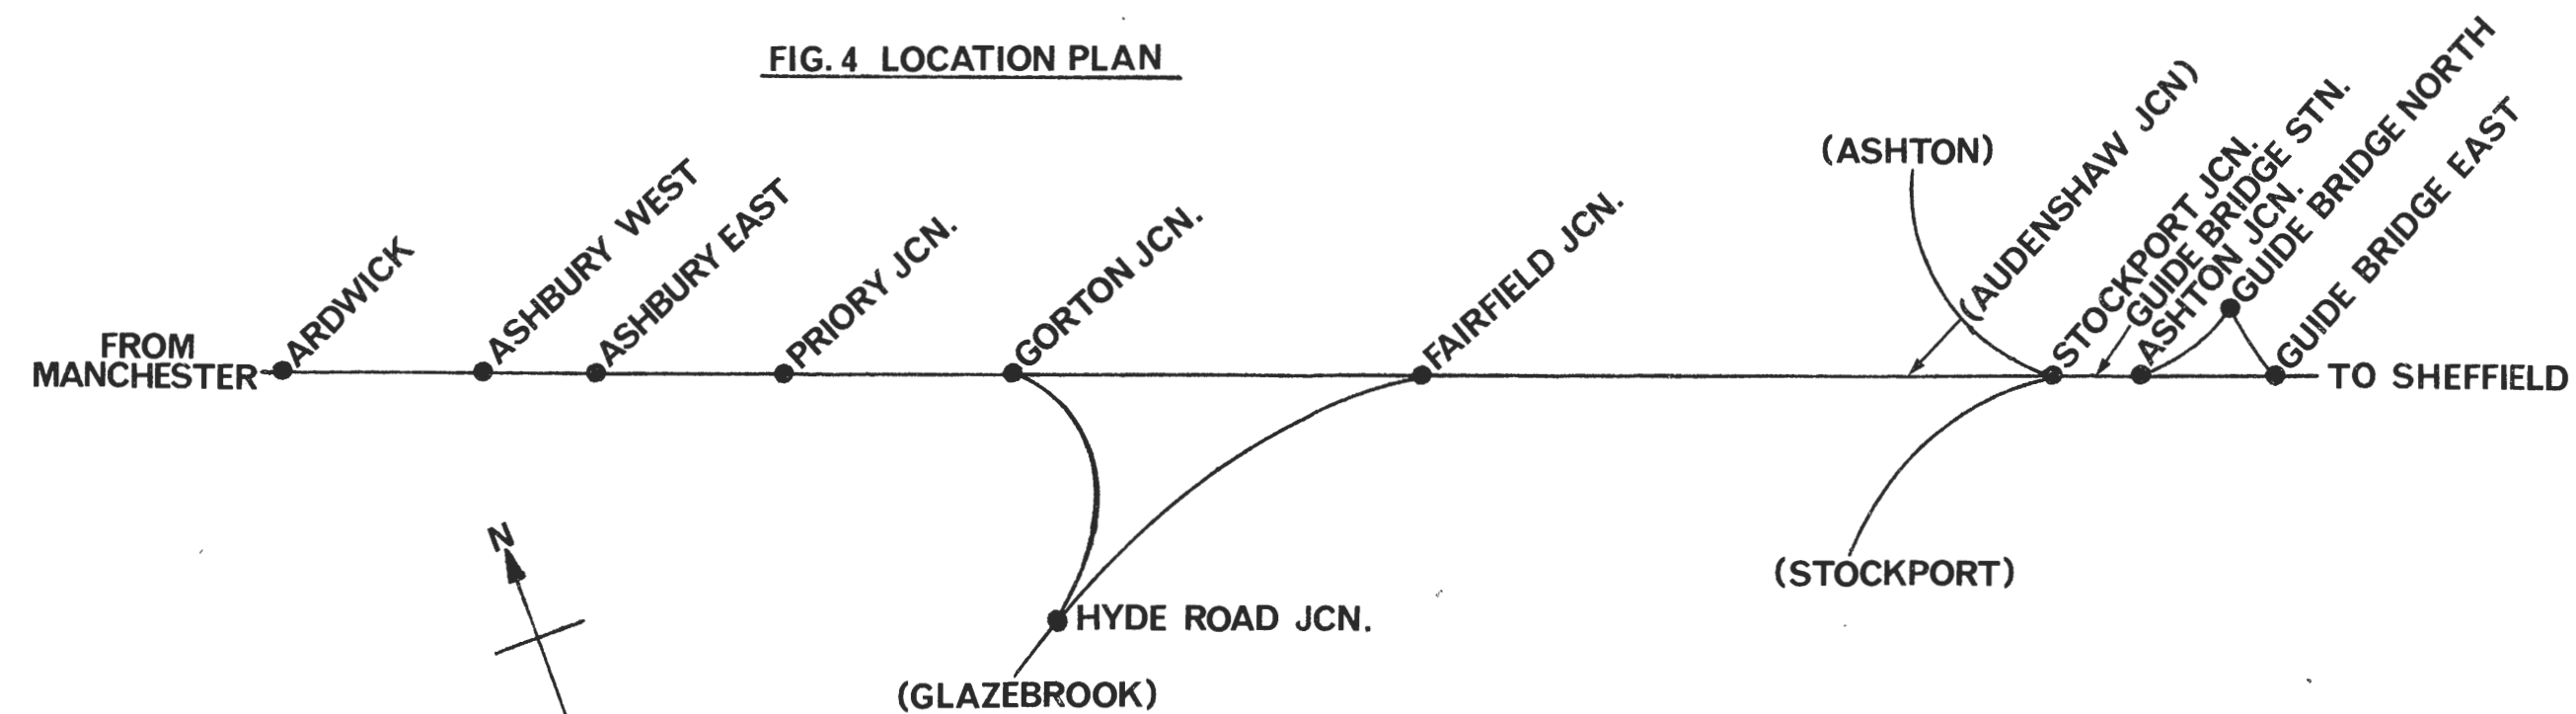
FIG. 4 LOCATION PLAN

1. The Manchester-Sheffield main line via Hadfield and Penistone is electrified on the overhead system at 1500 volts DC. Audenshaw Junction as shown in Fig. 4 at the back of this report, lies between Fairfield Junction and Guide Bridge stations and is about $4\frac{1}{2}$ miles from Manchester Piccadilly station. It is controlled from Stockport Junction signalbox beside the Down Fast line (Down to Manchester) at the Manchester end of Guide Bridge station. The Up and Down Slow lines lie to the north of the Up and Down Fast lines, and are connected with them through a left hand double crossover at Audenshaw some 1300 yards from the signalbox, and out of sight of it. There is a right hand double crossover by the signalbox where branch lines from Ashton Moss South and Denton Junction also connect. The gradients are 1 in 133 rising from Fairfield Junction and 1 in 364 on the approach to and over Audenshaw Junction up to the signalbox.

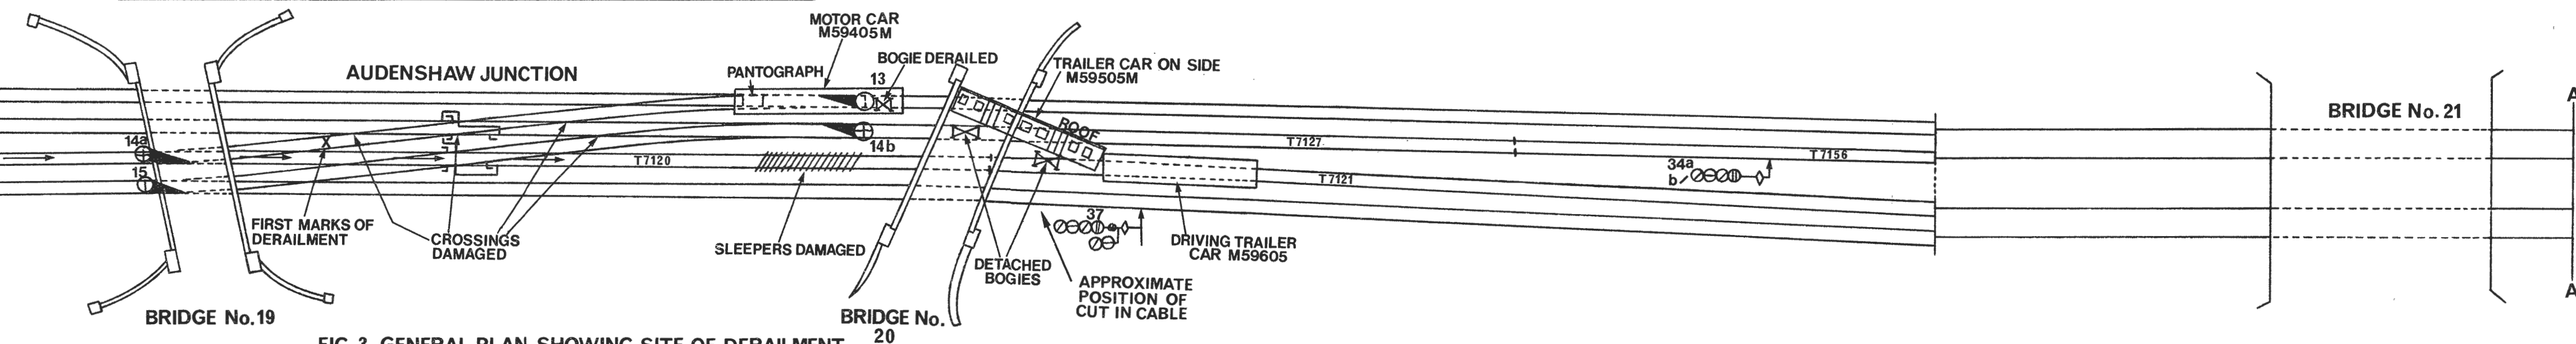
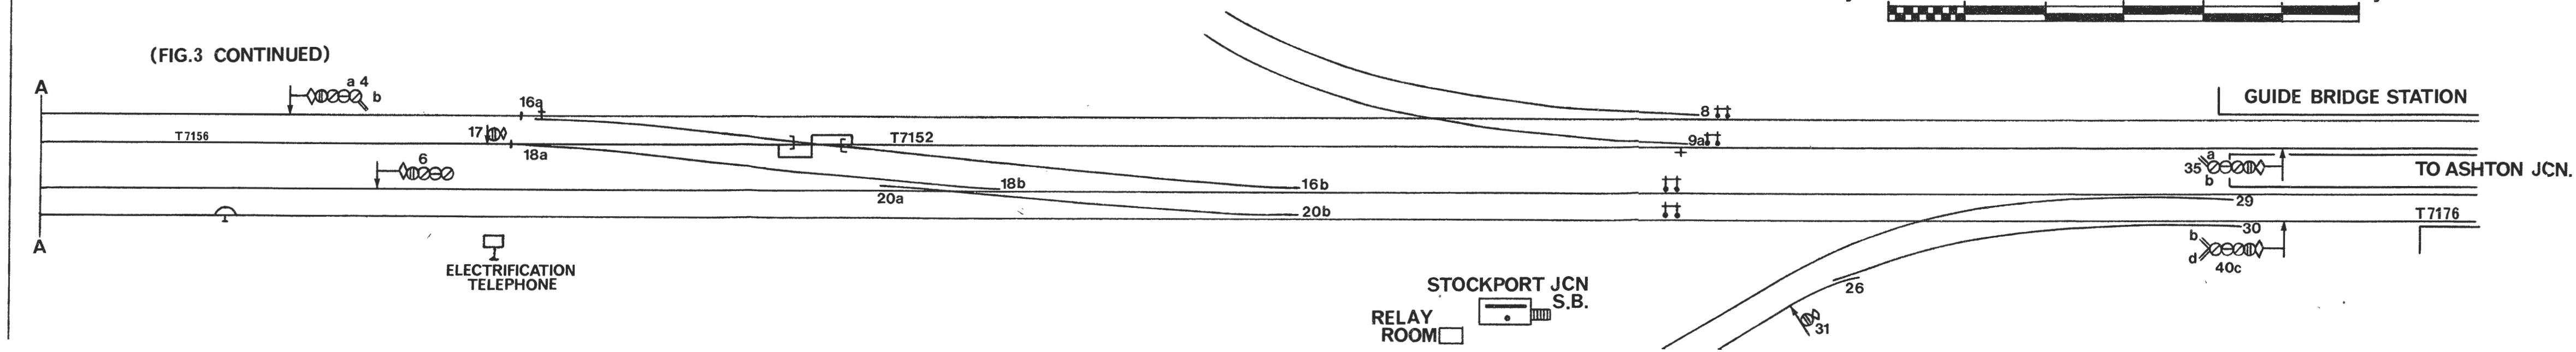
FIG. 3 GENERAL PLAN SHOWING SITE OF DERAILMENT

9. The train came to rest with the driver's cab on the Up Fast line some 120 yards beyond No. 14a facing points and the rear car on the Up Slow line some 73 yards beyond the points as shown in Fig. 3. Between them lay the middle car on its near side its bogies having become detached from it which were lying derailed on the Up Fast and Down Slow lines. There were no marks of damage on 14a switches and the first mark of derailment was on the crossover beyond the common crossing where the marks on the sleepers in the 4 foot of the crossover and the point rail of the Up Fast line were consistent with those of a bogie having been jerked sideways off the track between the common crossing and the end diamond crossing in the Down Slow line, to the offside of it in the direction of the Up Fast line. Damage to the points and crossing work beyond that point was considerable especially to the diamond crossing, and sleepers had been damaged by both the derailed bogies of the centre car as they were dragged along the Up Fast and Down Slow lines. Trailing points No. 13 were also slightly damaged and the point operating equipment beside the Up Slow line severely damaged.

31. *S & T Technician E. R. Clark* was sent to Stockport Junction signalbox on about 2nd October to deliver wiring diagrams to the relay room and to change some lamps on the block shelf. He told me that on arriving at the signalbox he went straight to the relay room behind it and was surprised when Signalman Walmsley came down there and began questioning him about the equipment. Walmsley then returned to the signalbox and Clark later followed him. He said that before changing the lamps and while standing near the signalbox door he saw Walmsley pull slide No. 30 fully reverse and then replace it to the mid position. Surprised, he asked Walmsley why he had done it and Walmsley replied that it enabled him to beat the approach locking of the points. (No. 30 points are approach locked when track circuit No. 7176 is occupied until 60 seconds have elapsed). He understood from Walmsley that he did this when he was not certain of the destination of the next train and it allowed him to move the points immediately the driver telephoned him from the signal, instead of having to wait the full release time. (The points are shown in Fig. 3).

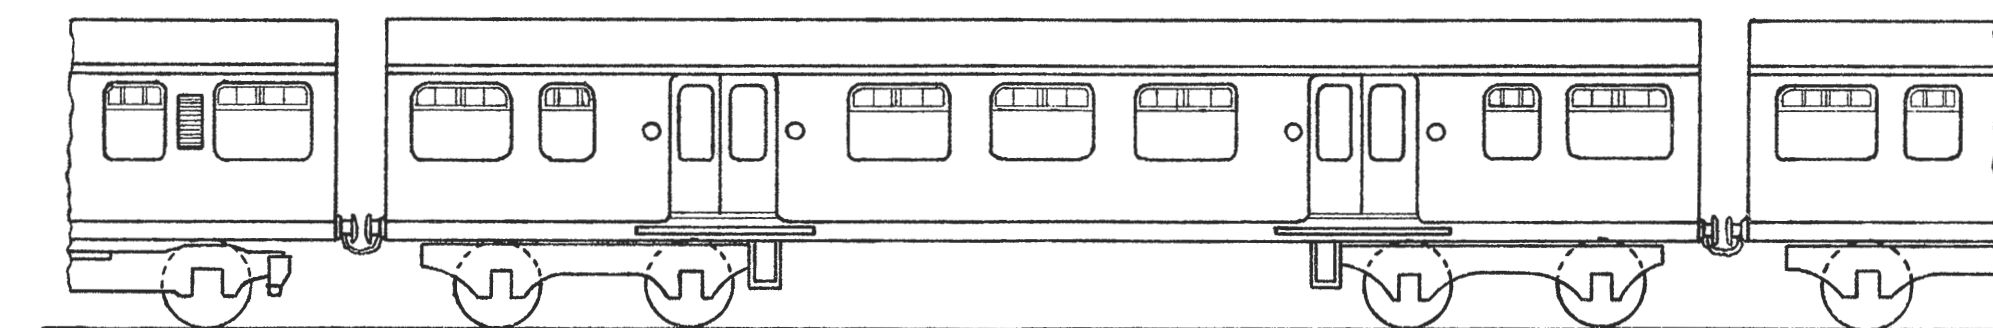
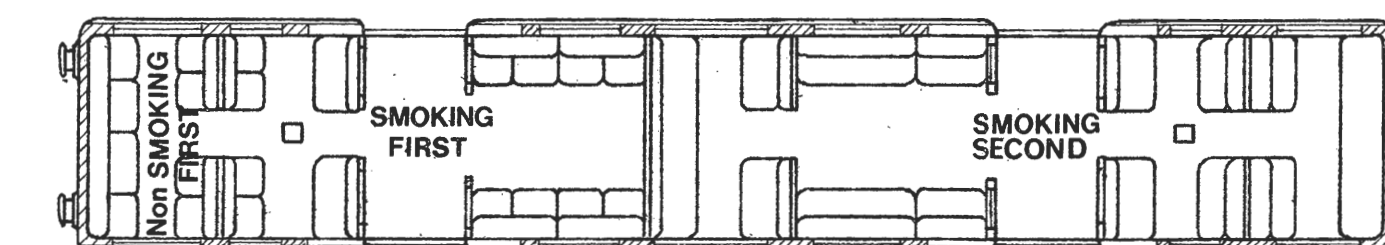
FIG. 7
CENTRAL CAR COMPOSITE
TRAILER M59505M

8. The train was 178 feet overall and weighed 104 tons 16 cwt. Its wheelbase overall was 165 ft 5 in and the clear wheelbase of the central car was 38 ft 0 in. It was screw coupled with side buffers. Each car had two power operated sliding doors for passengers on each side but there was no inter-connection between cars. Moreover the central car was divided into two separate compartments for 38 second class passengers (to the front) and 24 first class passengers (to their rear), with no through door. Seats were placed both laterally and longitudinally in both, as shown in Fig. 7.
