DEPARTMENT OF TRANSPORT

RAILWAY ACCIDENT

**Report on the Collision that
occurred on 19th December 1978
between Hassocks and Preston Park**

IN THE
SOUTHERN REGION
BRITISH RAILWAYS

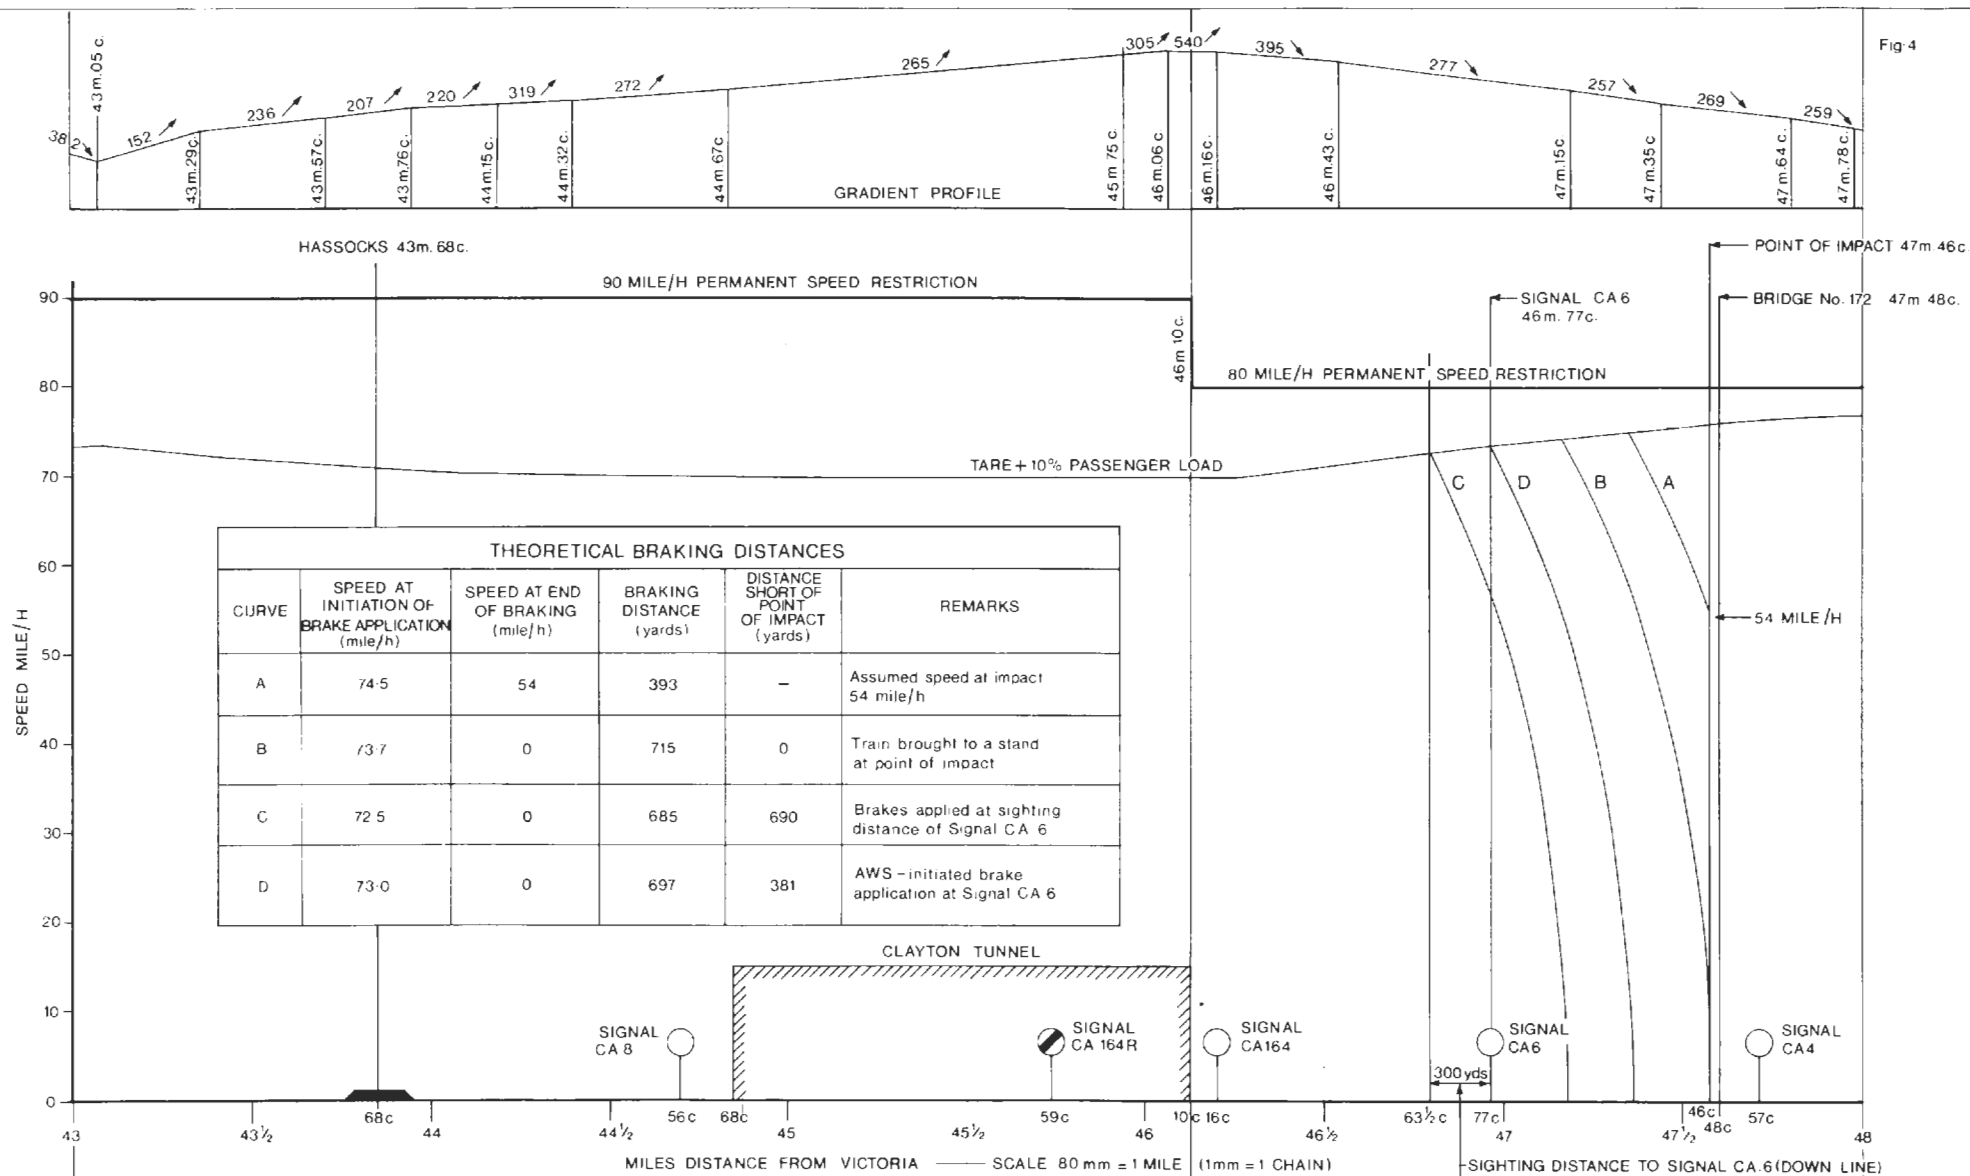
Fig 4

36. To supplement these practical tests Mr Vine produced a number of theoretical curves based on the known train performance and braking data. They assume a train formation identical to that of the 21.40 train, with a 10 per cent passenger load, as estimated for the train in question, and a line voltage of 675 volts. With the train on full power the speed passing Hassocks was calculated to be just above 70 mile/h, the speed through the tunnel as just fractionally below 70 mile/h and thereafter increasing to 73 mile/h at Signal CA.6. These speeds may be compared to the actual speeds recorded during Test 3, the fact that the actual speeds were higher being due to the test train being empty and running during the night when the traction voltage may have been above 675 volts. The curves are shown in Figure 4 opposite. The first curve (A) assumes an impact speed of 54 mile/h, the speed at which the speedometer needle jammed. If the train had been under full power, the emergency brake application would have been initiated 393 yards before the back of the 21.50 train. This should be compared with the 418 yards sighting distance to the rear blind of this train. The duration of the emergency application would have been 12 seconds and this should be compared with Guard Wadey's estimate of a 10 second emergency brake application before the collision — see paragraph 22. The second curve (B) assumes that the train was under full power but that the emergency application was just able to bring the train to rest before it hit the train in front. To do this the braking would have had to be initiated 715 yards in rear of the other train, that is at a greater distance than the available sighting distance. The third curve (C) assumes that the train is driven past Signal CA.164 under full power and an emergency application made as Signal CA.6 comes into sight, at red, the normal sighting distance to this signal being 300 yards. This shows that the train would over-run the signal by 385 yards but would stop 690 yards clear of a 12-car train stopped at Signal CA.4. The final curve (D) shows the effect of a non-cancelled AWS warning at Signal CA.6 and shows that from a speed of 72 mile/h the train would be brought to a stop in 697 yards, that is 381 yards short of the train ahead.

45. The curves reproduced in Figure 4 on page 11 show that an AWS-initiated brake application at Signal CA.6 would have brought the train to a stand 381 yards short of the train ahead even had it been travelling at 72 mile/h as it approached the unlit signal. This accident must, therefore, join the list of other serious accidents in Southern Region which would in all probability have been avoided had the signals and trains concerned been fitted with AWS. In his report on the high speed collision near Marden in January 1969, Colonel Robertson summarised the history of AWS in Southern Region and explained why the Region was less advanced than the rest of British Railways in the provision of AWS. The situation, as it then existed, was also described by Lieutenant Colonel McNaughton in his report on the collision at Copyhold Junction, near Haywards Heath, on the London to Brighton Line, in December 1972. Further developments have taken place since then. In order to present a coherent account, I shall reiterate briefly the history of AWS in Southern Region and bring the story up to date.

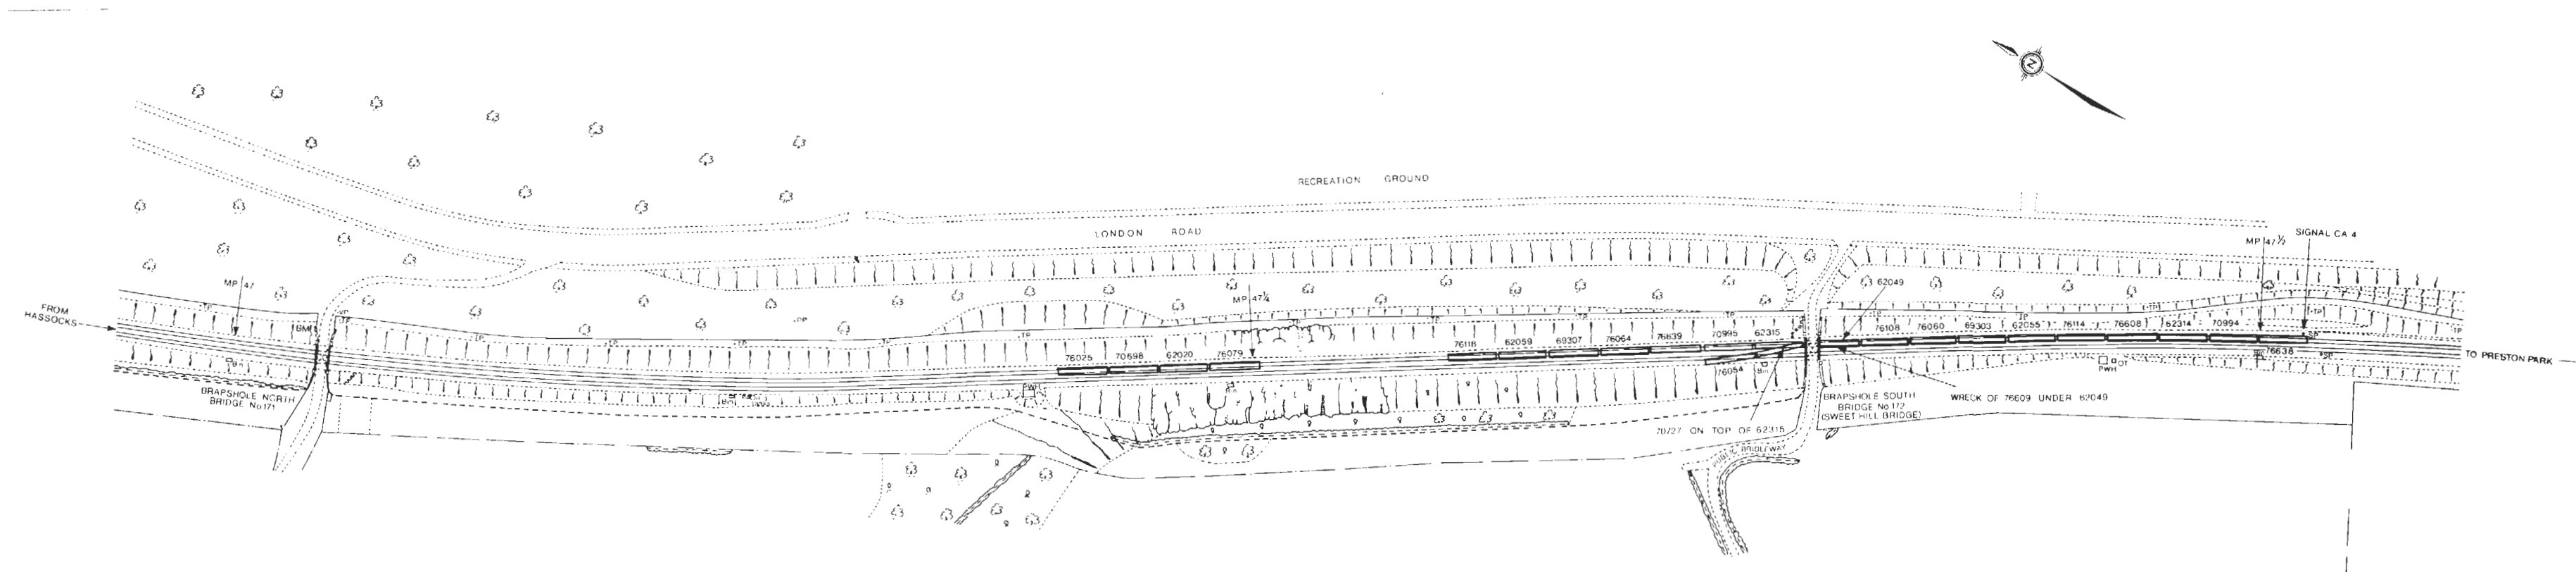
FIG:2

8. Figure 2 at the back of the report shows the position of the individual coaches within each train at the time of the accident.

top of the tenth coach and the underside of the bridge. When the Littlehampton train came to rest, what remained of its leading coach was under the tenth coach of the Brighton train, the rear parts of both these coaches being under Sweet Hill Bridge. Immediately to the north of the bridge came the second and subsequent coaches of the Littlehampton train, still in line and on the rails. The eleventh coach of the Brighton train was lying at an angle on top of the second coach of the Littlehampton train and the twelfth Brighton coach was diagonally across the Up line, alongside the third coach of the Littlehampton train.
