# RAILWAY ACCIDENT

**Report on the Collision that  
occurred on 26th January 1985  
near Micheldever**

IN THE  
SOUTHERN REGION  
OF BRITISH RAILWAYS

*1st February 1986*

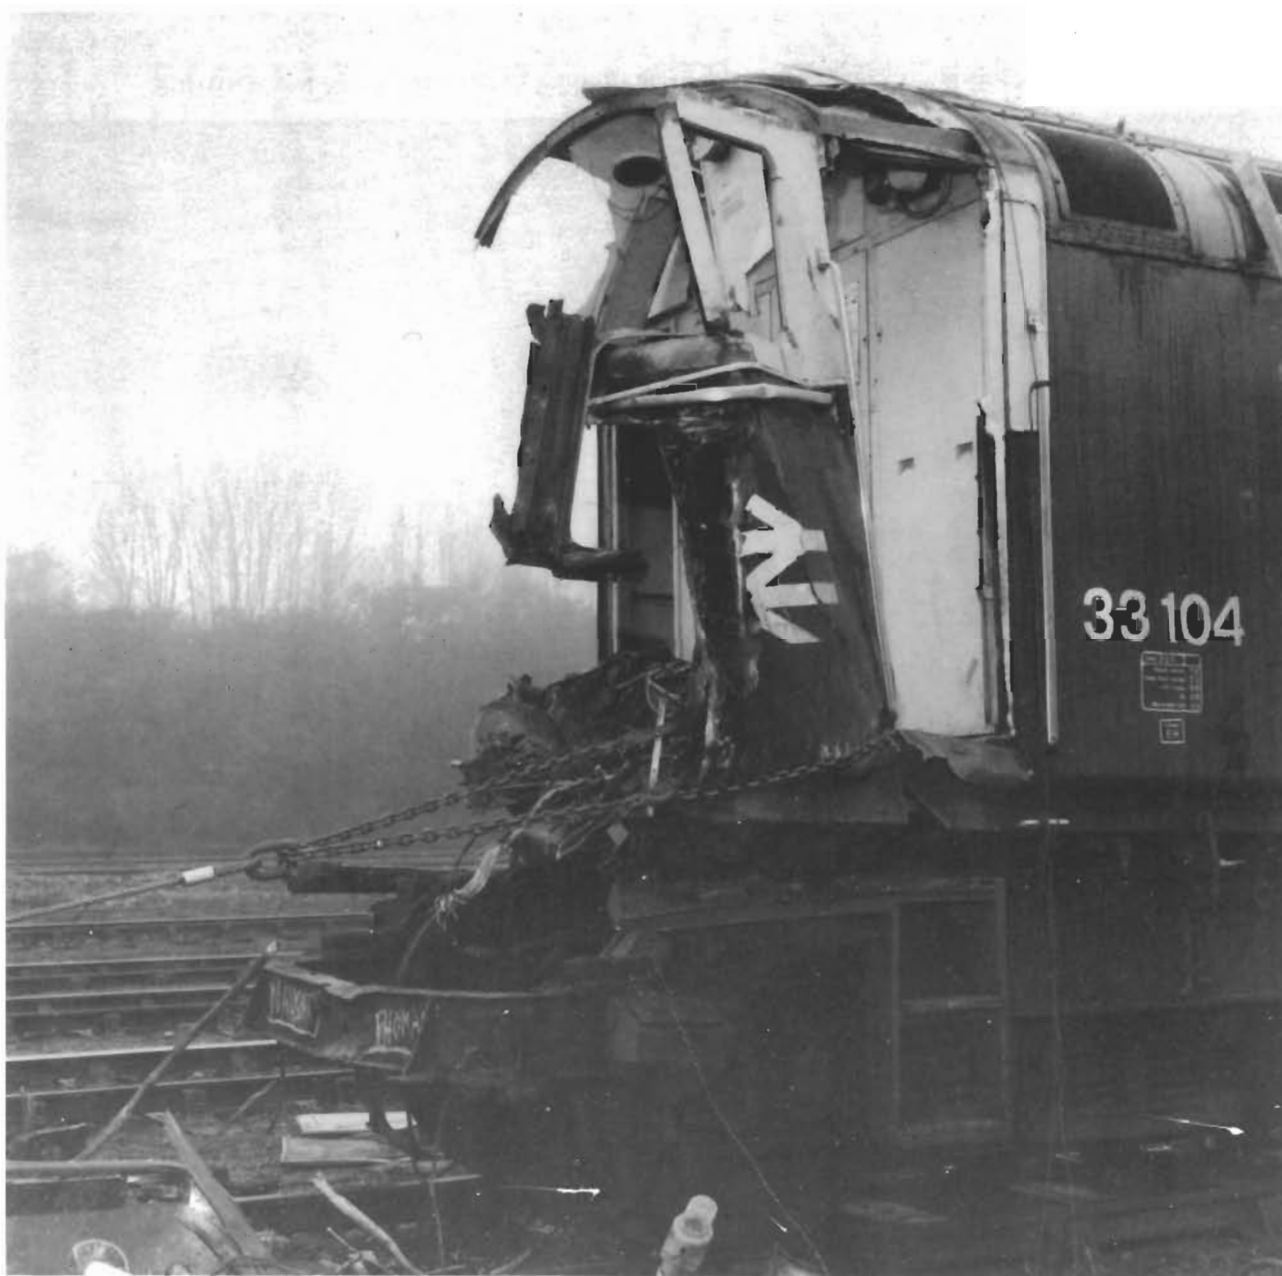
7. The Class 33/1 locomotive received extensive damage to No.2 cab, which was leading. Both bogies were displaced, the centre castings being sheared, and the underframe was badly distorted causing damage to the underframe equipment and pipework. Most of the cab structure and fittings had to be removed to free the crew and to bring the locomotive within gauge prior to movement from the site. Photograph No.1 illustrates the amount of damage sustained by the leading end; at the time the photograph was taken, the bogies had been temporarily replaced.

PHOTOGRAPH No. 1. Damage to No.2 cab of Locomotive No.33104 — part removed to free crew

43. The damage to the cab of the Class 33 locomotive illustrates once again the vulnerability of the design of 'soft fronted' cabs and contrasts greatly with the slight distortion suffered by the leading vehicle of the EMU. In his report of the collision that occurred at Crewe on 7th November 1980\*, Major P. M. Olver commented on the cab designs of diesel and electric locomotives used on British Railways but observed that it was obviously impracticable to modify the existing fleet to give greater protection to the drivers and their assistants in the event of a collision. I agree entirely with his remarks and have no further comment. Major Olver also reported that he had received an assurance from the Director of Mechanical and Electrical Engineering, British Railways Board, that the driving cabs of all new designs of traction units would conform with the standards of the International Union of Railways (UIC). The Special Safety Regulations for the Driver's Cabs of Traction Units, UIC Codes 617-5 OR, lay down that the cabs shall be capable of withstanding compression forces of 200kN applied at headstock level and 300kN at the bottom of the windows. That these requirements are adequate is demonstrated by the photograph of the leading vehicle of the EMU, which was built to similar standards.

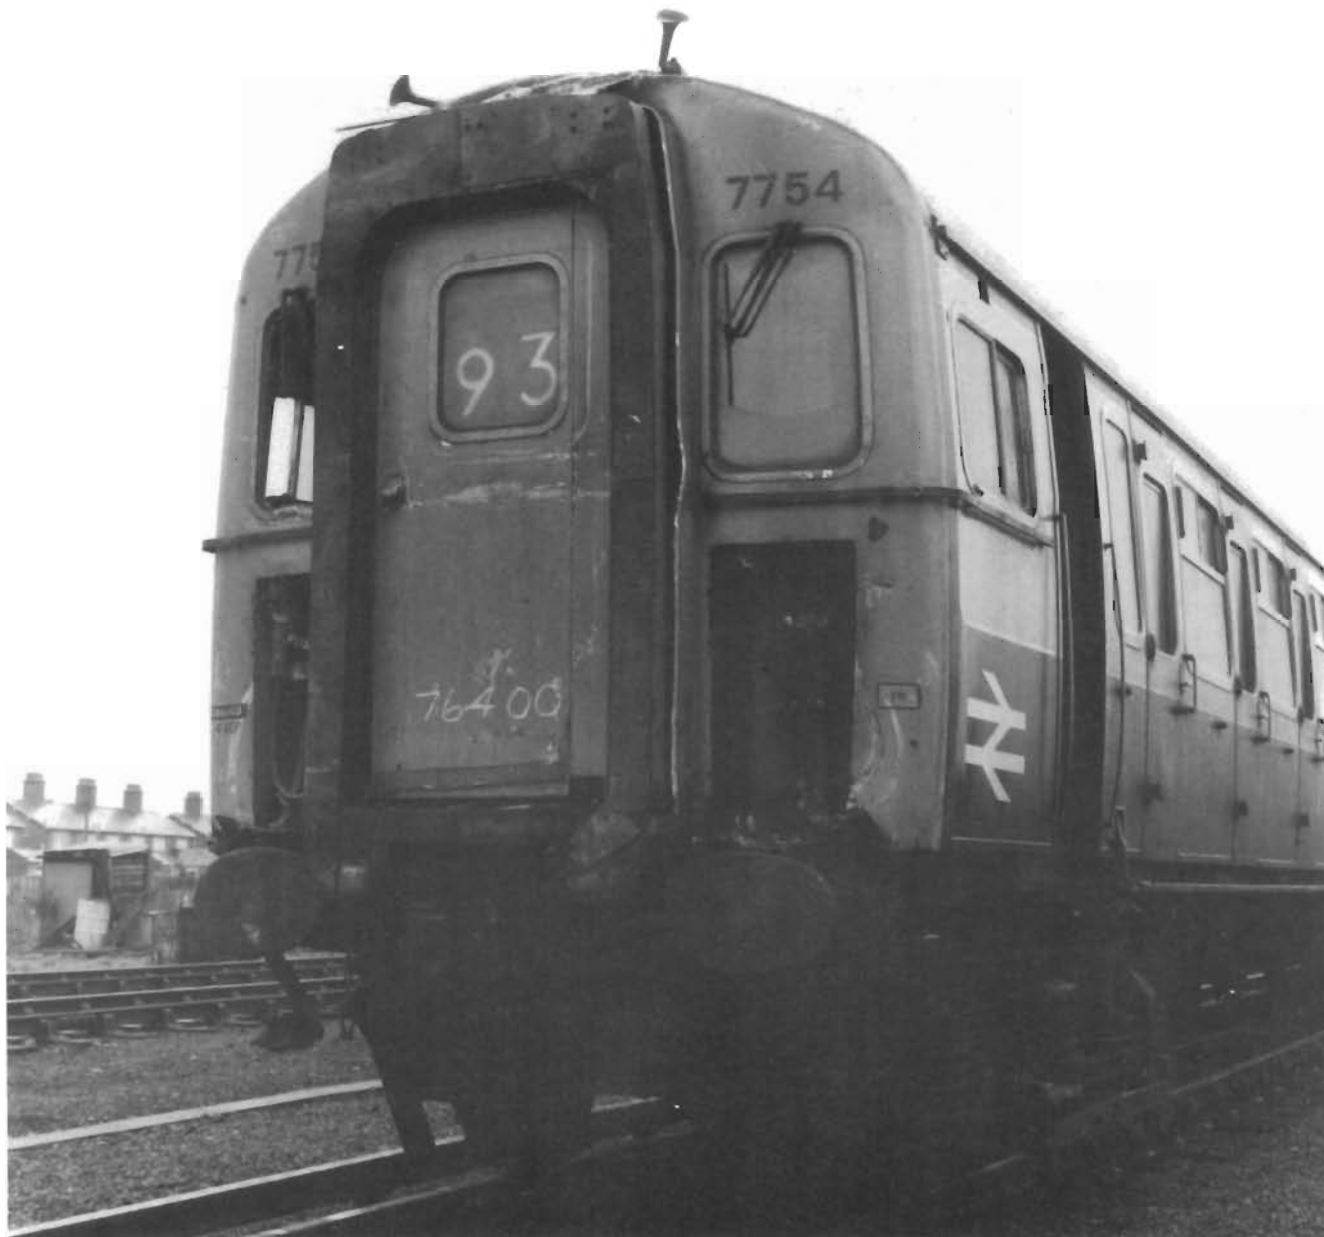
8. In contrast, the leading vehicle of the EMU, Driving Trailer Composite No.S76400, withstood the impact extremely well. Although the leading bogie was displaced, the damage to the vehicle was mainly confined to the buffers, drawgear and gangway connections; Photograph No.2 shows the extent of this.

PHOTOGRAPH NO. 2. Damage to leading end of Driving Trailer Composite No.S76400
