DEPARTMENT OF TRANSPORT

RAILWAY ACCIDENT

Report on the Derailment that occurred on 24th June 1984 at Morpeth

IN THE
EASTERN REGION
OF BRITISH RAILWAYS

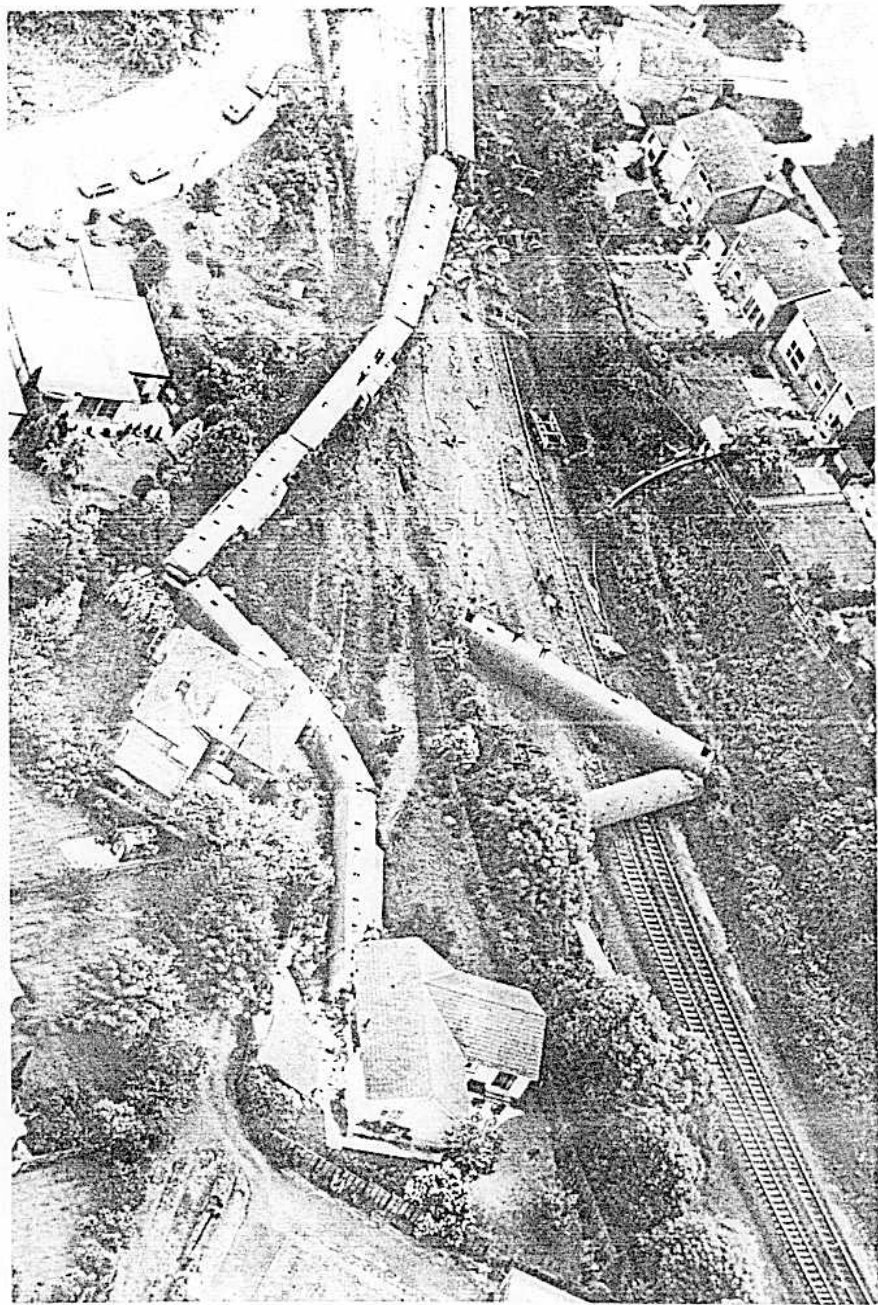
Photograph A
Aerial View of Train — Photograph by Gordon Amory of Daily Express

The train was a locomotive-hauled Aberdeen to Kings Cross sleeping-car train which comprised seven modern Mk III sleeping cars with two bogie brake vans, one at each end of the train. It was running at speed under clear signals as it approached Morpeth. The Morpeth Curve is of some 14 chains radius (285 metres). From the north, the curve is left-handed and commences within the length of Morpeth Station platform. The maximum permitted speed around it is 50 mile/h; the train entered the curve at a speed of between 85 and 90 mile/h and overturned shortly afterwards. The driver, who suffered a bad cut over his left eye, a broken collar bone and a badly lacerated leg, later remembered nothing of the accident.

The first vehicles to overturn were probably the leading two sleeping cars and the coupling between them parted. The leading car remained coupled to the van and locomotive causing them to overturn too. The locomotive came to rest on its off-side against a bank having crossed over the Down line, which it destroyed, and the two vehicles following it jack-knifed behind it and came to rest on their sides across both lines completely blocking the railway.

The second sleeping car led the remainder of the train on a tangential course across the Down line and into a group of bungalows, two of which were badly damaged. All the coaches were on their off-sides except the rear sleeping car and a van which remained upright although both were derailed.

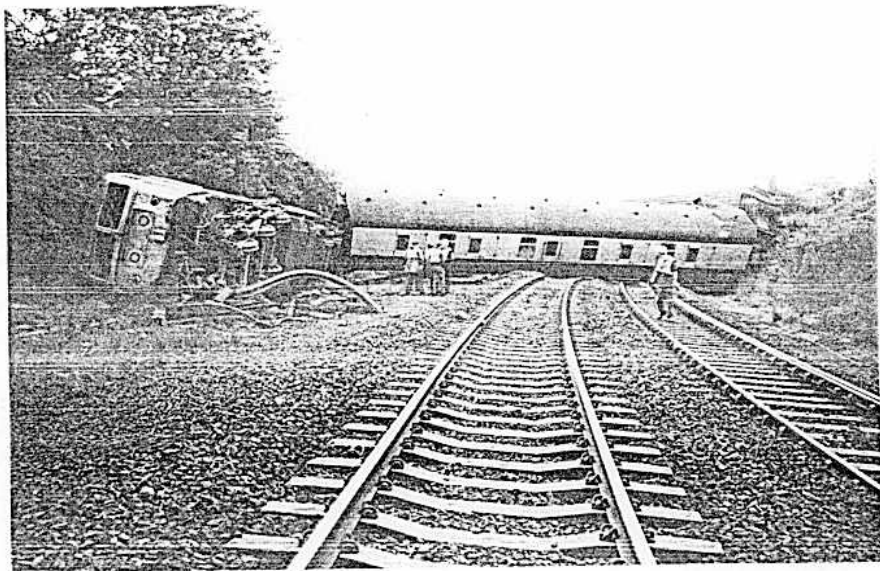
15. The locomotive came to rest on its 'off'-side up against the side of the cutting and 7 m clear of the Down line. Its rear cab was stove in but the leading cab suffered little damage. The leading van and first sleeping car (Coach G) jack-knifed across both tracks between the two cutting sides. (See Photograph B).

Photograph B
Locomotive and leading Van
Up line is on the Right

33. I called on the doctor, *Dr. J. A. Cunningham* on the afternoon of 16th July, and asked him to describe how he got to the driver's side. Photograph B shows the locomotive on its side. Dr. Cunningham told me that those who had attended the driver had got in through the lower (off-side) broken front windscreen, and that the driver had fallen from his chair and was sitting across the side of the cab with his back to the front of the locomotive. The driver was conscious and reacted to his requests to move his limbs. Although he was close beside him he did not notice any smell of alcohol on his breath. After deciding that the driver could be moved, the firemen and others took him out of the front window and onto a stretcher.

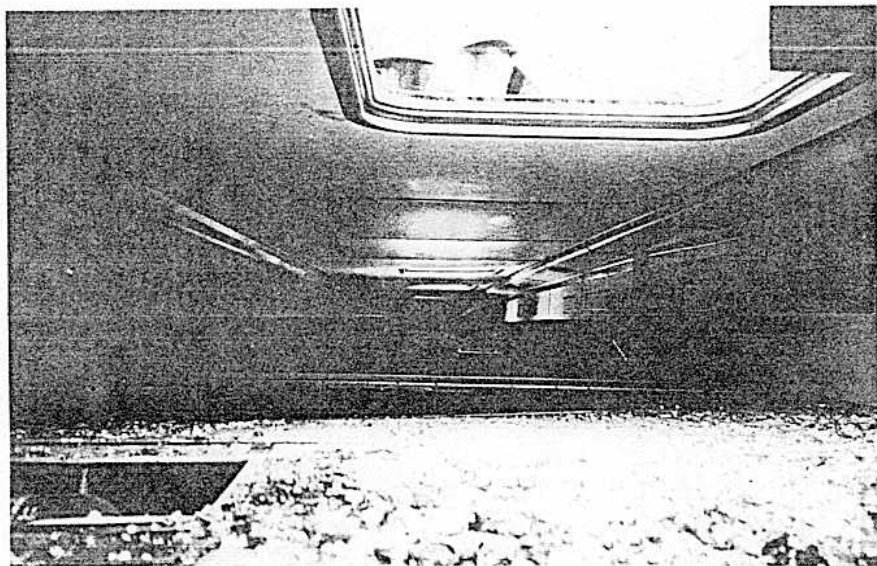
Photograph C
Overturned sleeping car—corridor uppermost
illustrating the fireman's problem

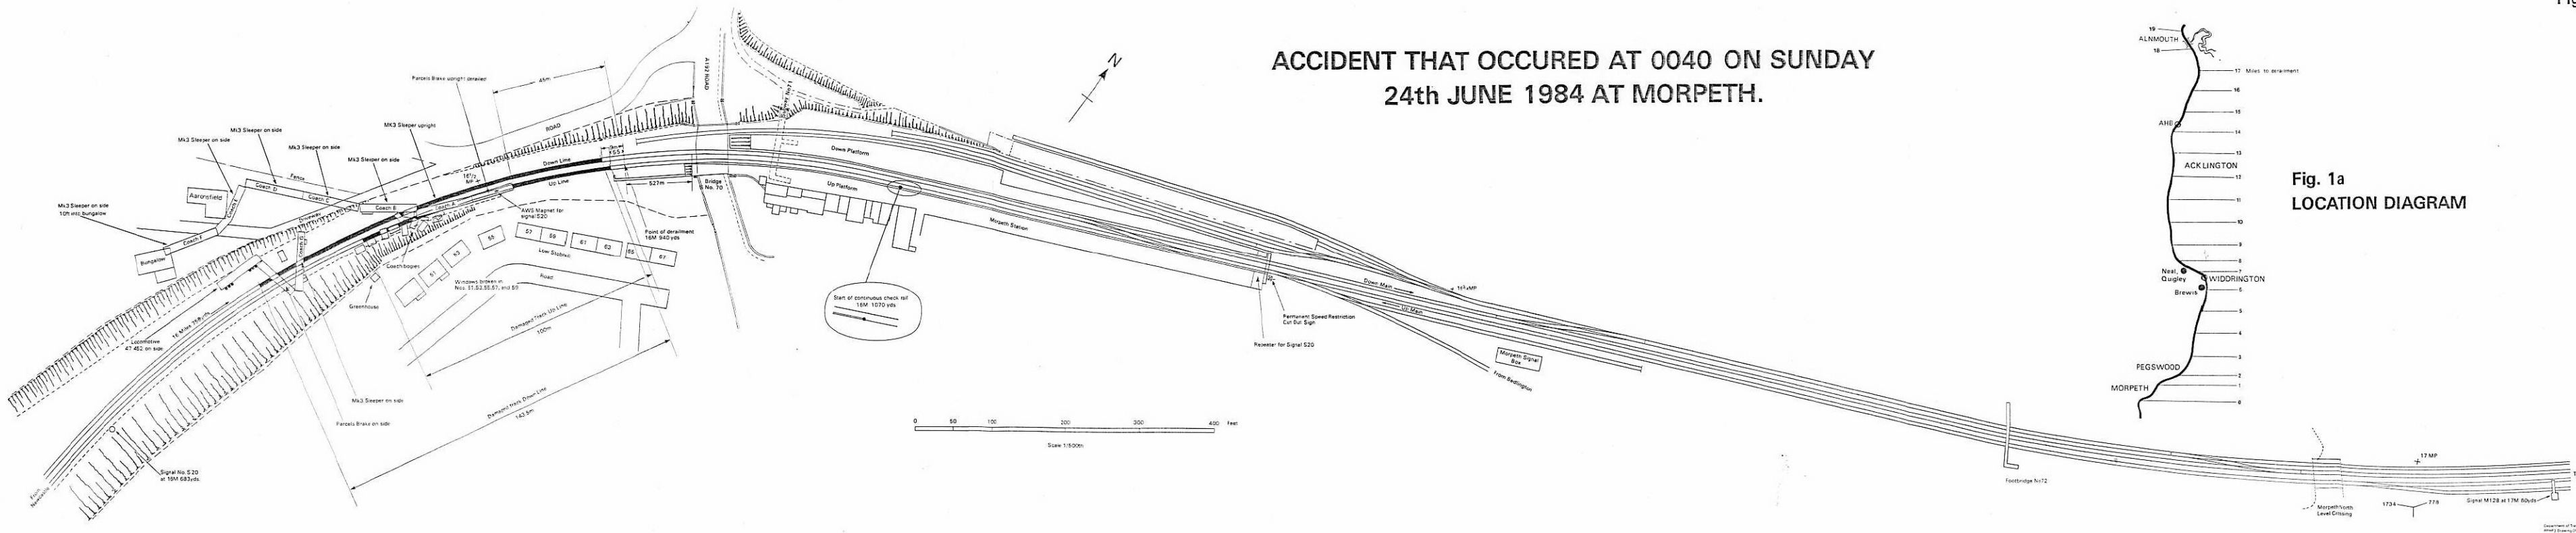
ACCIDENT THAT OCCURED AT 0040 ON SUNDAY
24th JUNE 1984 AT MORPETH.

14. As shown in Figure 1, the point of initial derailment was easily identified at 16 miles 940 yards which is 41 m beyond the top of the south end Morpeth Station Up platform ramp. (See Paragraph 40). The Up line was not at all damaged up to this point and for a distance of 5.5 m beyond it, and thereafter, although damaged for a length of 100 m, it was still in situ. The Down line, however, was destroyed for a length of 144 m commencing 9 m south of the point of derailment on the Up line. One rail was thrown out of the Down line and across the Up line and lay up the bank beside the Up line, the end of it piercing a greenhouse in a garden at the top. Ballast thrown up in the derailment broke windows in four houses beside the Up line and passed over their roofs into the roadway beyond them; roof tiles, windows and doors were damaged.

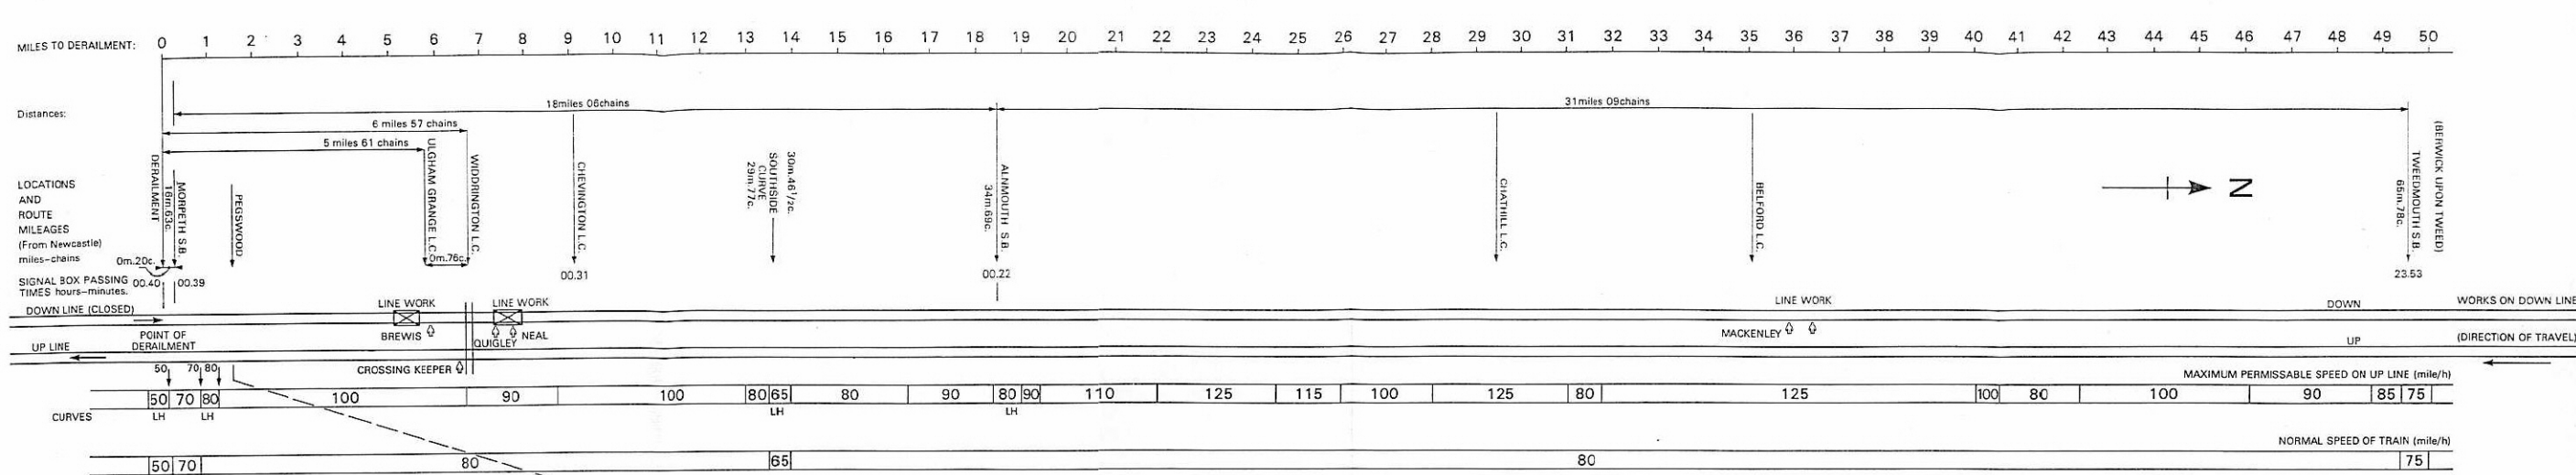
Fig. 2 THE UP LINE – TWEEDMOUTH-MORPETH
SUNDAY 24th JUNE 1984

1. Figure 2 at the back of this report illustrates the Up line from Berwick upon Tweed at 65 miles 78 chains up to the Morpeth Curve at 16 miles 50 chains. (Mileages are from Newcastle). The maximum line speed from the north as far as Alnmouth is 125 mile/h with the many permanent restrictions of speed as shown but thereafter it is reduced to 100 mile/h. After passing over the viaduct at Alnmouth where the speed is 80 mile/h, the line speed is 90 for 2 miles, 80 for 2½ miles reducing to 65 for half a mile around the Southside Curve, 80 for half a mile and then 100 mile/h for 4½ miles until the Up and Down loops and crossovers at Chevington are passed. The speed is thereafter 90 mile/h for 2 miles to Widdrington Level Crossing where the

reduce its speed. This was introduced and has become known as the 'Morpeth Warning' or an 'Automatic Warning Indicator'. Colonel Robertson agreed that AWI should be provided wherever the line speed is 75 mile/h or more and the reduction of speed is 30% or more. Its extension was already being considered to include line speeds down to 60 mile/h where the reduction of speed is 40 mile/h or more. It should be noted that no AWI was required on the 50 mile long stretch of line between Berwick upon Tweed and Morpeth (See Figure 2) at any of the 12 reducing speed restrictions.
