DEPARTMENT OF TRANSPORT

# **RAILWAY ACCIDENT**

**Report on the Collisions that  
occurred on 18th August 1981  
at Parks Bridge Junction  
and on 13th November 1981  
at Bromley Junction**

IN THE  
SOUTHERN REGION  
OF BRITISH RAILWAYS

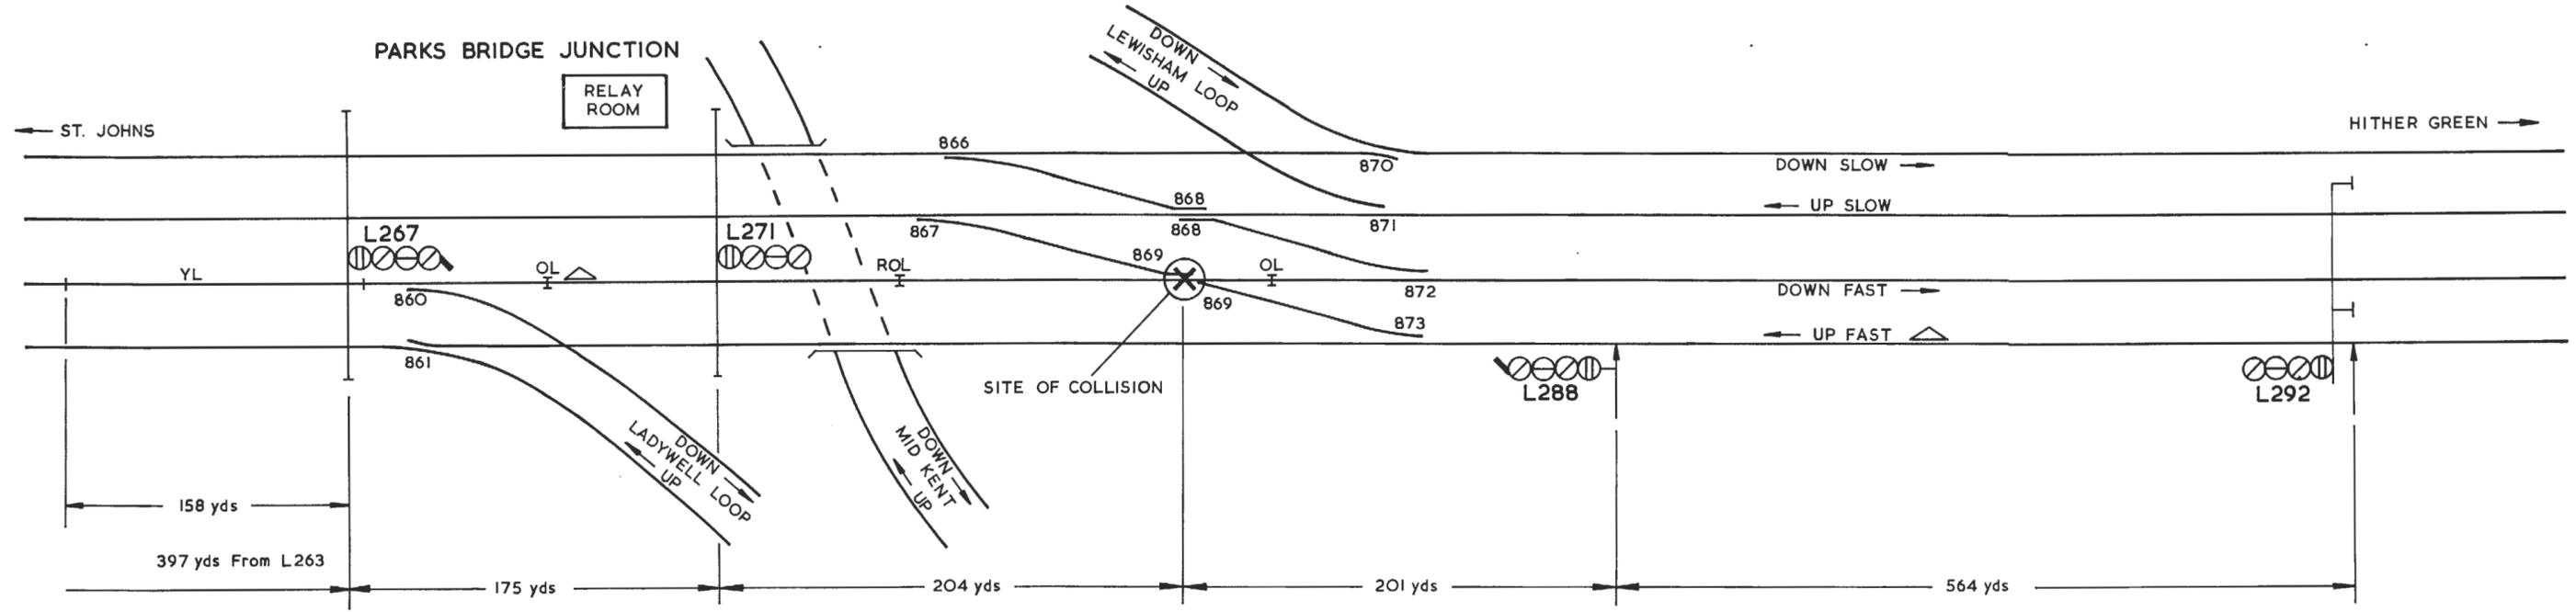
Fig. 1 GENERAL SITE PLAN SHOWING SIGNALLING, TRACK LAYOUT AND SITE OF COLLISION

11. Both accidents were due to the drivers of trains passing the signals protecting the junctions at Danger. At Parks Bridge Junction the driver of the Charing Cross to Bromley North EMU, having been brought nearly to a halt at Signal L267 on the Down Fast line before it changed to a single Yellow because the reduced overlap for Signal L271 had been selected, on account of the route for the Dover to Cannon Street express, 1G51, having been set across the path of the other train, accelerated and passed Signal

L271 at Danger. The driver, on observing the express crossing his path some 80 yards away, immediately made an emergency brake application but was unable to prevent the nearside corner of his driving cab from striking the nearside corner of the rearmost cab of the Up express.
