**A report of the collision  
that occurred on 8 January 1991  
at Cannon Street Station**

The Permanent Under Secretary of State  
Department of Transport

2 March 1992

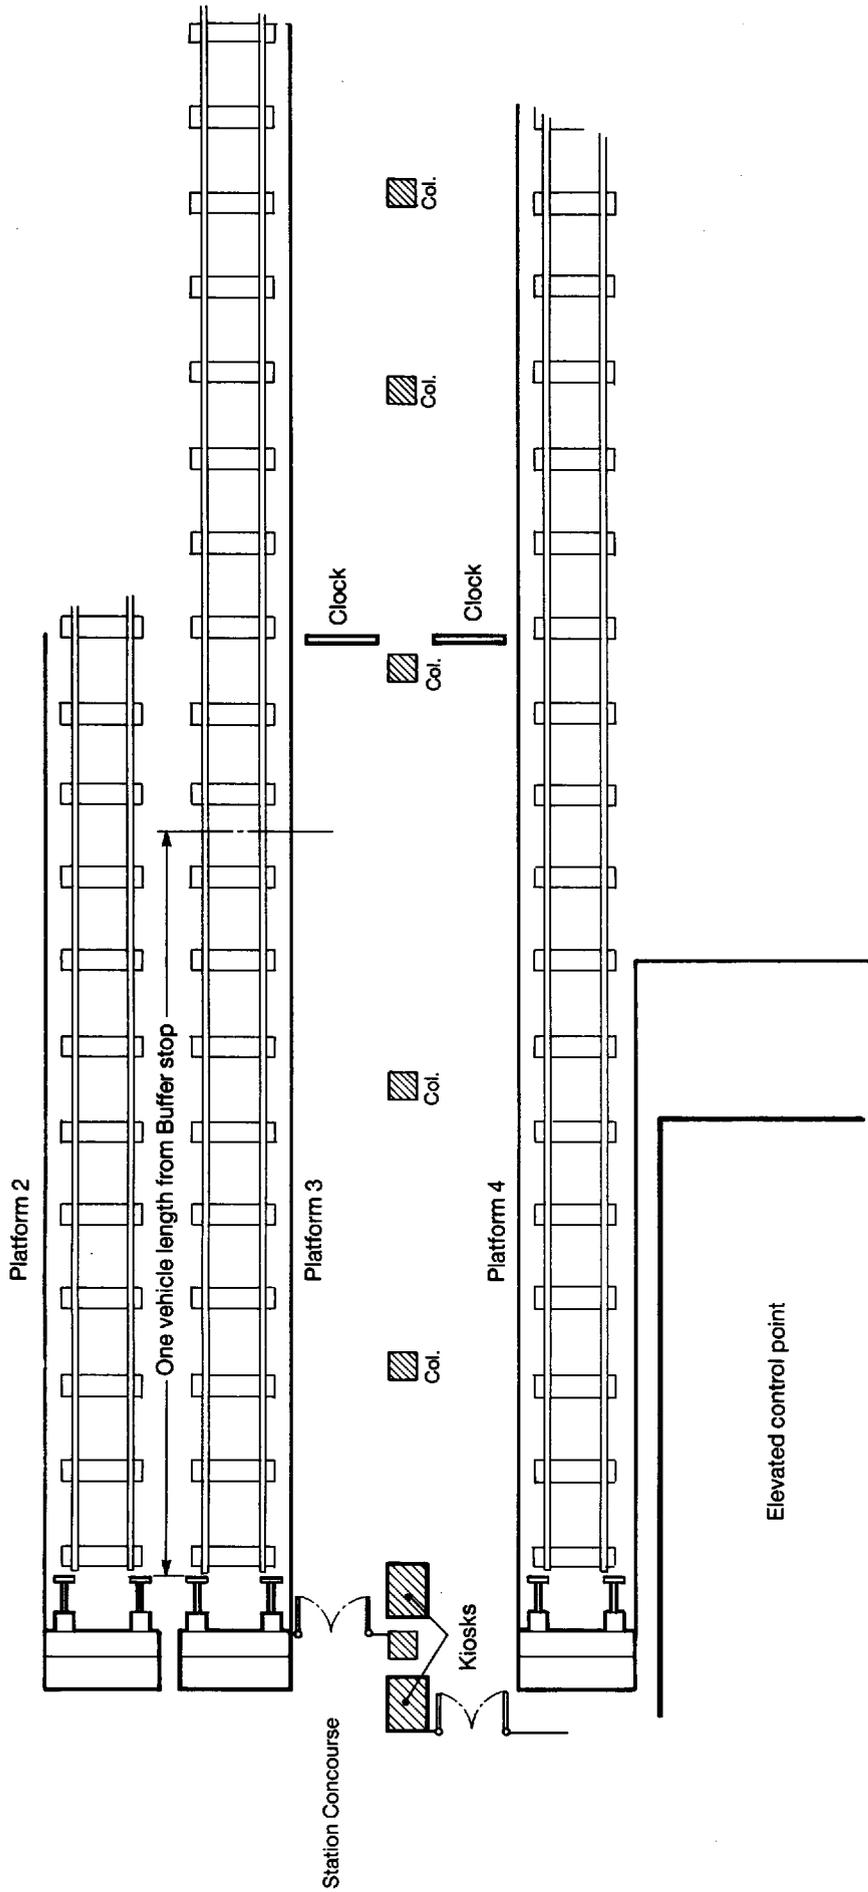
Figure 1 Cannon Street Station plan of buffer stop area.

98 He inspected the buffers at about 14 00 on the day of the accident. He noted that the train was hard against the buffers which had been compressed their full 24 inches (610 mm). The buffers were set in a concrete base which was not disturbed but a hardwood timber between the buffers and the concrete was compressed by 50 mm. After the train had been moved away, Mr Rayner was instructed to remove the buffers for tests and repair, which he did, having first taken measurements and photographs to record their condition and any damage sustained. The state of the buffers, he explained, was judged to be secondary to the cause of the accident. It was considered essential to remove, test, repair and replace the buffers as quickly as possible in order that platform 3 could be brought back into commission.

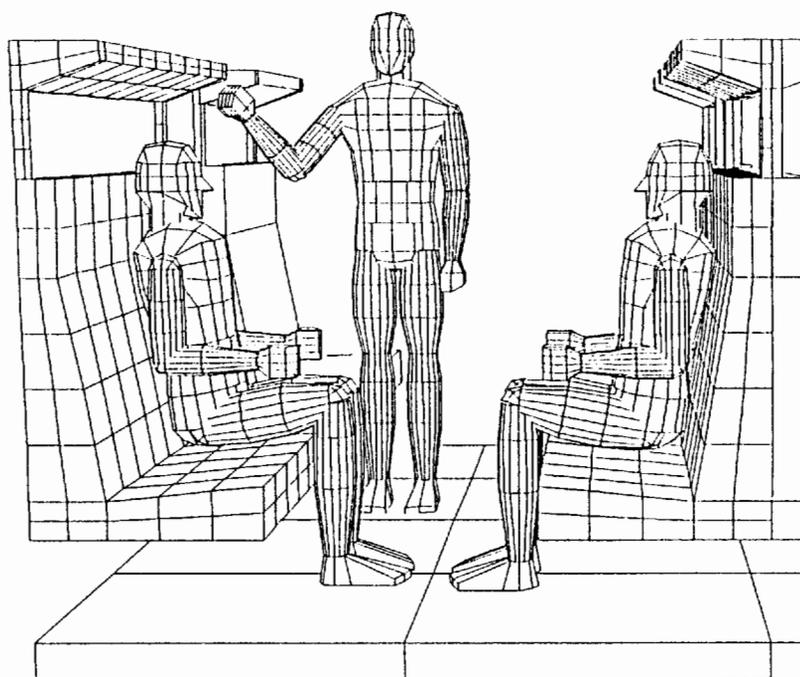
**Figure 6** Five mile/h impact

194 With the standing passenger's knee joints rigid during a 5 mile/h impact, the model's behaviour was similar to the basic case but as his legs do not bend when he falls over, the way in which he fell and how he struck the seats was different. However, with a more open stance the standing passenger did not fall and no significant force was generated at his grip of the luggage rack.
