# **The Southall Rail Accident Inquiry Report**

**Professor John Uff QC FREng**

### **Inquiry into Southall Railway Accident**

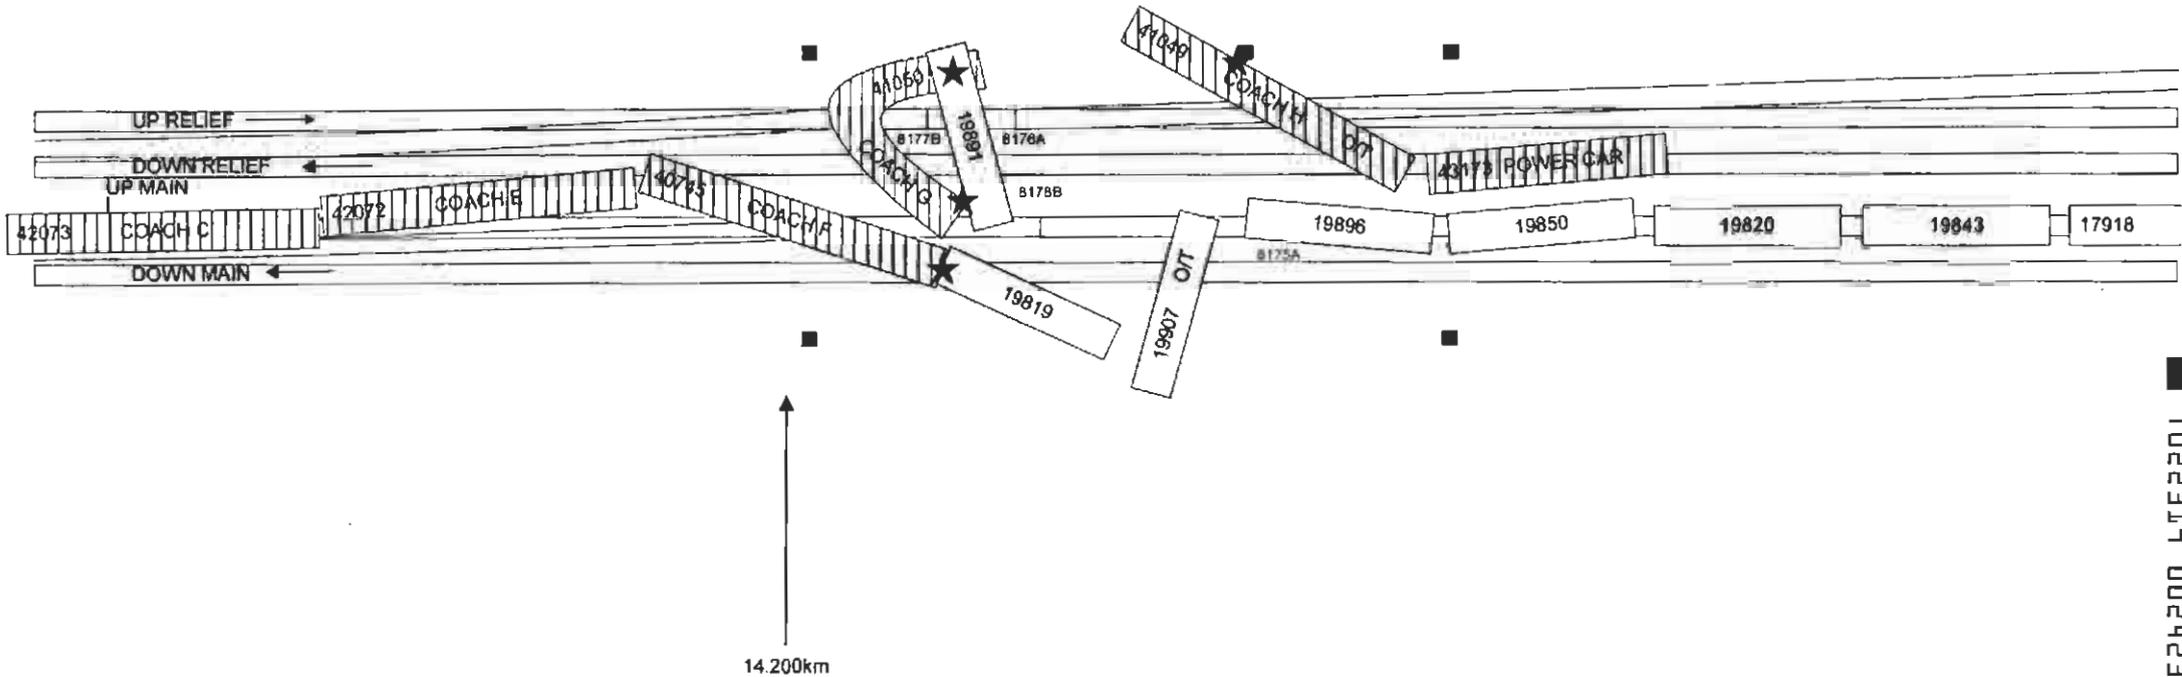
**Crash site at time 8.5 secs after collision**

Coach F impacts with Coach G which bends, allowing F to pass, colliding with wagon 19819.

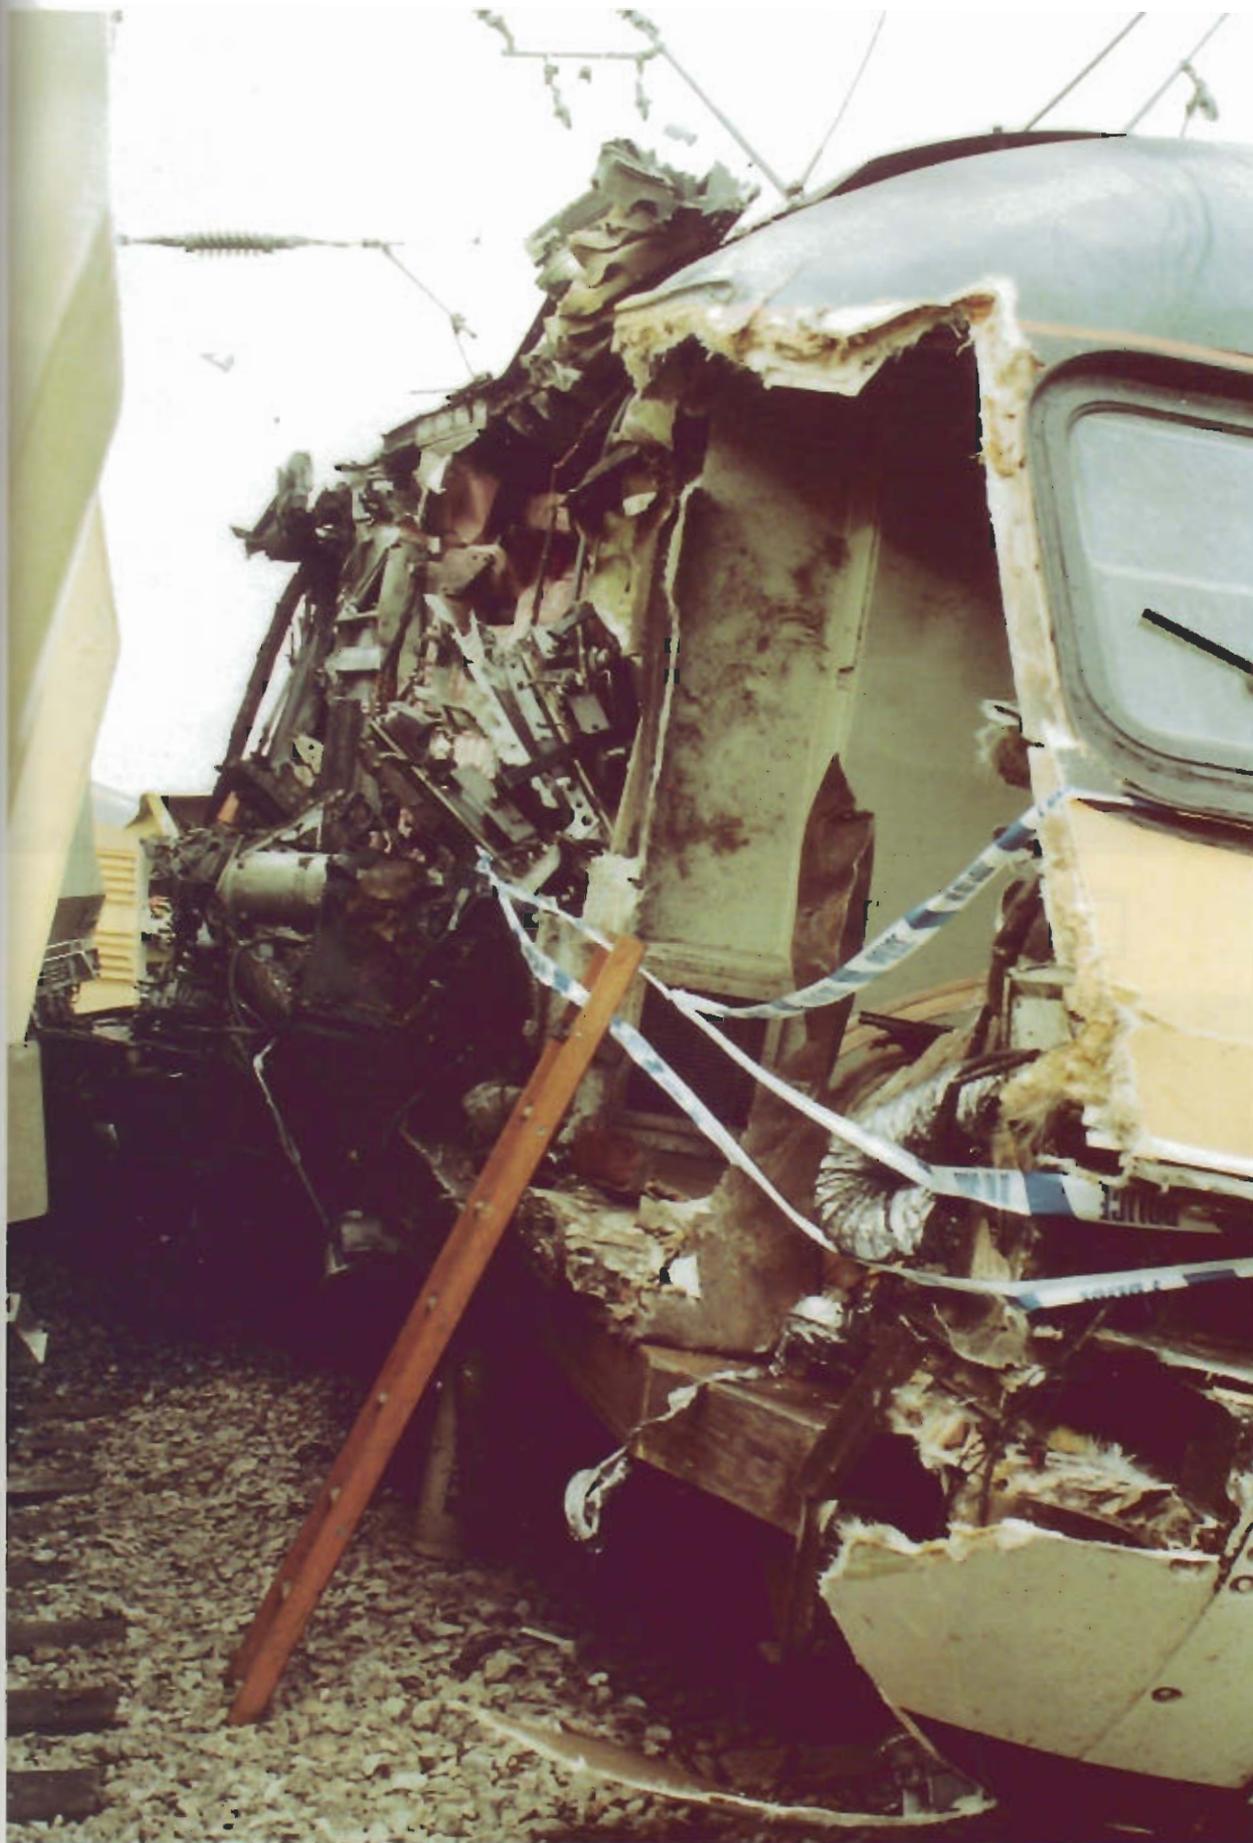
Damage to Power Car 43173 (Right Hand Side)

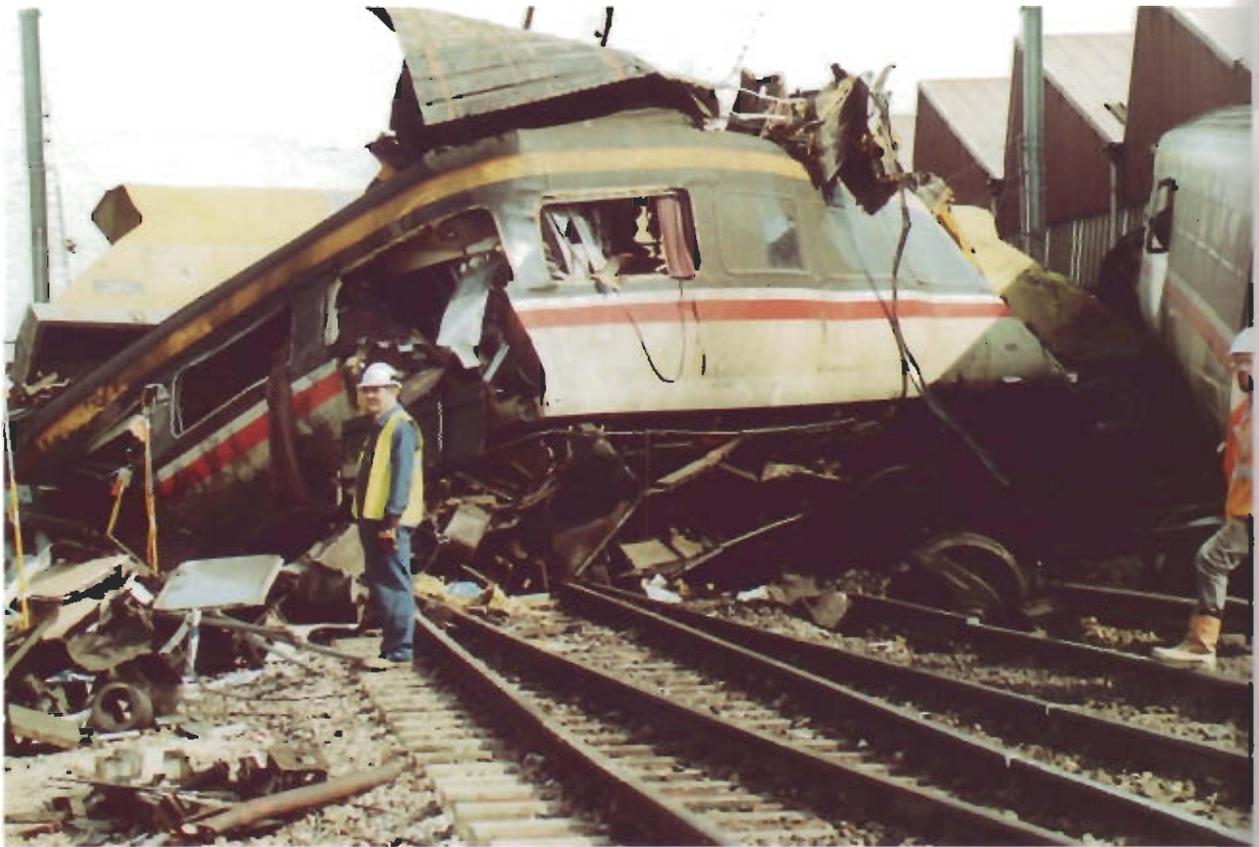
Damage to Coach G (main picture) and to Coach F (RHS)

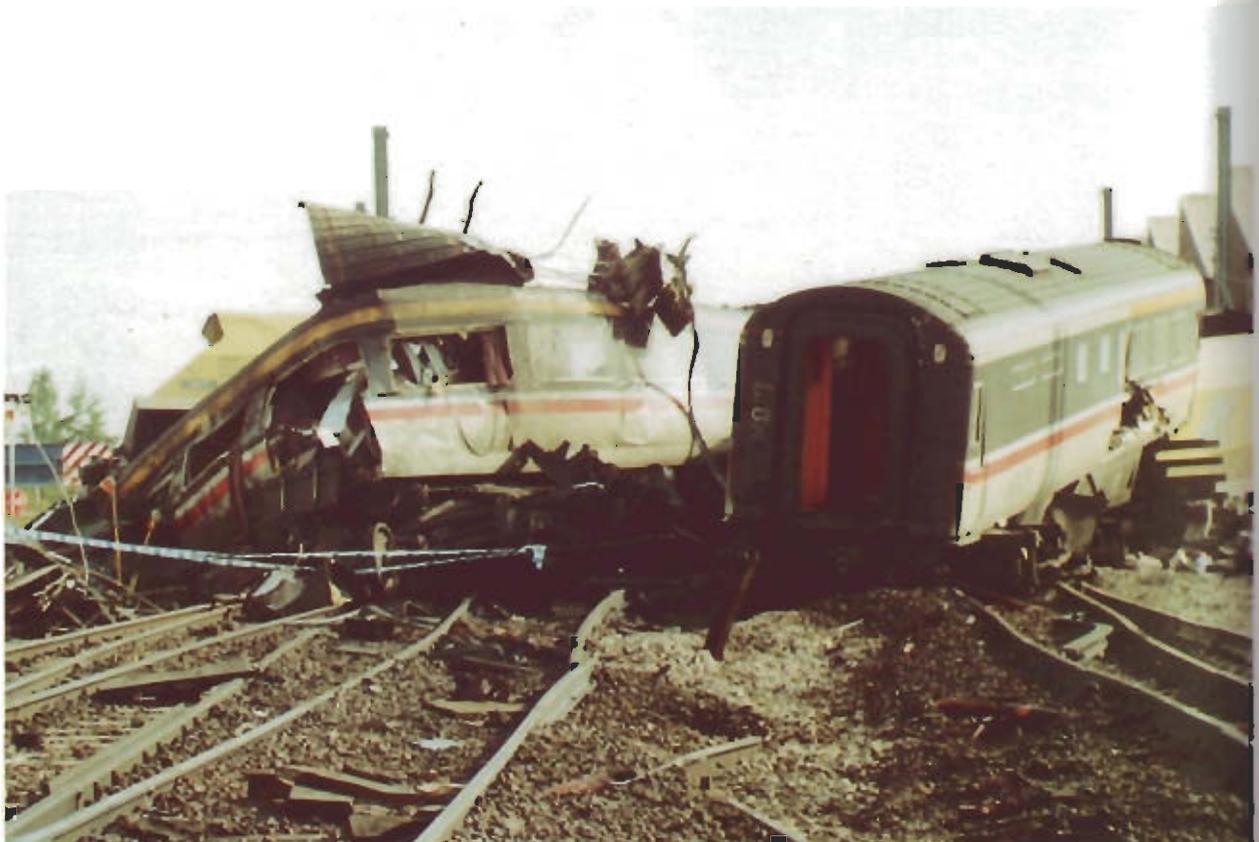
Damage to Coach G with Freight Wagon Coupler to left of picture / Coach F to the right

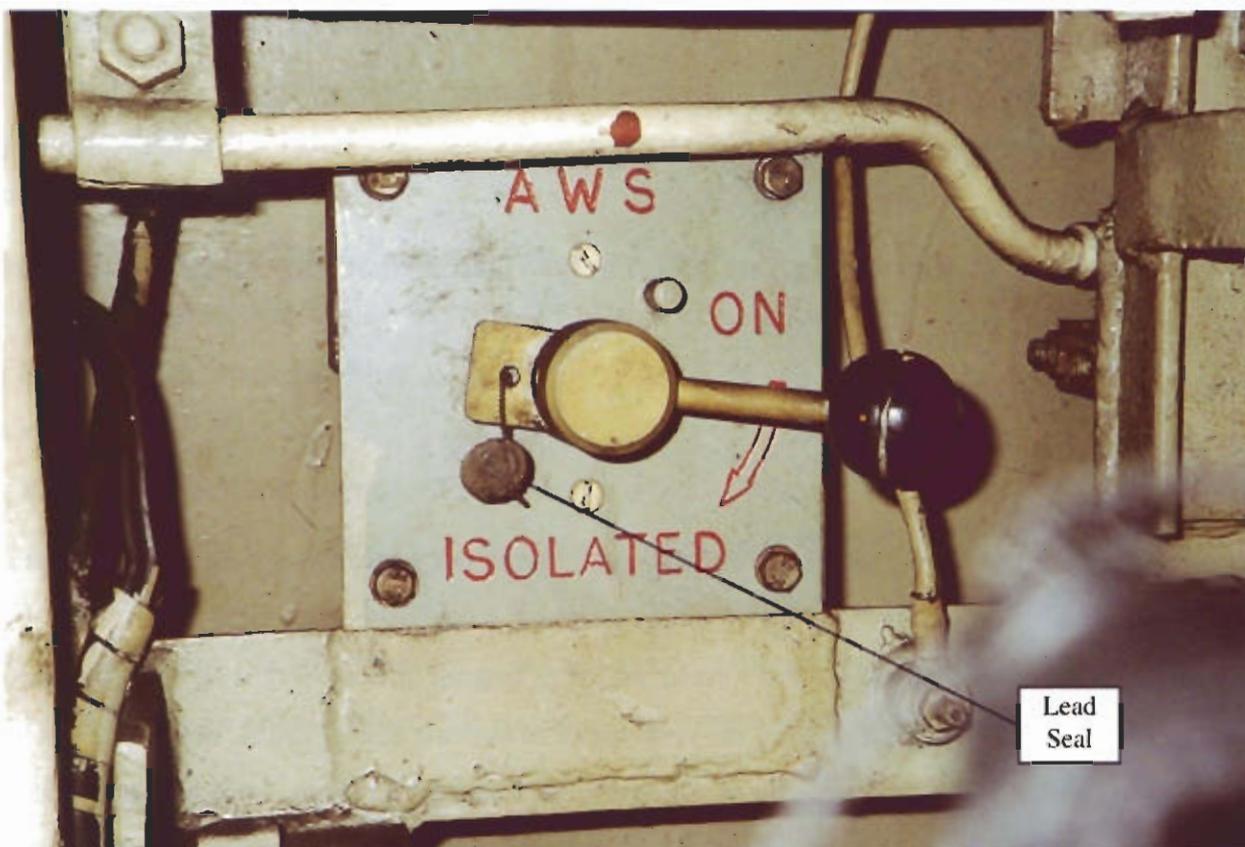
AWS Isolation Switch with lead seal in place

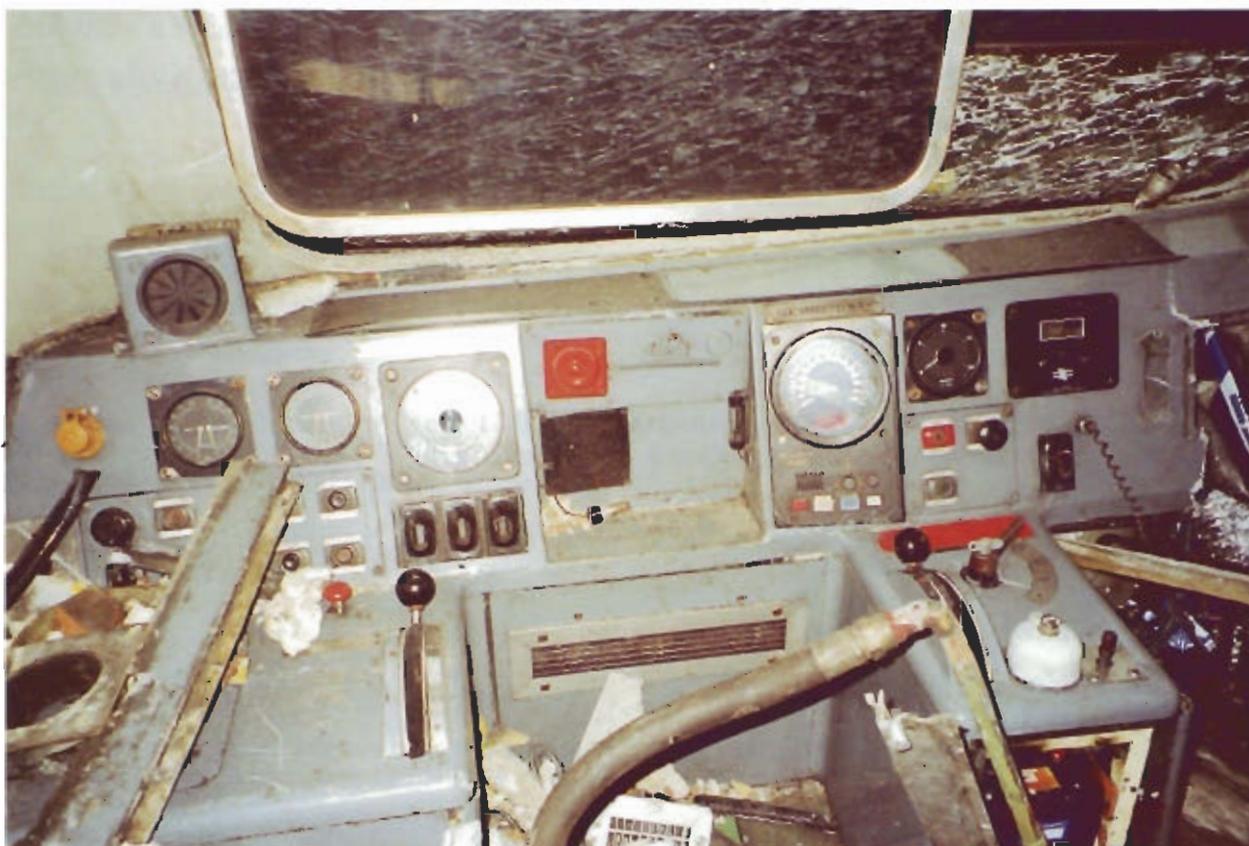
Driver's cab from Power Car 43173 Post Accident
