Ministry of War Transport,
Berkeley Square House,
Berkeley Square,
London, W.1.

10th February, 1943.

I have the honour to report for the information of the Minister of War Transport, in accordance with the Order dated the 13th November 1942, the result of my Inquiry into the accident, which occurred at about 1.45 a.m. on that day at the outlet from the Appleford Down Goods Loop, about one mile from Didcot, on the Didcot - Oxford Main line of the Great Western Railway.

DERAILMENT AND COLLISION
AT APPLEFORD CROSSING,
DIDCOT.

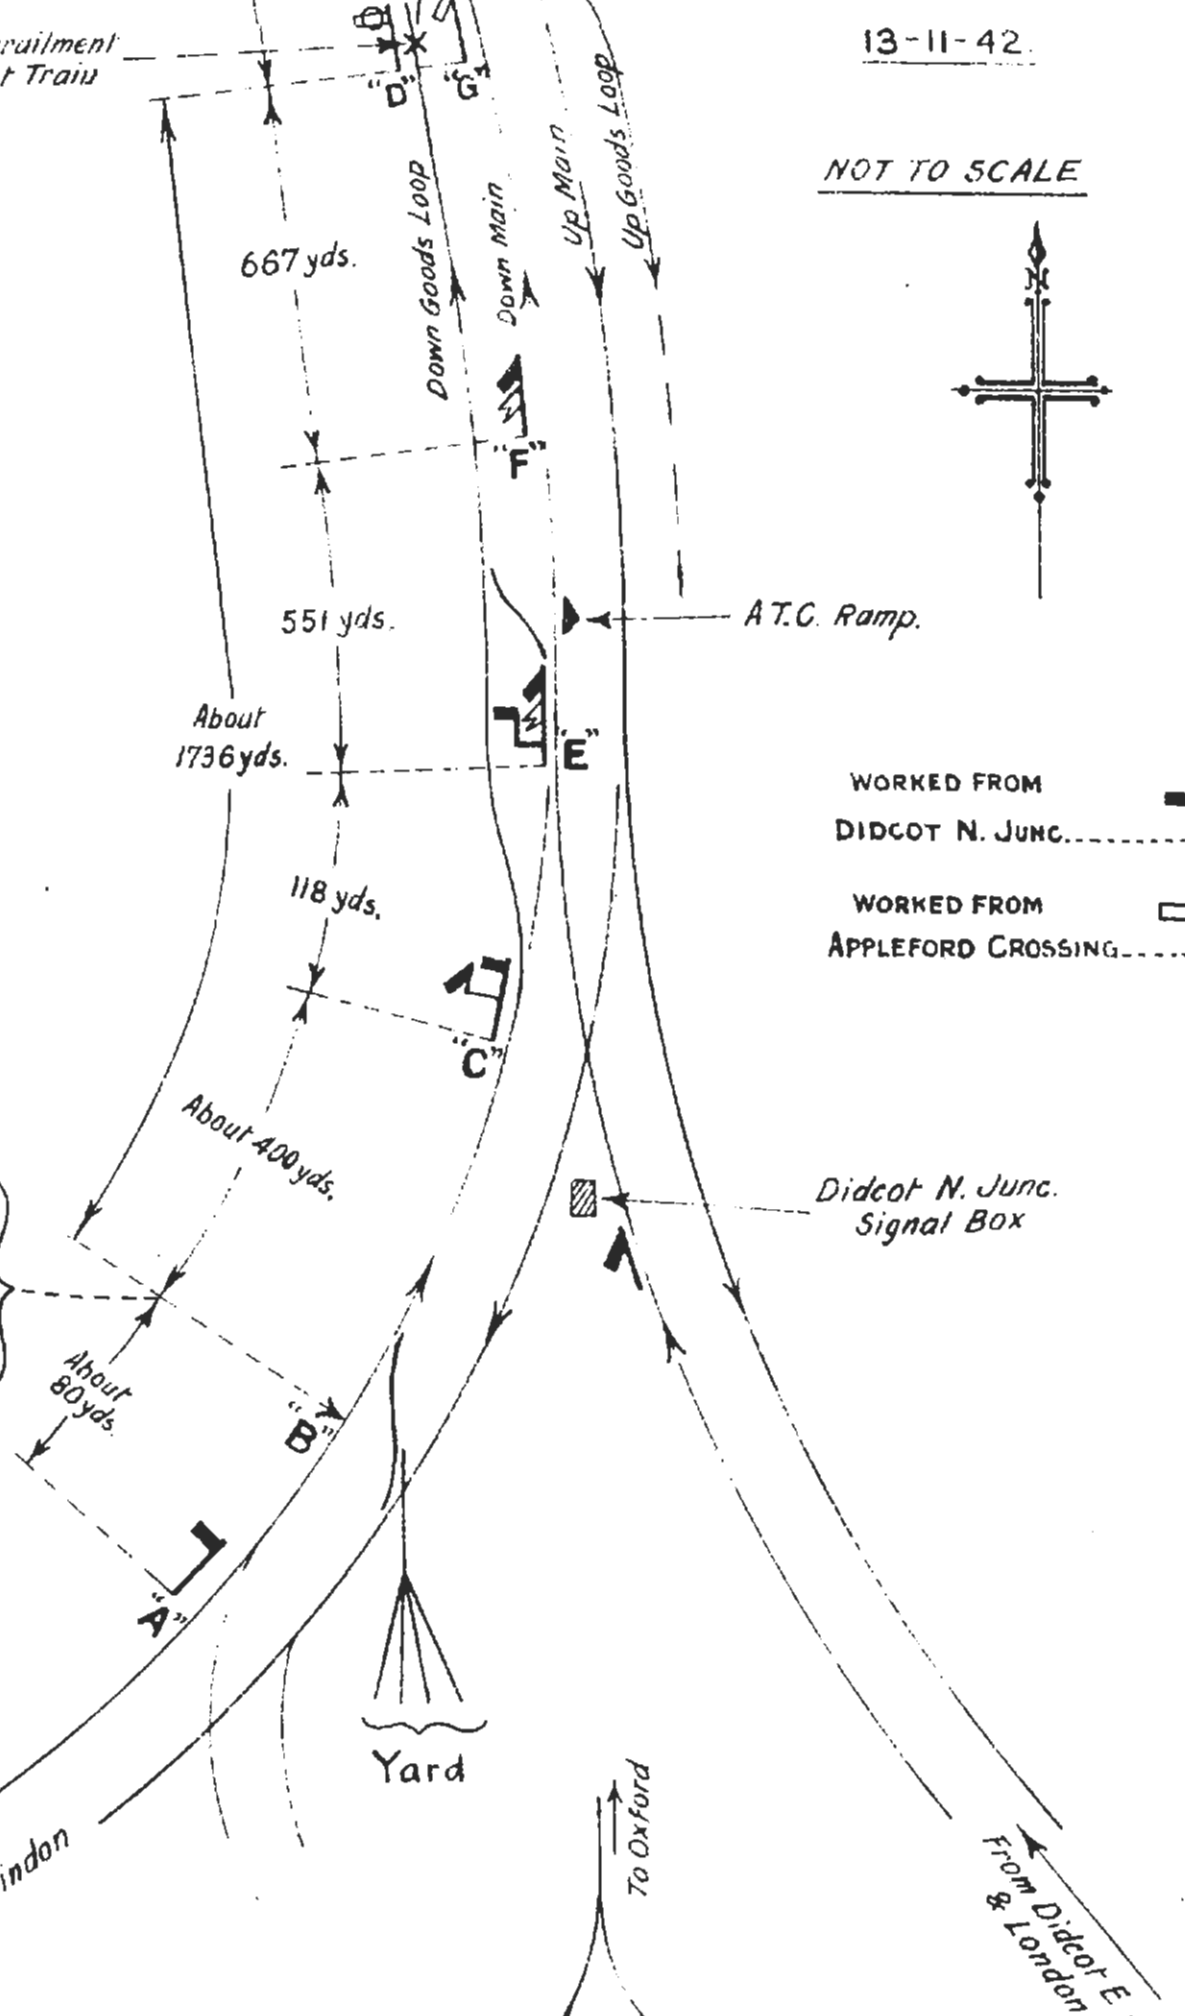
1. With reference to the attached line diagram, the Appleford Down Goods Loop lies immediately to the left of the Down Main line just beyond the northern apex of the Didcot triangular junction, and is approximately 1,250 yards long between fouling points. It was constructed (together with the Up Loop) as a work to facilitate wartime traffic, and was brought into use in October 1941, about 13 months before the accident.
2. Permissive working is in force over the loop between Didcot North Junction signal box in the apex of the triangle and Appleford Crossing box at the outlet; on this occasion, the loop

4. With reference to the diagram, the engine of the freight train started from the point B, as nearly as can be determined, after attaching some wagons from the yard. The next signal applying to this train was the bracket signal C which controls the entrance to the loop, and whose left hand arm was lowered. I travelled on the footplate of a similar engine, and observed that, from the starting point, signal C was barely visible through the right hand cab window, clear of the front corner of the engine firebox, and from the fireman's side was masked by the twin posts of some nearby Up line signals. Onwards from the starting point, signal C is screened from the driver's view by the boiler, but is clearly visible from the fireman's side until it is passed.

Thereafter there are no further signals applicable to the loop until reaching the outlet signal D, which was at "Danger", but the bracket signal E, which controls the entrance to the loop from the Down Main, would come into the view of a driver proceeding into the loop from the Swindon direction, at about the same time as he lost sight of signal C, or a little after; he would subsequently see signal F, and then signal G; each at a range of about 500 yards. Owing to the left hand curvature, the loop outlet signal D is not visible from the driver's side of the footplate until the engine is about 220 yards from it, but it can be seen for about 1,000 yards from the fireman's side, although it is obscured from time to time by a heavy telegraph pole route on the left.

14. I am satisfied from the evidence that the loop outlet signal was at "Danger", and that its light was burning properly. There can be no doubt, therefore, that the sole cause of this regrettable accident was the failure of Driver Forse to obey this signal. Although the fact that he and Fireman Jarvis were killed precludes any direct evidence as to what happened on the footplate, it is possible to suggest a partial explanation of his failure.
