MINISTRY OF TRANSPORT

REPORT on the DERAILMENT

that occurred on
1st August 1962

BARNHAM

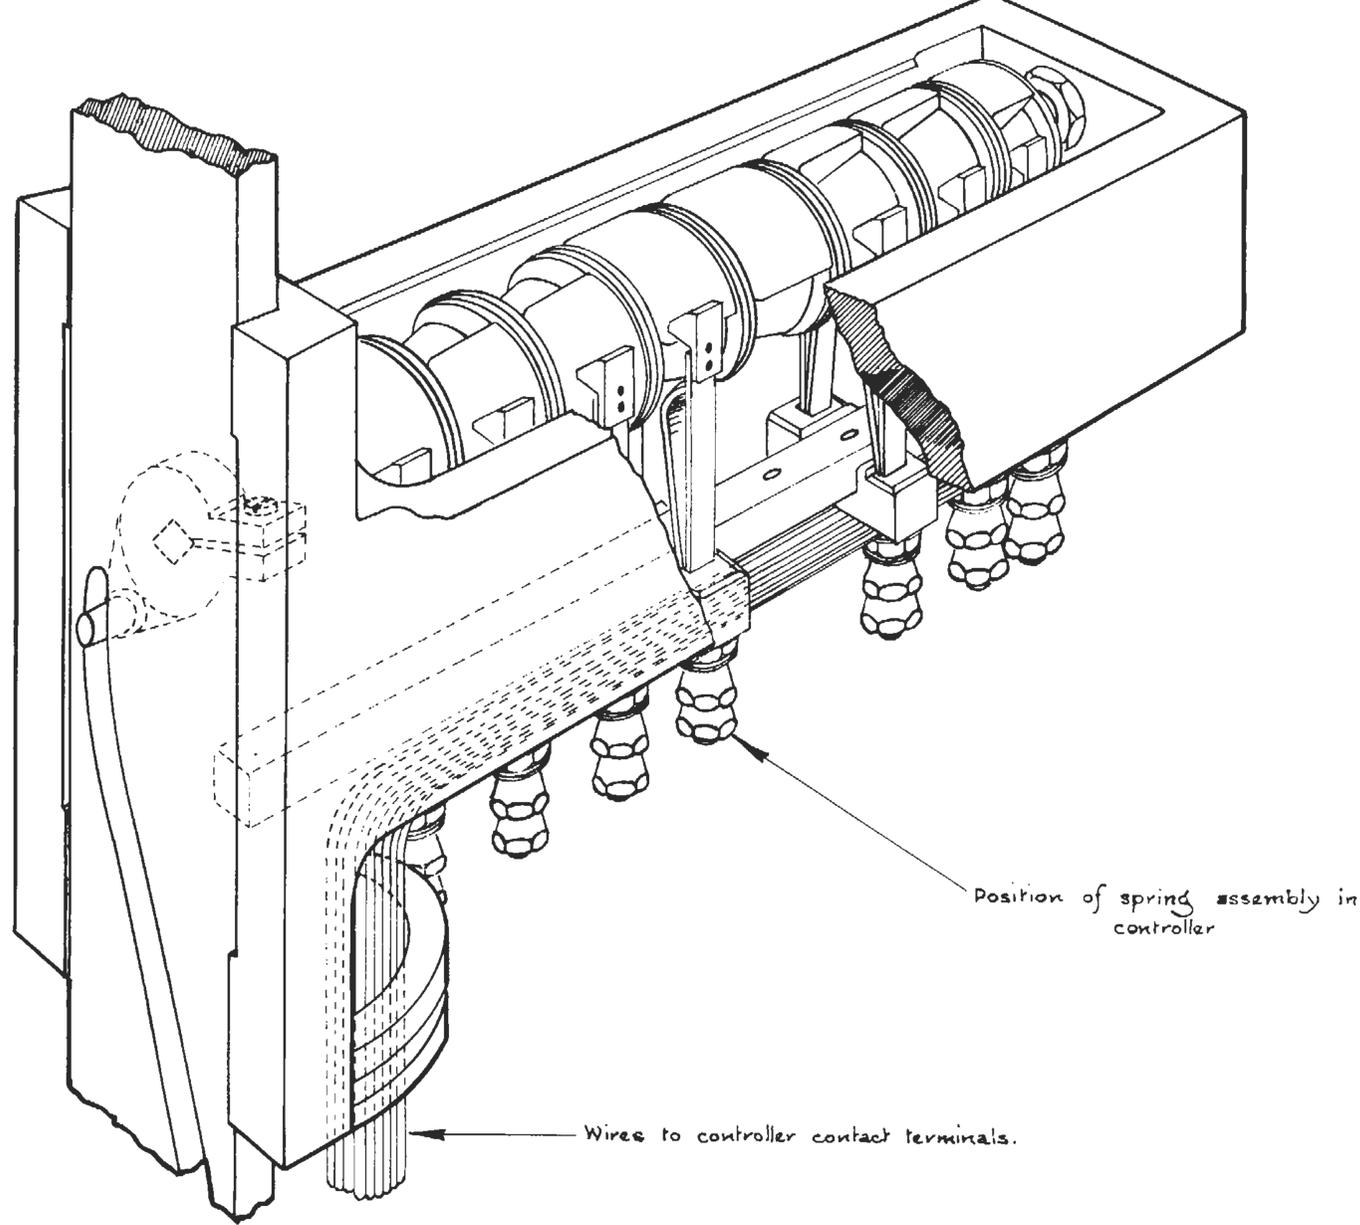
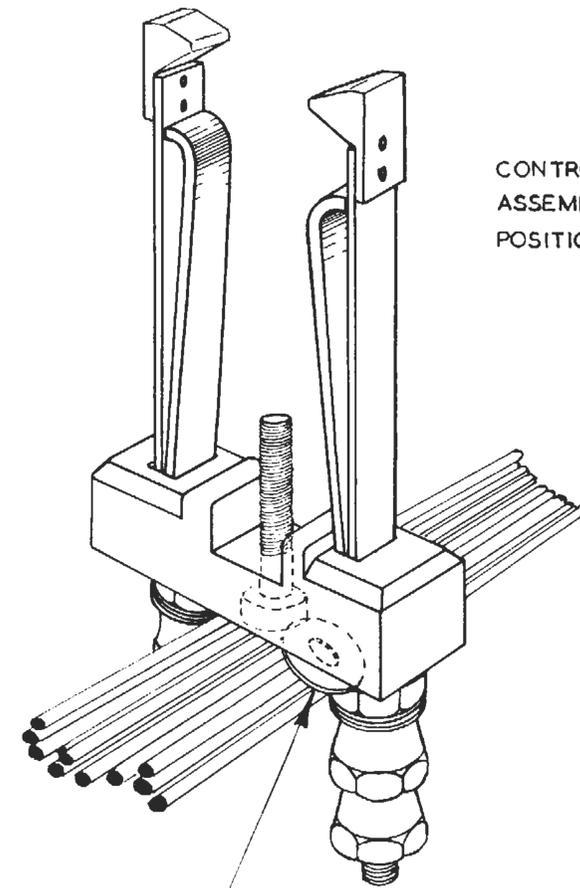
DRAWING No. 1

19. Signal and Telecommunications Inspector F. Castle arrived at the site at about 1.30 p.m. and carried out a detailed test of circuits assisted by Sub-Inspector Green. He found all the circuits in order until he applied the volt meter across the reverse operating wire for No. 8 facing points and the return wire. This test was made on the wiring inside the signalbox with the line fuses withdrawn. He said that he held the meter across these wires for quite a time and noticed that there was a varying voltage of between 5 and 25 volts which coincided with the starting of trains from the loop platform line. There should have been no voltage across the wires and he therefore had a careful examination made which included the dismantling of the circuit controller. It was then that a washer was found supported on the wiring under the controller where it was bridging the reverse wire contact to a holding down screw on the frame of the controller, which is joined to the lever frame and so via the rodding to the rails. When this washer was removed no voltage was recorded between the reverse operating wire and the return wire.

24. I have no doubt that the accident was due to the bridging by the washer of the gap from the reverse operating wire contact in the controller to the frame of the controller. With the points normal the reverse operating circuit was closed at the points machine, though open at the points lever controller in the signalbox; there the washer provided a connection from the reverse operating circuit to the frame of the controller and thence through the locking frame and rodding to the running rail. As the train started up and took current from the conductor rail there was sufficient electrical pressure between the running rail and earth to energise the points motor and to open the points. The normal operating circuit was thereby closed at the points machine. When No. 21 signal lever was restored to normal in the frame the normal operating circuit was completed and the motor was energised to work the points to normal, which the sub-Inspector heard.

CIRCUIT CONTROLLER (W. B. & S. CO. DESIGN)

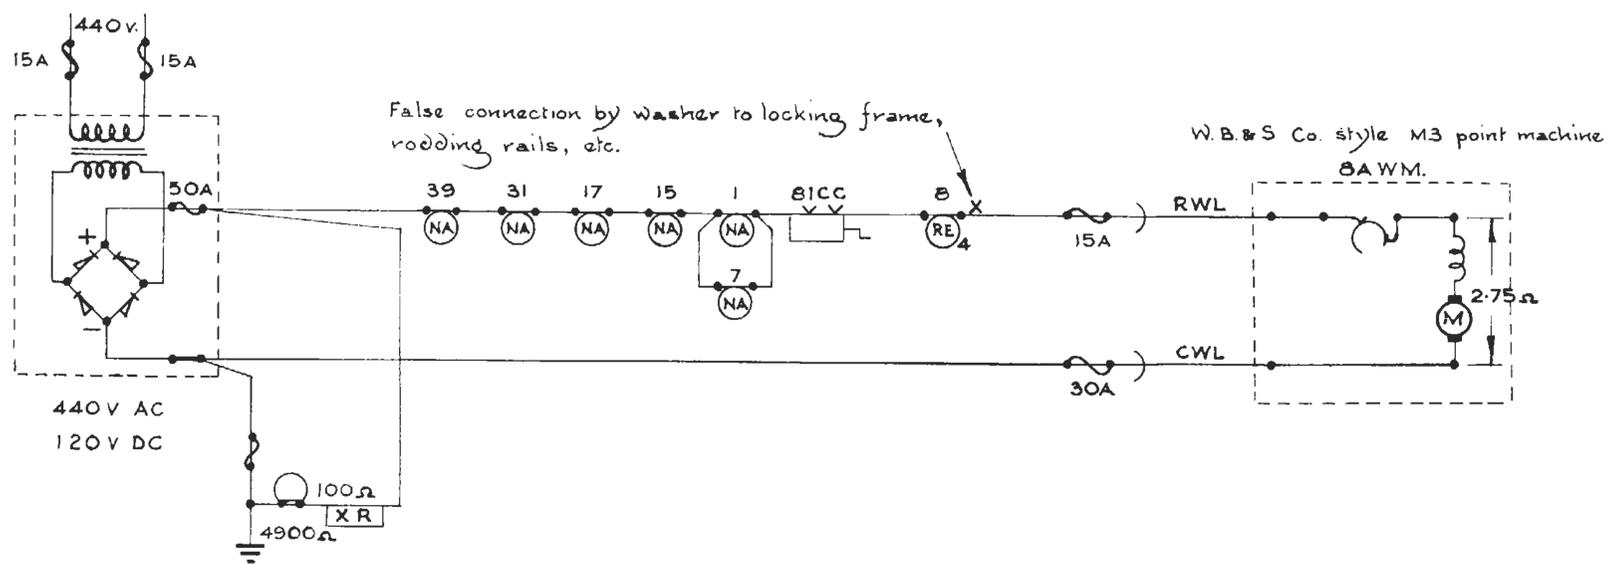
RELEVANT SIGNALLING CIRCUIT
(for operating No 8 points to reverse)

20. I asked Mr. J. F. H. Tyler, Chief Signal and Telecommunications Engineer, Southern Region, to describe the effects of this wrong connection and to tell me of voltage tests which he had subsequently made to ascertain whether this had been the cause of the points being made to move. He had prepared sketches of the circuit controller showing where the loose washer was found, and simplified diagrams of the electrical circuits to the points machine. These are attached as drawings Nos. 1 and 2. Mr. Tyler said that the effect of the connection between the terminal of the reverse operating wire and the holding down screw underneath was to connect the wire to the running rail via the locking frame and the rodding. When the points machine was in the normal position, in which the reverse operating wire is connected to the motor and the other side of the motor is connected to earth via the return wire to the rectifier which is itself earthed by an earth plate, an electrical circuit was completed from the running rail via

the washer and the reverse operating connections of the points machine, and so to earth. As the running rails are not deliberately earthed an appreciable voltage potential between them and earth develops when an electric train is accelerating and taking heavy current; this voltage is at its highest at the mid point between sub-stations. In the Barnham area such voltages are normally very low, but when the sub-station is out of service they can be considerable. He added that measurements, taken after the accident with the sub-station out of service, showed electrical pressures of 60 volts between rail and earth when trains were taking heavy current whilst starting from the station. Such a voltage would have been sufficient to run the motor of the points machine and this condition was undoubtedly the cause of the points moving on this occasion.
