MINISTRY OF TRANSPORT & CIVIL AVIATION

REPORT ON THE DERAILMENT

4th September 1953

BETHNAL GREEN STATION

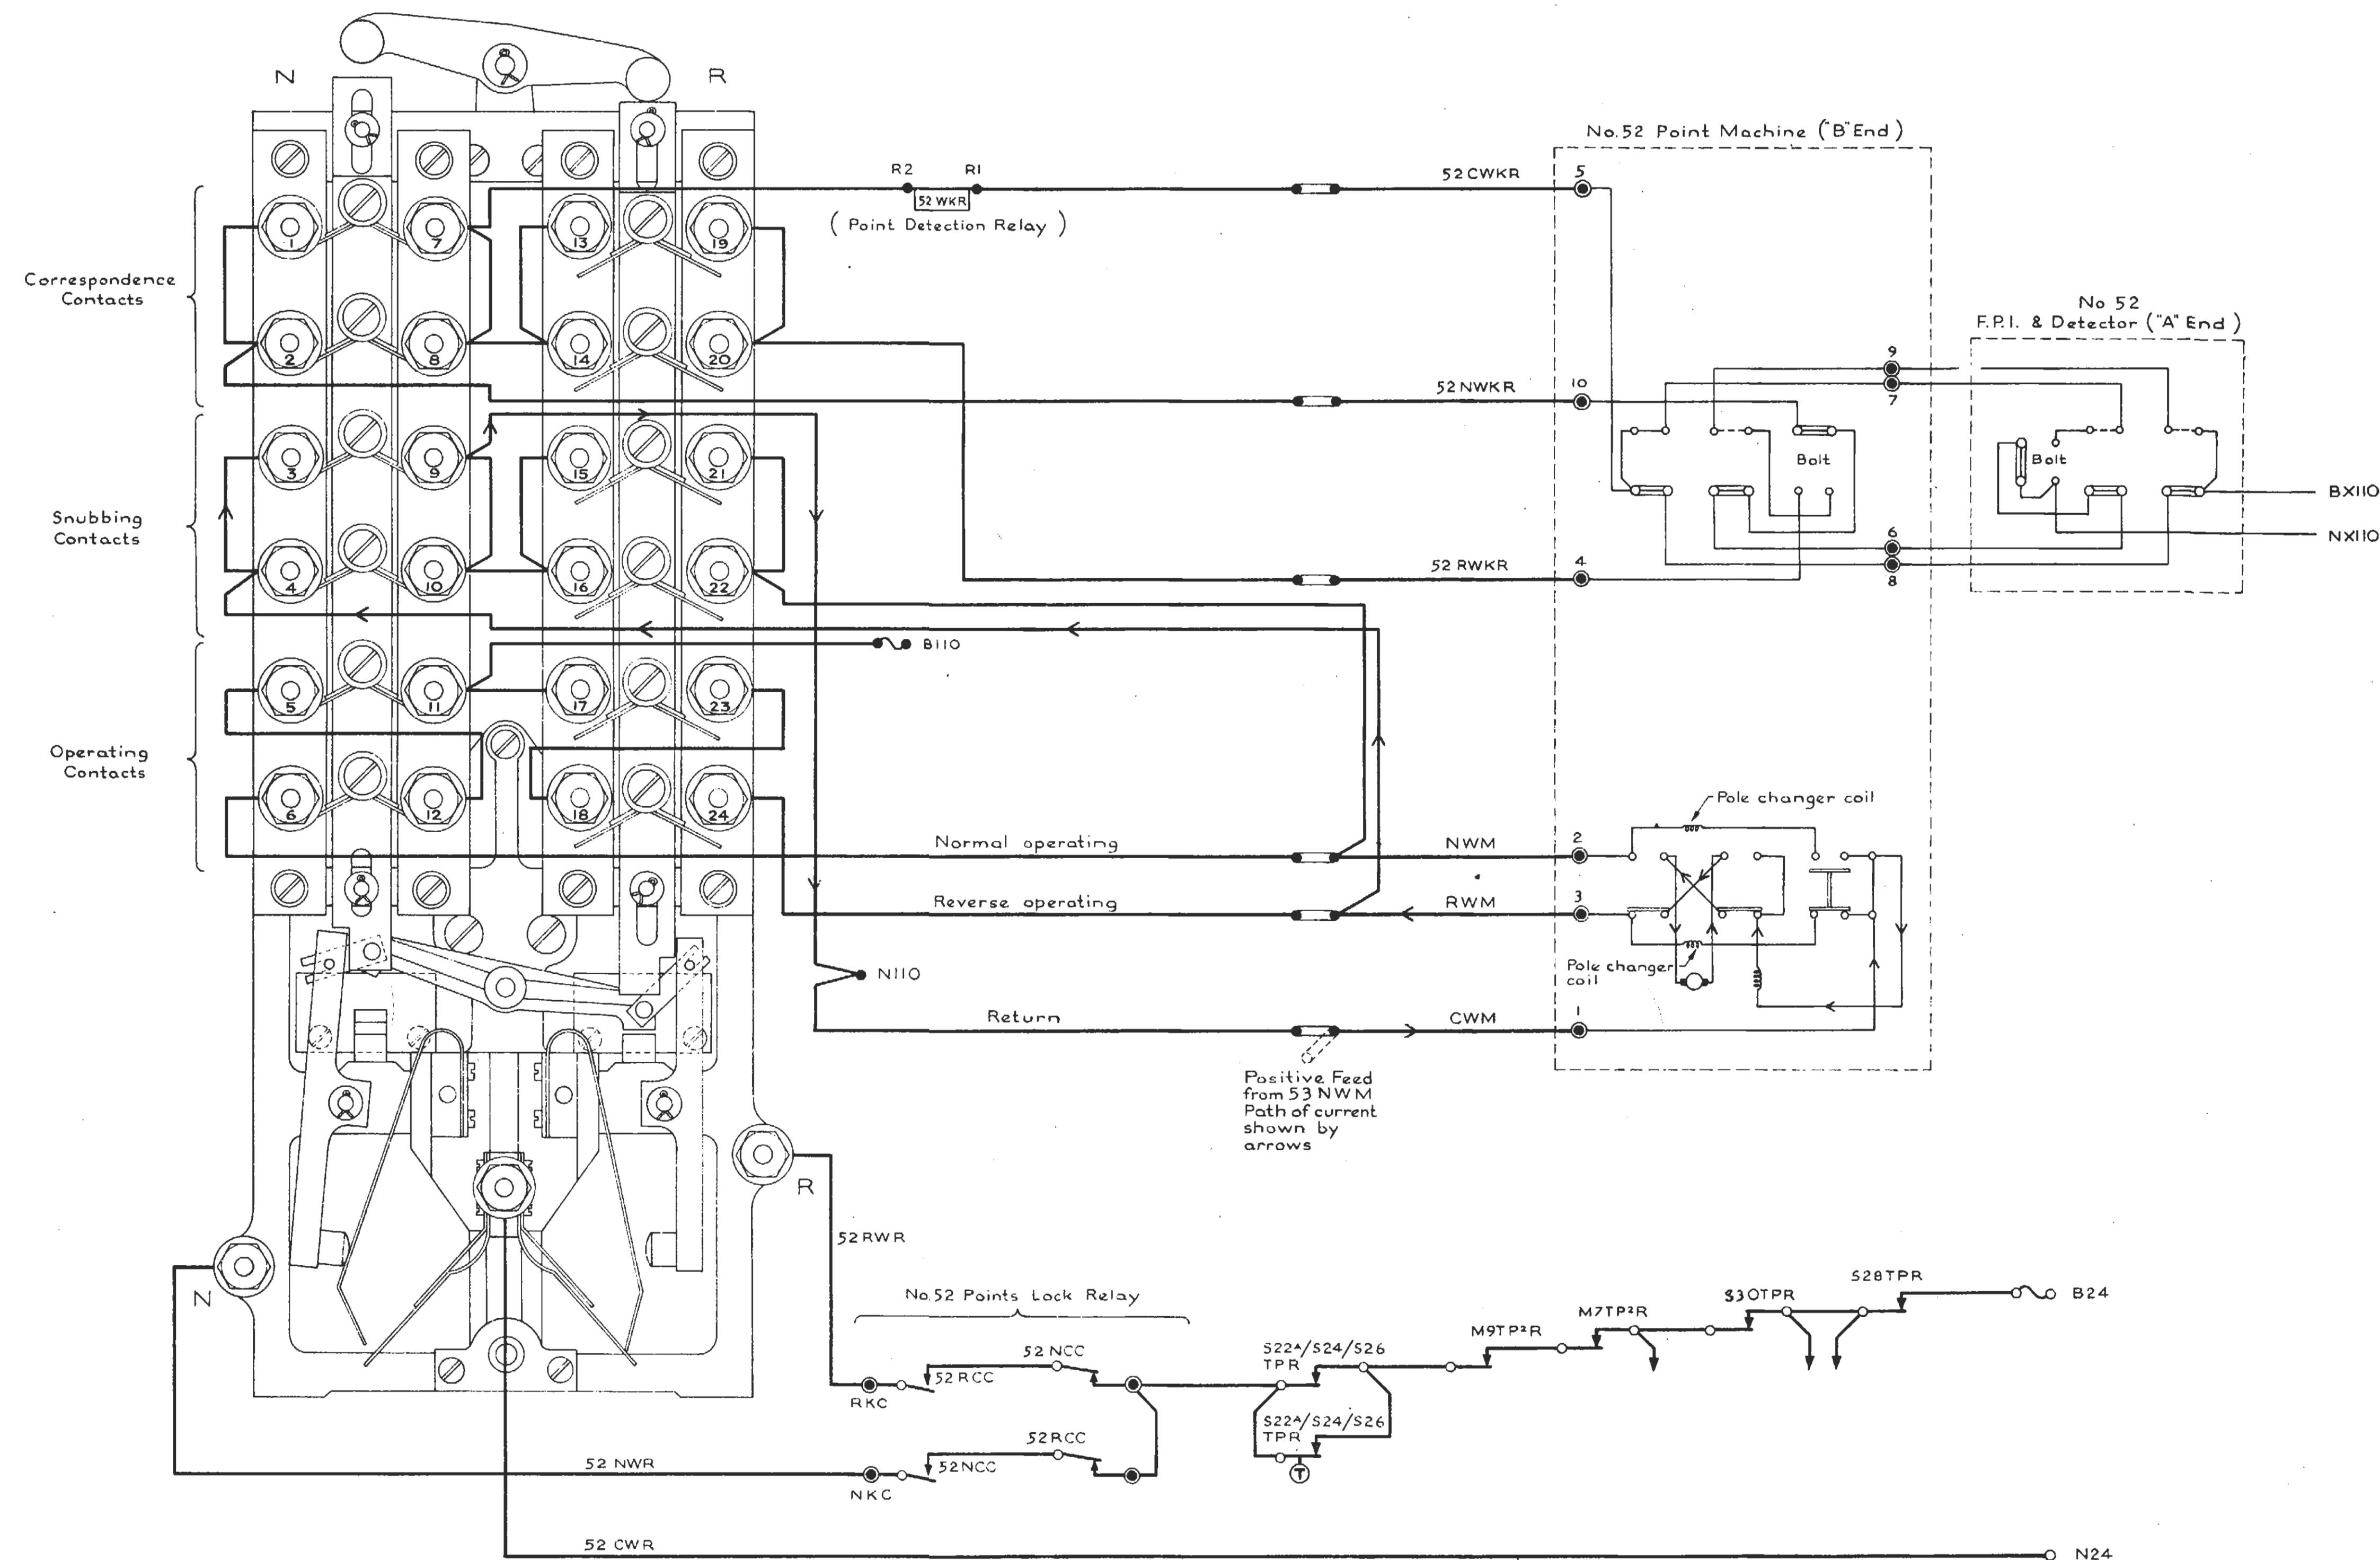
FIG. 7 No. 52 POINTS CONTROL RELAY (SHOWN SET IN THE NORMAL POSITION)

In each case the negative return from No. 52 points motor was broken at the link and this cable was connected to the live positive NWM circuit of No. 53 points control relay, which was in the normal position. Thus a positive feed was applied to No. 52 points motor via cable N.110, the return path to negative being in the reverse direction through the reverse operating snubbing contacts as illustrated by the arrows on Fig. 7.

60. If a broken piece of the cast iron cover of the machine had dropped on to Nos. 2 and 3 terminals (see Fig. 7), some current from the normal operating wire, which was alive, might have passed to the reverse operating terminal, thereby energising the motor, though the subsidiary circuit to the snubbing contact would probably have provided a more direct negative return and might in consequence have blown a fuse. The cover was found smashed after the accident but examination of the trains running on the Suburban lines failed to reveal any missing part which might have dropped on to the machine and broken it before the accident. On the other hand, the rear bogie of the leading coach of the derailed train had ploughed its way through the points machine. There is little doubt therefore that the damage was caused by this means and that the machine was intact when the points began to move. Thus the application of a false feed from this source need not be further considered.

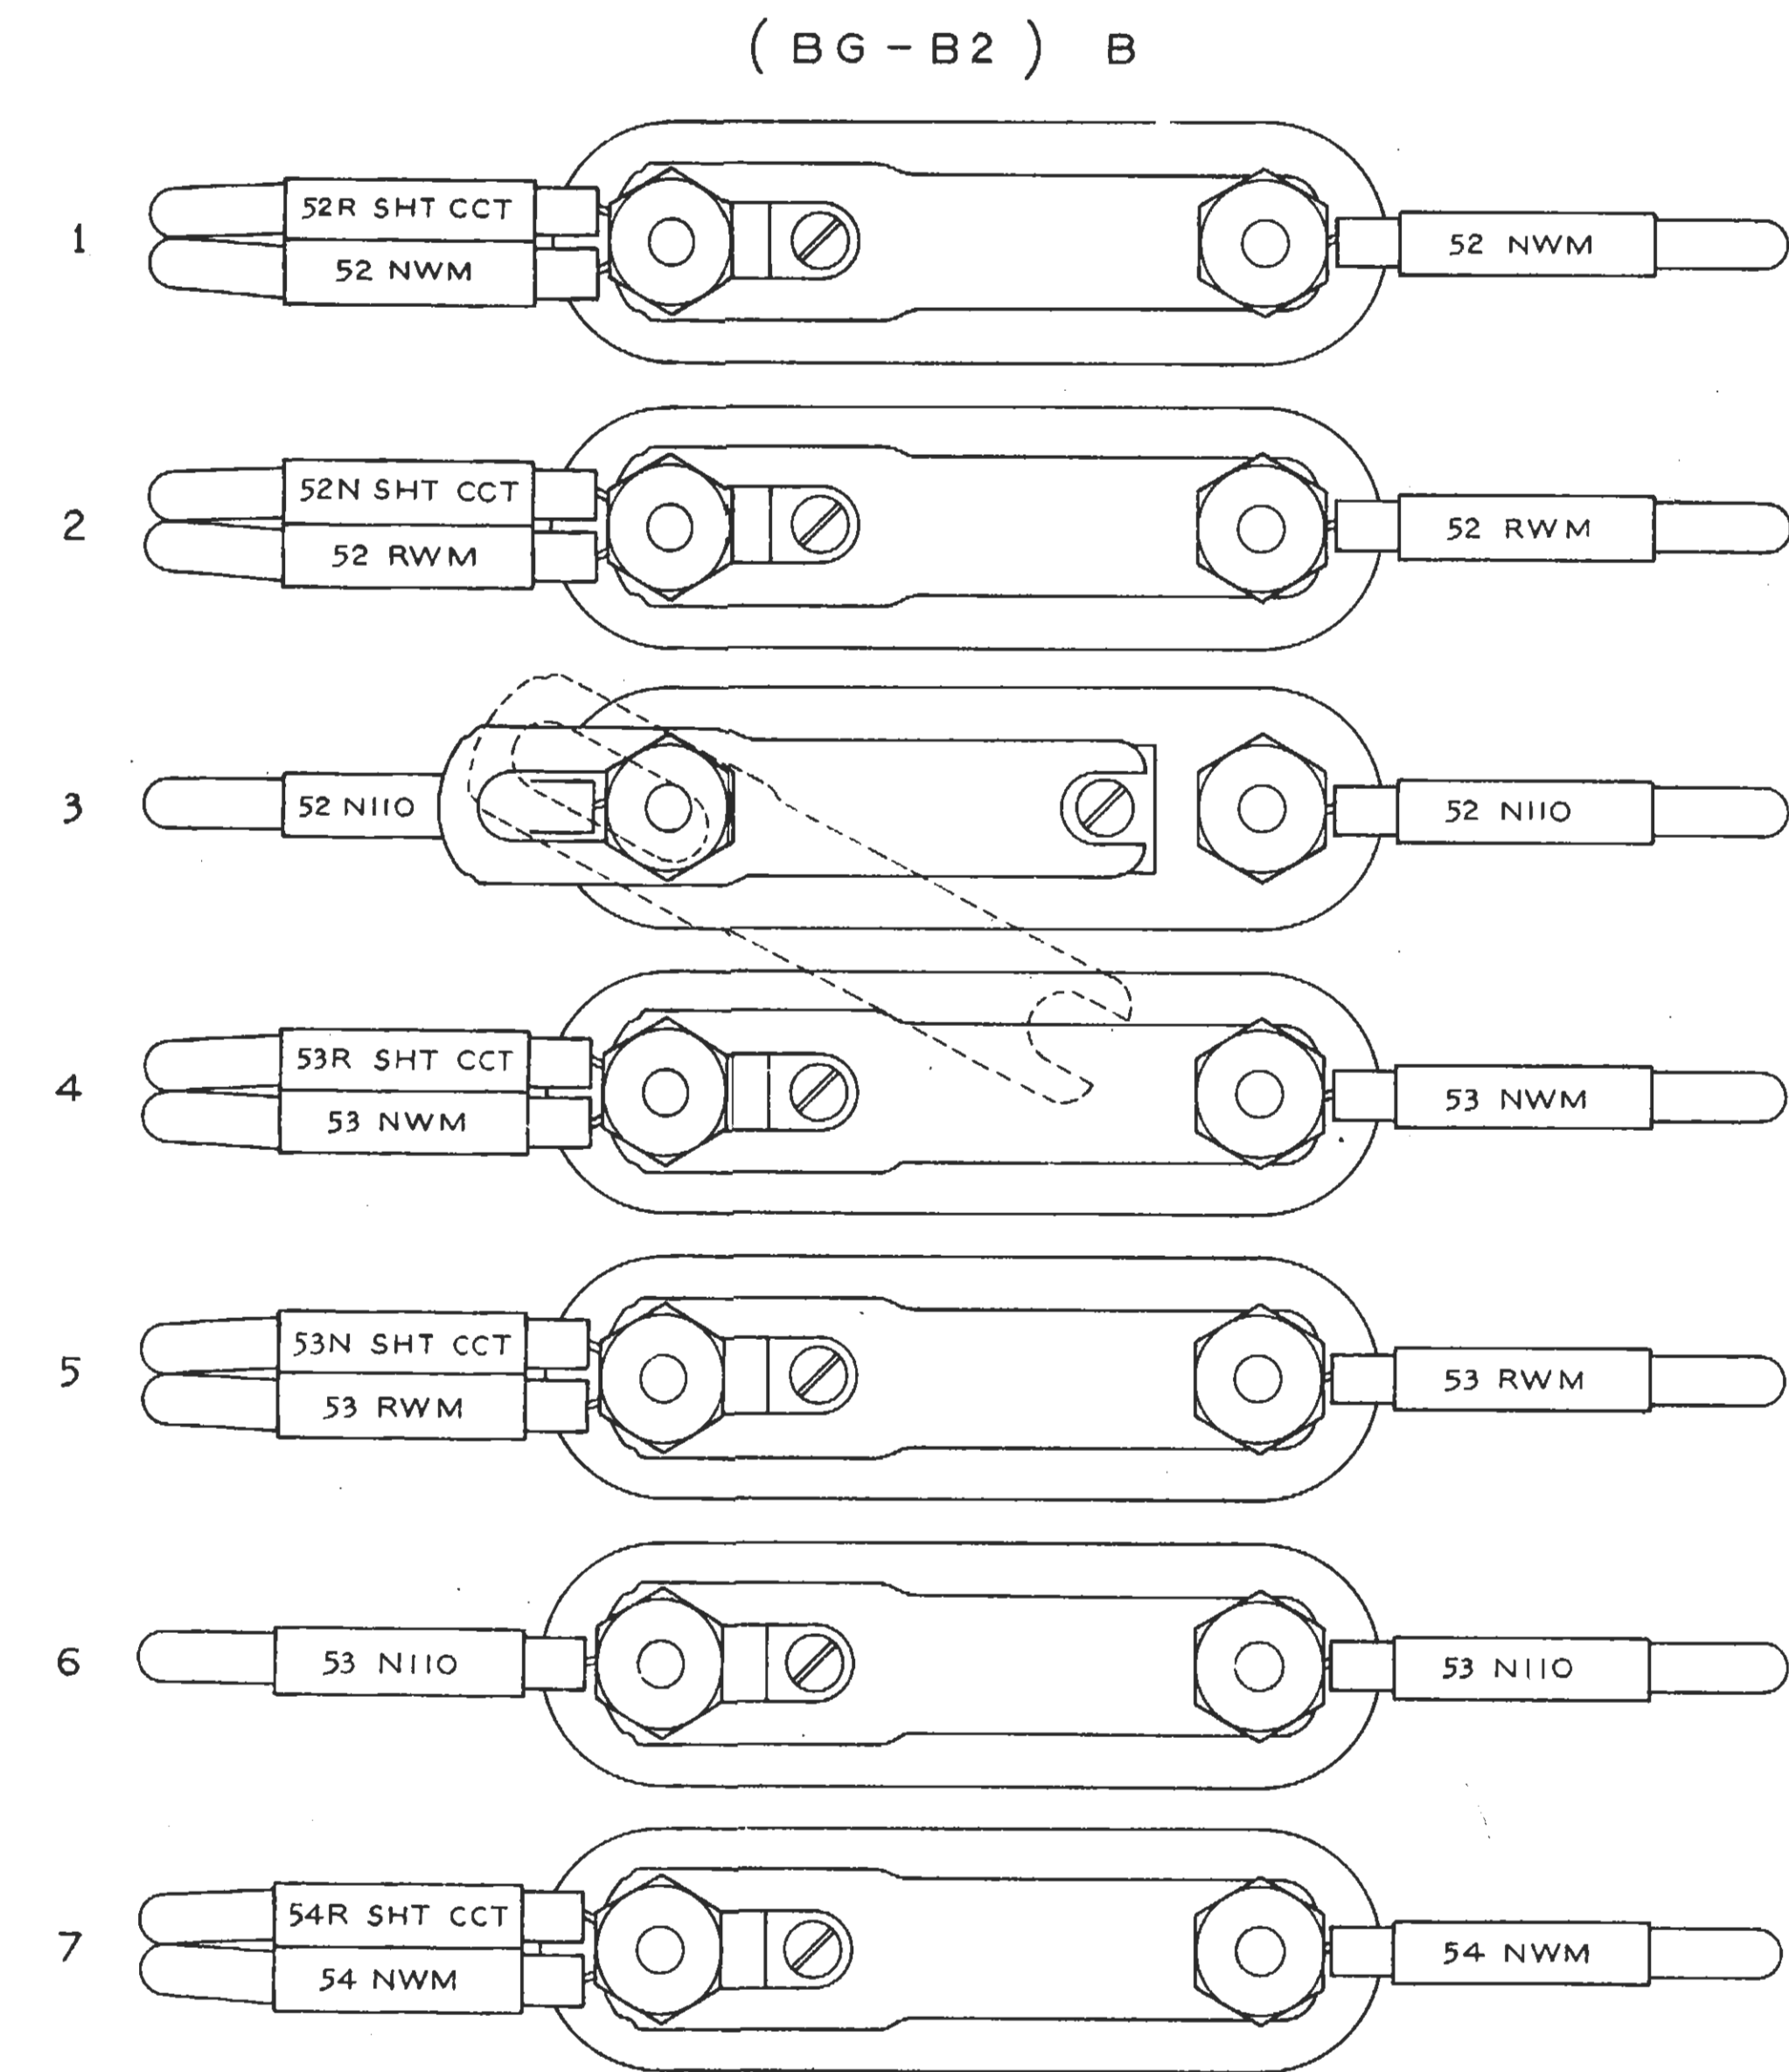
FIG. 8 No. 19 TERMINAL BOARD
(BG-B2) B Multi-Core Cable Links
(SLIPPED LINK SHOWN DOTTED)
SCALE: FULL SIZE

51. Although it appeared that a false feed by this means could be ruled out, examination of the wiring diagrams indicated that a current could be applied to No. 52 points by withdrawing No. 3 link and allowing it to slip on to No. 4 link directly below it, as shown by Fig. 8. Also, if the right-hand terminal of No. 3 link was so loosened that the link no longer made contact with the terminal (see Fig. 9) a current could then be applied to the point motor by connecting the left-hand terminal of this link to No. 4 by means of the wire guard of the wander lamp.

63. No. 52 points were reversed underneath the first coach of the train by the irregular operation of the points machine. This can only have been caused by a false feed through a cross-connection of the 110 volt D.C. circuits. Lineman Eastwood was working on these circuits at the time and I have no doubt that he made the connection inadvertently either by touching the links with his lamp with No. 3 terminal loosened, or, more probably, by letting No. 3 link slip on to No. 4.

65. The more likely cause of the accident, however, was the slipping of a terminal link during testing, and, as explained earlier, this could easily occur if the lineman was not careful. The type of link in use at Bethnal Green and also at one or two other signal boxes in the Eastern Region is an obsolescent pattern. It is being replaced by a modern link fitted with a tough fibre extension in the shape of a slot which embraces the terminal when the link is shifted to break the circuit, thus ensuring that the link cannot slip and make contact with the adjacent terminals.
