MINISTRY OF TRANSPORT

RAILWAY ACCIDENT

Report on the Derailment that occurred on 12th February 1964 at Bethnal Green

IN THE
EASTERN REGION
BRITISH RAILWAYS

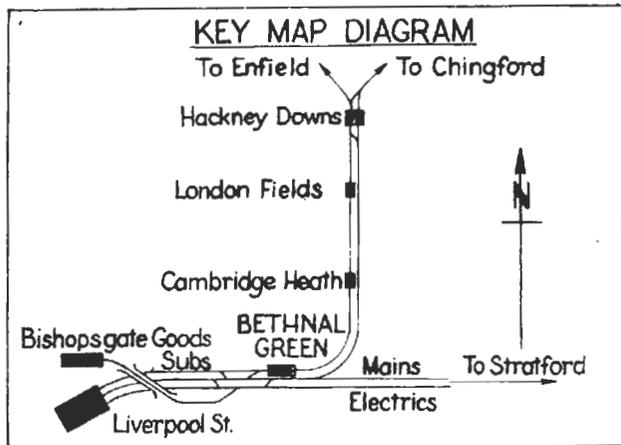
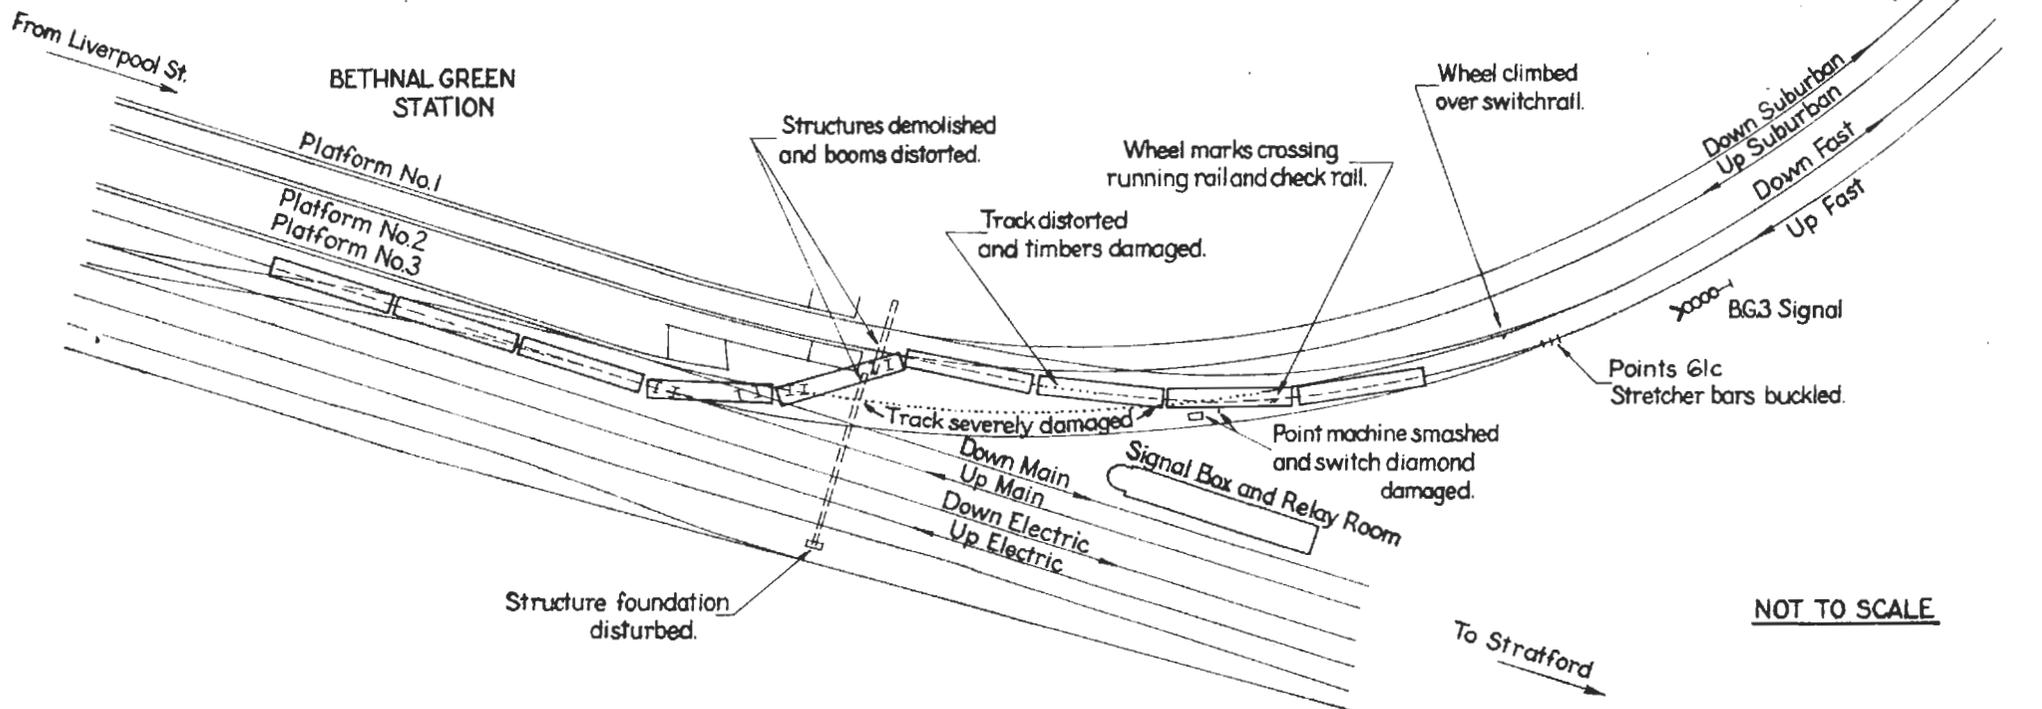
EASTERN REGION
DERAILMENT AT BETHNAL GREEN STATION
12th. FEBRUARY, 1964

2. The designations of the lines on the two routes and the general layout of the junction are shown on the sketch on page 2. The path of the train was from the Up Fast to the Up Main line and Points No. 61C which in their normal position lead from the Up Fast to the Up Suburban line, were the ones that moved under the train. They are about 200 ft. from the centre of the signalbox. The crossing of which these points form a part, is worked by three electric point motors, 61A Down Main facing points, 61B switch diamonds, and 61C Up Fast facing points. The motors move the points from normal to reverse and vice versa in approximately two seconds.

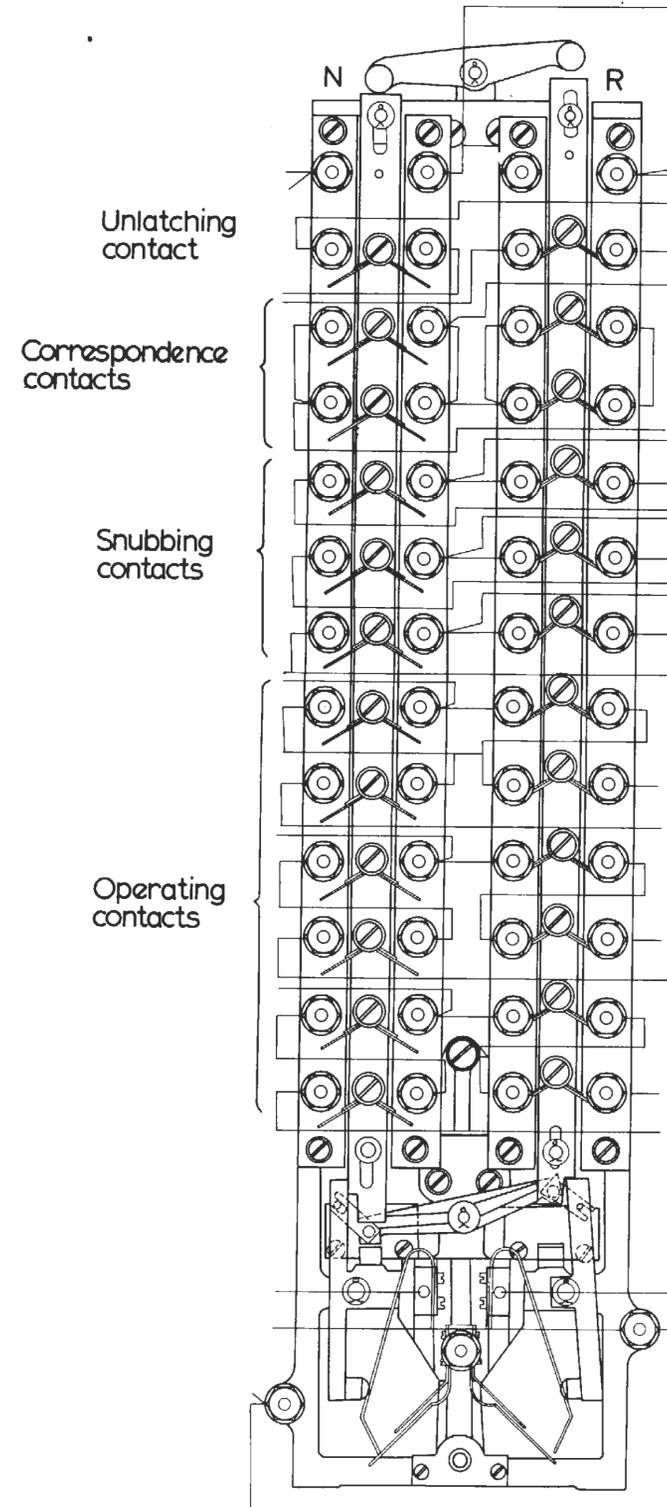
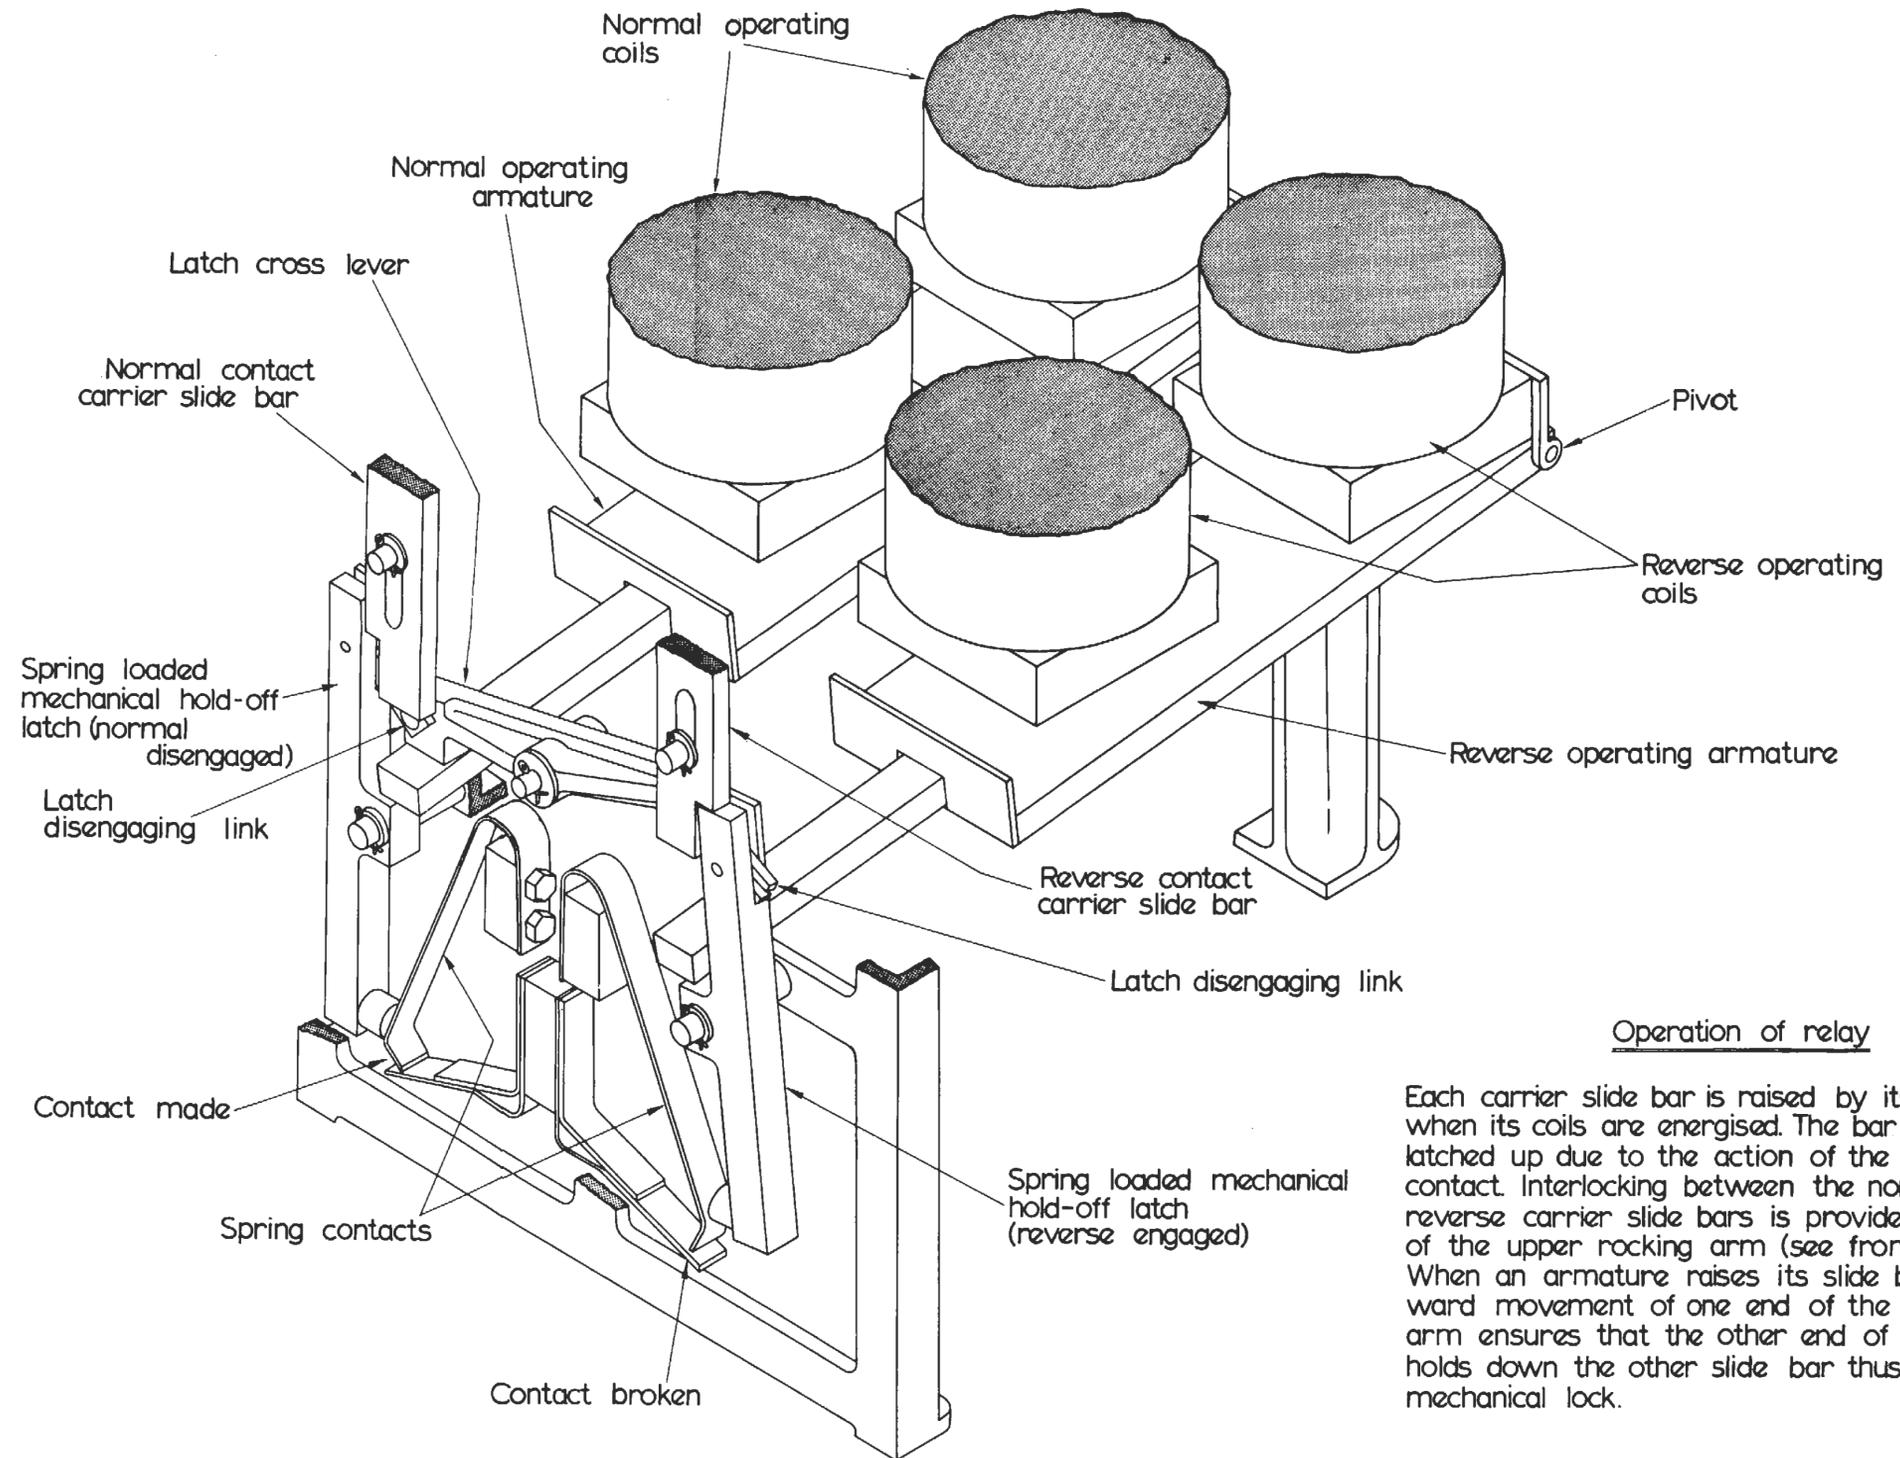
DOUBLE COIL D.C. INTERLOCKED & LATCHED RELAY AS USED IN BETHNAL GREEN SIGNAL BOX

5. The point control relays are of a type that has long since been superseded by others of more compact and fully enclosed design, but I understand that they have given good service for many years and are by no means life expired. They control the electricity supply to the point motors and they comprise a somewhat bulky armature and windings with exposed contactor gear above. A drawing is at the end of the Report. The two sets of contacts, for normal and reverse operation, are operated by individual slides which are moved vertically upwards by separate armatures to close the contacts. A rocking lever above the slides prevents both being in the Up position together. Just before lifting its slide the arm of the energised armature rocks a cross lever which at mid-stroke trips out a latch on the other slide. This slide is thus made free to fall just before the rocking lever is pushed over by the rising slide above the energised armature. The movement of the relay is completed by the latch slipping into the notch of the raised slide, thus latching it up.

7. The latches can sometimes stick in the engaged position thus locking the relay, and the manipulation of the latch to free it is one of the actions taken by the signal maintenance staff men when tracing faults. Such manipulation is intended only to disengage the latch of one slide to allow the other one to lift if the armature coil is properly energised, but it is not difficult to lift an armature by hand thus making the contacts on the slide above it.

22. The immediate cause of this accident was clear and, as I have said, it was due to ill-advised manipulation of the point control relay from reverse to normal, causing the points to move as the train was passing over them. This manipulation was possible because the technician had exposed the relay in a manner to which he was accustomed, and which was accepted by his superiors, for the purpose of manipulating the latch. I find it difficult to accept that he manipulated the normal armature unintentionally instead of freeing the reverse latch, and think it more likely that he assumed that he had possession of the points and did it intentionally, before realising that his action could be dangerous. Whatever may have been in his mind, his action in making the relay accessible in order to manipulate it, without first taking possession of the points, was, in my opinion, flirting with danger. The custom has developed, no doubt, in praiseworthy effort to reduce delays but it is obviously unsound and should be checked.

23. I discussed what happened with Mr. R. A. Green, Chief Signal and Telecommunications Engineer, Eastern Region, and he informed me that orders were issued immediately after the accident to enforce strict observance of Instruction 16-2. He has also agreed, because of the possibility of staff considering minor adjustment such as was talked about at my Inquiry not to fall within the Instruction, to prohibit the manipulation of this type of relay for any purpose without a formal possession, with signatures in the Occurrence Book at the signalbox.

24. I am glad to report that Mr. Green also advised me that work is in hand to replace this particular type of relay, which is in use only at Liverpool Street, Bethnal Green, King's Cross, Doncaster and Shenfield, by a modern form which will be totally enclosed and sealed, in conformity with all other types of signalling relays. The work will take a few years to complete but it is being dealt with as expeditiously as possible.
