# RAILWAY ACCIDENT

## **Report on the Collision that occurred on 12th November 1970 at Bexley Station**

IN THE  
SOUTHERN REGION  
BRITISH RAILWAYS

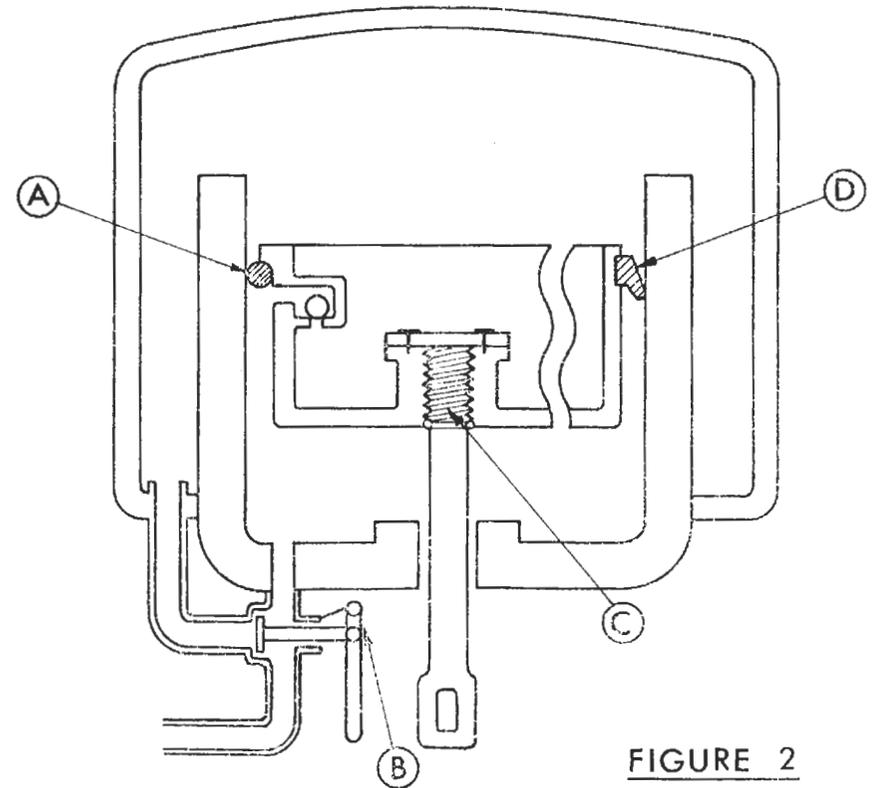
FIGURE 2

There are various types of cylinder but the sketch illustrates the faults found.

23. I was also present when the 5 defective wagon brake cylinders were examined in Hoo Junction Wagon Repair Depot. In addition to the 5 wagons, 4 wagons whose brakes were due for overhaul were also examined. The results, which are tabulated in Appendix A and illustrated in figure 2, were as follows. In two wagons (the 18th and 32nd) the pistons were found to have rotated until they had unscrewed themselves from their piston rods which are not free to rotate because of the brake rigging to which they are attached. In both cases the threads had been damaged by impact between the pistons and the ends of the rods. That on the 1st wagon had been fitted in February 1970 with a rolling ring which had become stretched and twisted and allowed the vacuum to pass by. That on the 4th wagon had a release valve, the lever pivot of which was seized in the open position so that pressures on both sides of the piston were permanently equalised, while it was the brake rigging itself on the 11th wagon which had seized so that the brake cylinder had badly bent

the rodding to the seized handbrake journal which had prevented it operating. Nothing could be found wrong with the 19th wagon's brake cylinder, and when it was reassembled and fitted to the vehicle the brakes worked properly. The failure was probably due to foreign matter which affected either the sliding band on the piston or the release valve, making one of them inoperative.

| WAGON | | | BRAKE | |
|---|---|---|---|---|
| 1 | S 12541 | Open | 2/70 | Defective rolling ring (A) |
| 4 | M 419674 | " | 4/69 | Seized release valve lever (B) |
| 18 | B 763123 | " | 5/69 | Piston adrift (C) |
| 19 | B 851116 | " | 12/69 | No fault found (D) |
| 32 | B 850185 | Van | 11/65 | Piston adrift (Overdue overhaul) (C) |
