RAILWAY ACCIDENTS

REPORT ON THE DERAILMENT

12th August 1958

BOROUGH MARKET JUNCTION

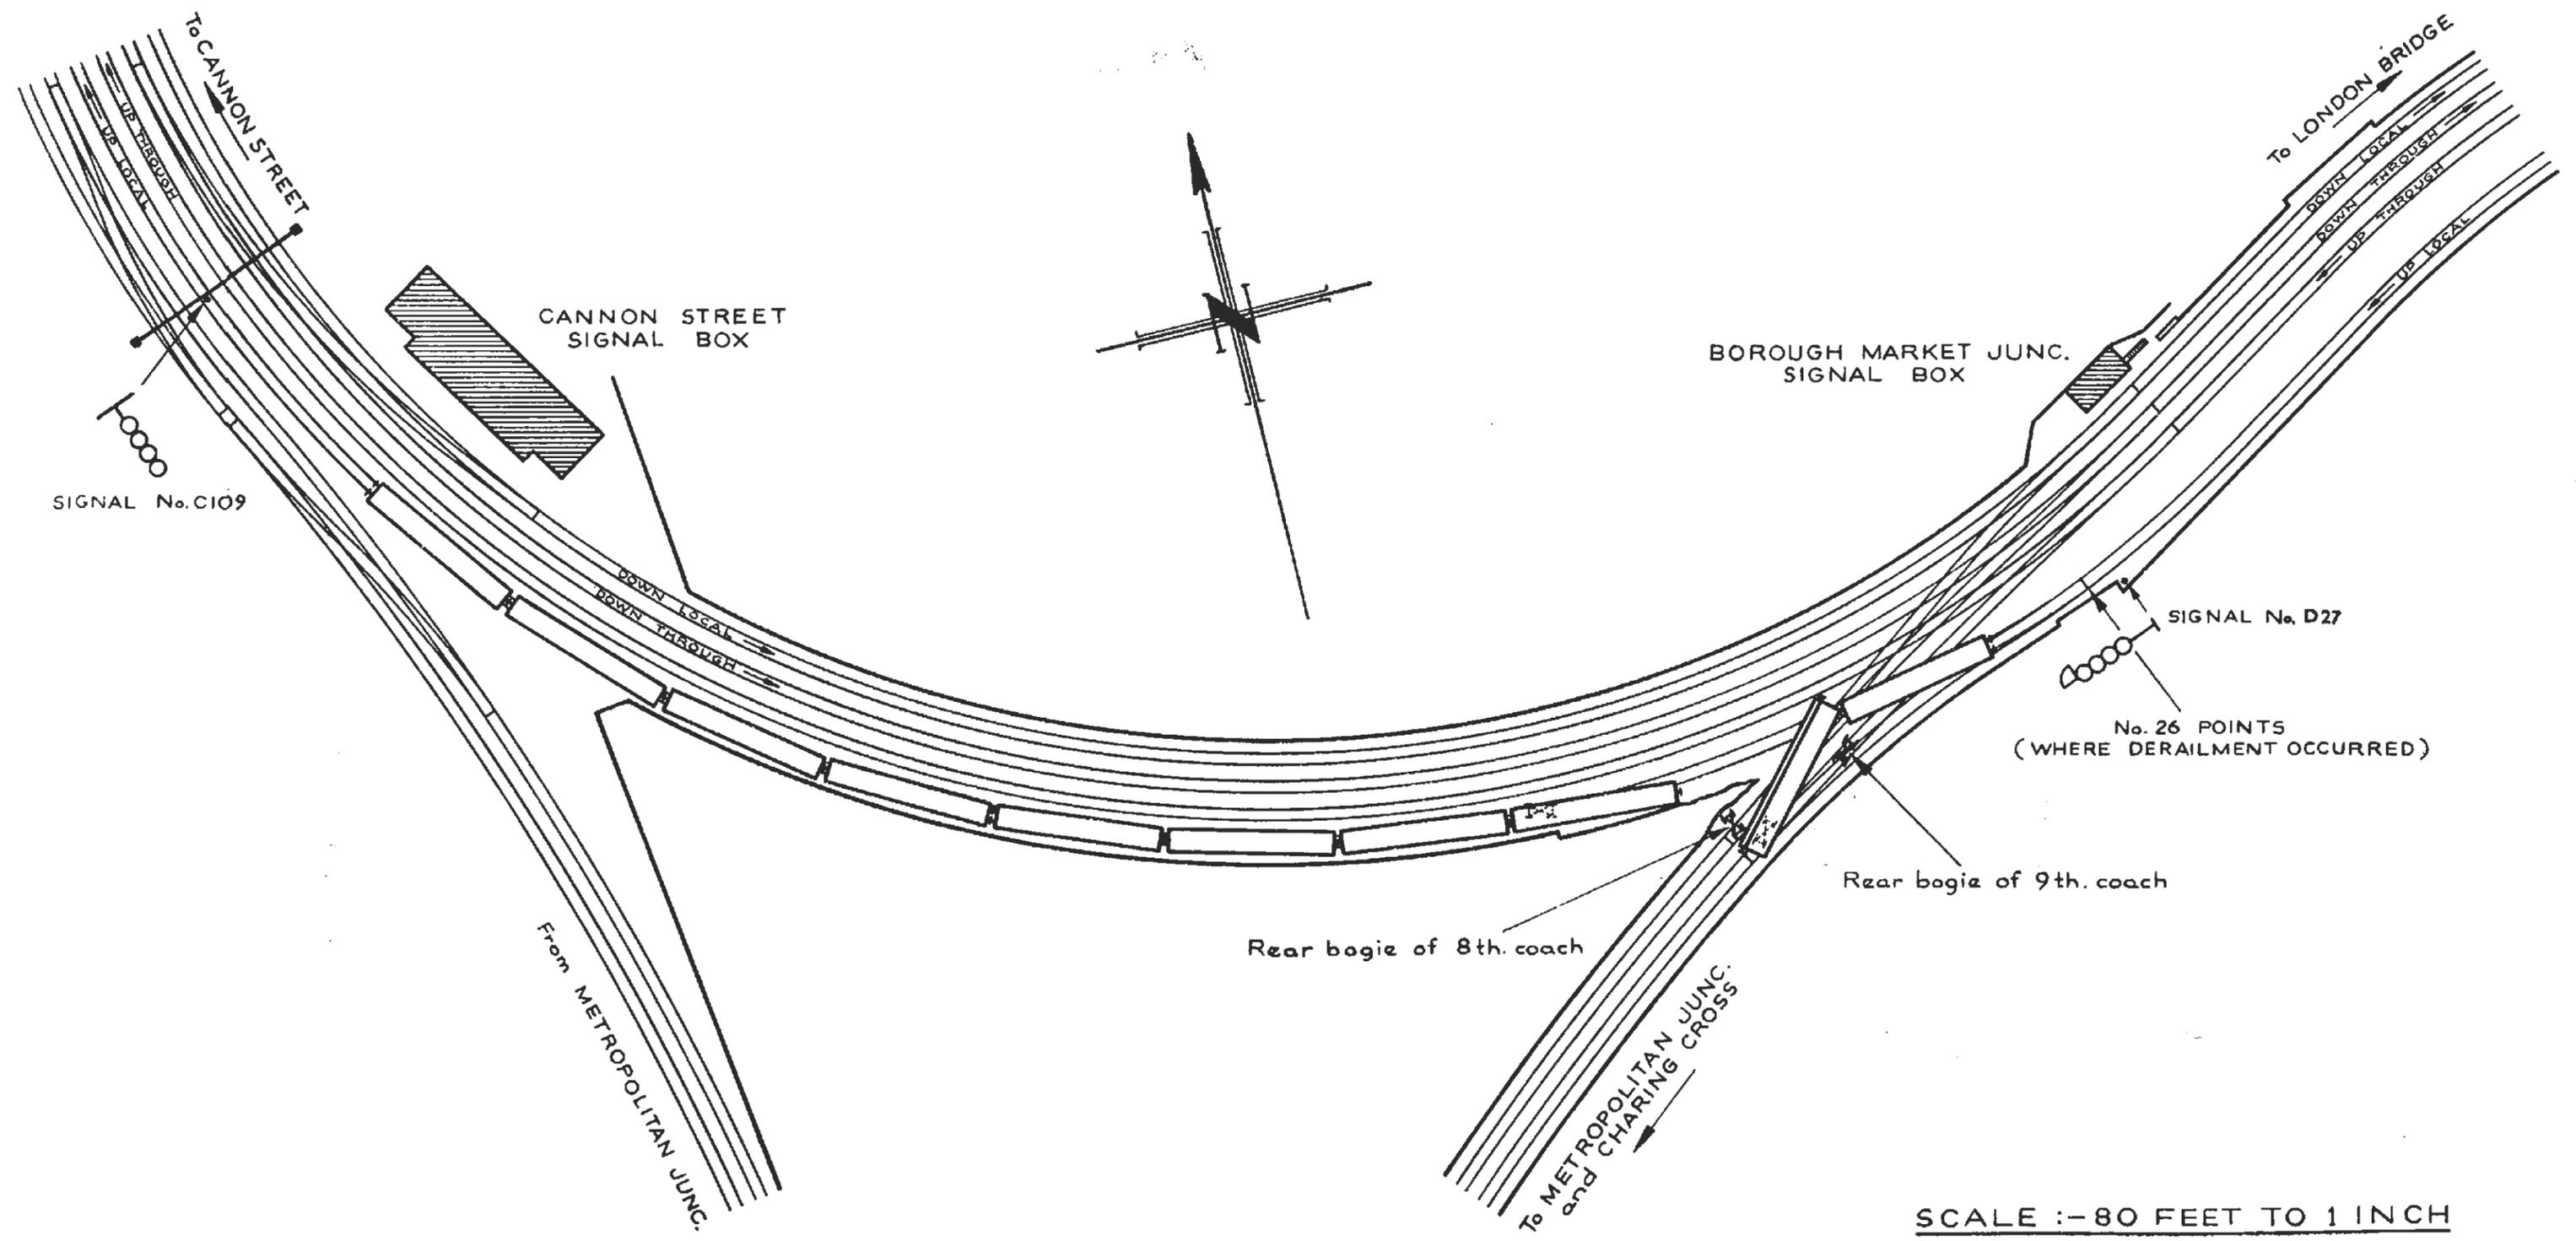
DERAILMENT AT BOROUGH MARKET JUNCTION

The sketch opposite illustrates the layout of the tracks and the position of the relevant signals. The 4-track route runs westwards in the Up direction from London Bridge in a left handed curve which changes to right handed at Borough Market Junction signal box, 260 yards from the London Bridge platforms. The route to Cannon Street then diverges to the north in a sharp right handed curve, while the double track route to Charing Cross, via Metropolitan Junction and Waterloo (Eastern), continues westwards, changing curvature to the left immediately beyond the junction points. A connection from Metropolitan Junction to Cannon Street (not shown on sketch) completes the triangle of routes, controlled at each point by Borough Market Junction, Cannon Street, and Metropolitan Junction signal boxes respectively.

The derailment took place on Borough Market Junction facing points No. 26 on the Up local line, almost opposite the signal box, where the turnout towards Cannon Street leads over a curve of 7 chains radius from the inside of the right handed curve of $12\frac{1}{2}$ chains radius towards Charing Cross. There is a permanent speed restriction of 20 m.p.h. through the turnout on both routes.

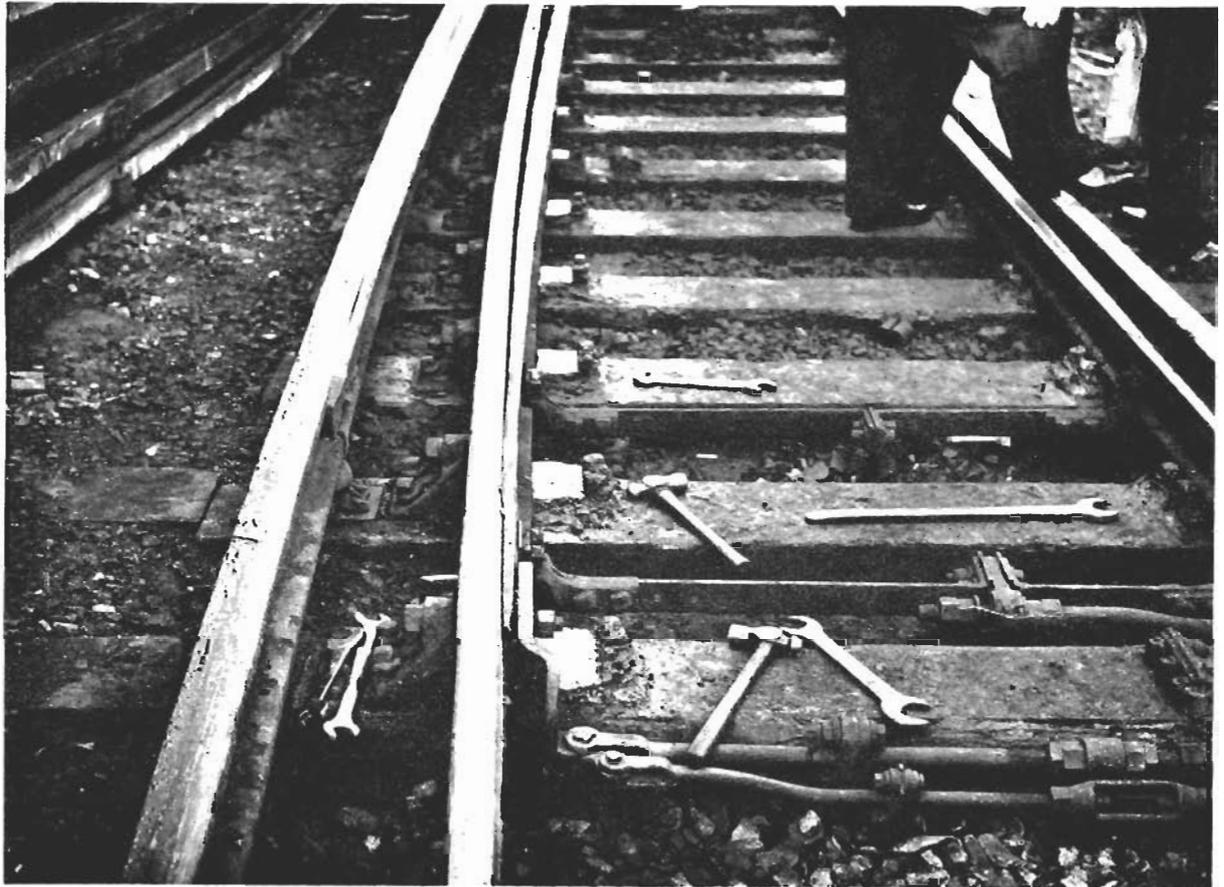
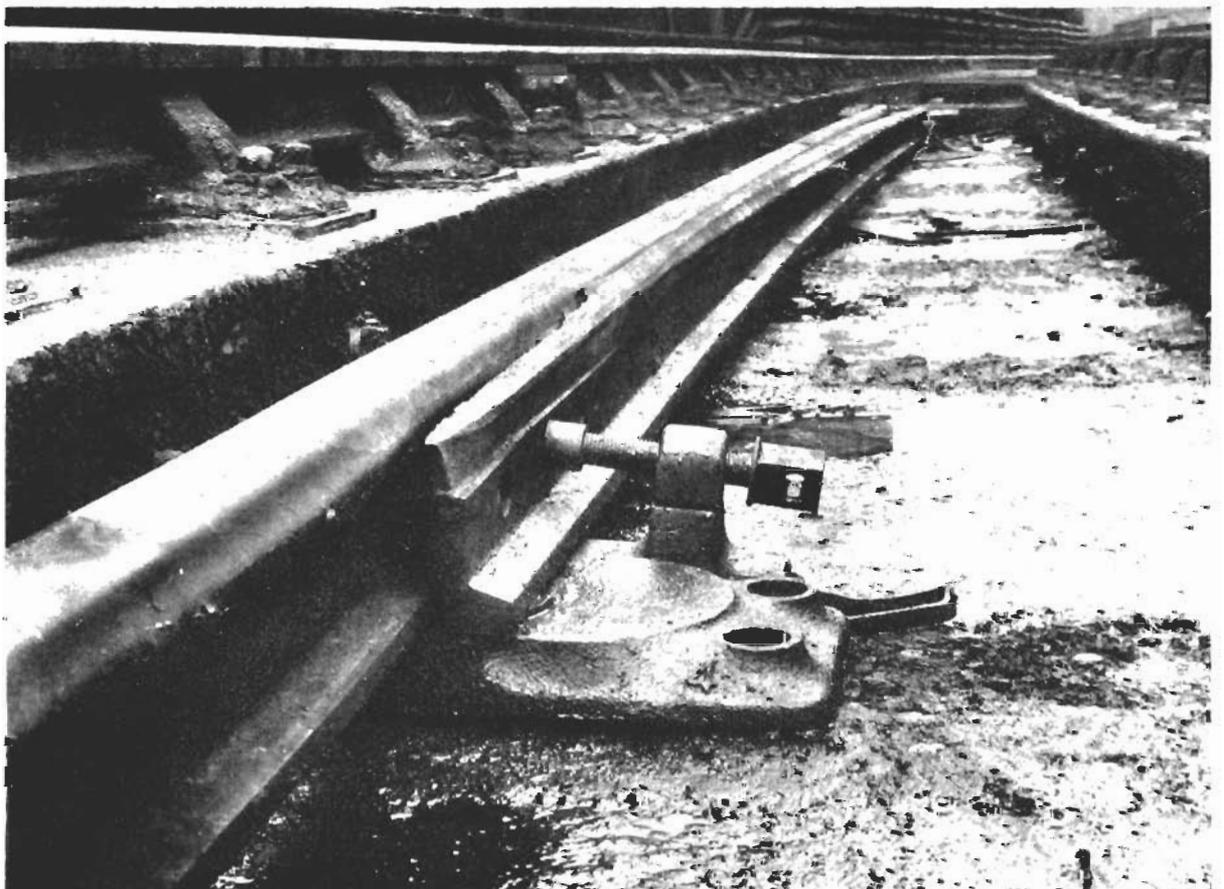
The switch rail was excessively "side-cut", and the top of it for about the first 2 feet from the end was chipped, leaving a flattened top instead of one sloped to fit against the stock rail. The stock rail was also excessively side-cut and the joggle had completely disappeared on the running edge so that the alignment was regular along the length of this rail on the route leading towards Charing Cross which, as already indicated, carries over three times as much traffic as the other route. As a result, when the points were closed for the Cannon Street route, the toe of the left hand switch projected inside the running edge of the rail and the flattened top provided a sort of ramp for the flanges of oncoming wheels, which would have been bearing against the left hand rail because of the curvature, to ride up it on to the rail table.

The photographs at the end of the report, one of which was taken after the switch and stock rail had been removed from the track and reassembled, show the heavy side wear and the even alignment of the running edge on the worn stock rail with no trace of joggle, though a vestige can be seen at the bottom of the head just clear of the toe of the switch. The ramp effect at the end of the switch, caused by battering can also be seen in the detailed photograph.

There were two interesting features in the wear on the switch and stock rails, which are worthy of comment. The first was the side cutting of the stock rail throughout its length, which as already stated was on a right handed curve of $12\frac{1}{2}$ chains radius, caused by the heavy traffic towards Charing Cross. This wear on the running edge meant that the top of the switch rail had no lateral support when closed against the stock rail for the Cannon Street route. The other feature was the complete disappearance of the joggle on the running edge of the stock rail which, combined with the side cutting, exposed the blunt end of the switch rail and allowed it to be battered by the flange of the leading outer wheel on each bogie on every train travelling towards Cannon Street. The flanges of such wheels would all have been bearing hard against the outer rail of this sharp curve, and the sideways pressure against the unsupported head of the switch where it was thinnest towards the nose, combined with the end batter on the exposed nose by the wheel flanges, undoubtedly caused the head to be chipped and broken away over about the first 2 feet of the switch rail, so that a rough ramp was developed.

Apart from the excessive wear in general of the switch and stock rail the absence of the joggle on the running edge of the stock rail was, in my opinion, a noticeable danger sign which Inspector Drane did not appreciate. It may be appropriate to draw the attention of Engineering staff to the significance of such wear.

I discussed with the officers of the Chief Civil Engineer's staff the advisability of using the joggle design on a turnout of similar flexure in circumstances such as this where there is a preponderance of traffic over the straighter route, but was advised that switches and stock rails of the alternative undercut or chamfered designs would wear so quickly as to be unacceptable. I was also assured that the supply arrangements for manganese steel replacements for switches such as these are being overhauled so that material will be available when required.
