RAILWAY ACCIDENT

Report on the Derailment
that occurred on 6th May 1977
at Borough Market Junction

IN THE
SOUTHERN REGION
BRITISH RAILWAYS

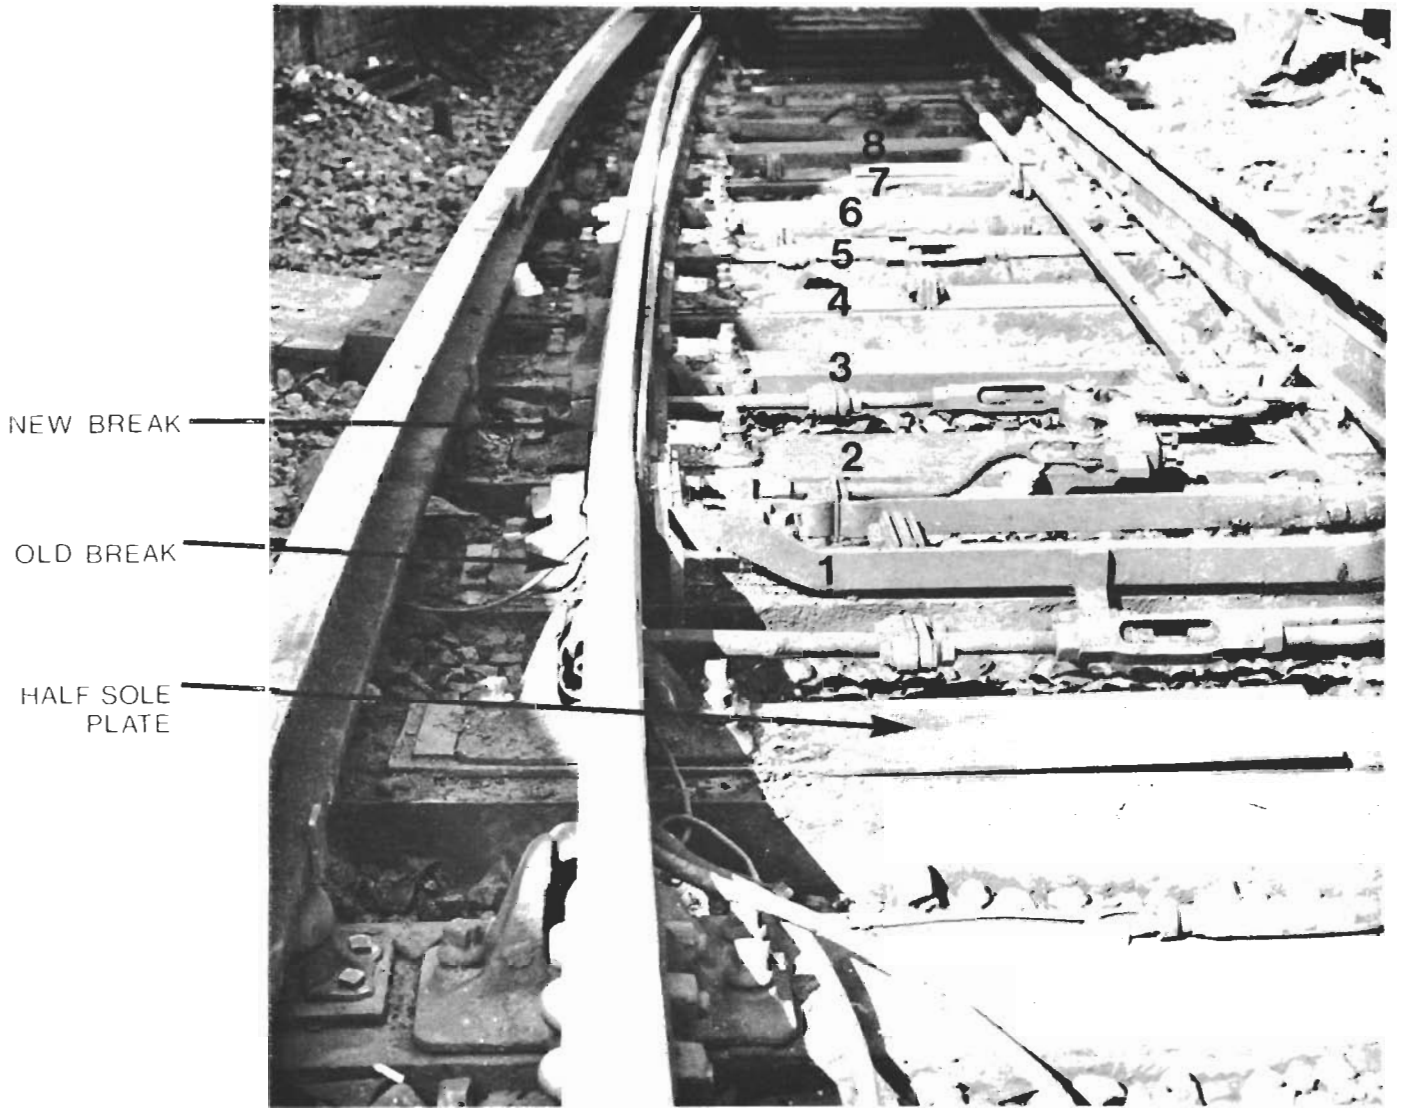
POINTS No. 715 - AFTER DERAILMENT

16. He could find nothing wrong with the buckeye couplings that had parted and assumed that they must have become disengaged because of excessive vertical movement. He noted that a piece about 70 mm long had been broken off the toe of the cress-side switch blade of Points No. 715 to a depth of about 9.5 mm, and that the break was old and rusty. There were wheel flange marks on the top of the blade and three 'drop off' marks where a wheel had dropped down between the blade and the stock rail some 420 mm, 460 mm and 520 mm from the tip of the points blade. There were also wheel flange marks on the outside of the blade to a depth of about 40 mm, about one metre after these 'drop off' points, and clear indications where the derailed wheels had struck chairs and a fishplate while dropping between the two rails. In his view, the wheels of the two motor bogies of the eighth and ninth cars had become derailed in this way.

17. The fit of the switch blade to the stock rail appeared to be good, but its top was sufficiently beneath the level of the top of the stock rail for several people to draw his attention to it; and the loss of metal over the first 70 mm accentuated this.

21. In addition to the normal sole plate on the first timber and the three gauge ties before the first timber, between the second and third timbers, and between the fourth and fifth timbers, there was an additional sole plate on the fourth timber. Half sole plates had also been inserted beneath the rails with a view to their being welded in situ. They were on the sleeper before the points and on the fifth, seventh, and tenth timbers. *Mr. Newing* told me that the first slide chair supporting the left-hand stock rail had broken several days before the derailment and plans had been made to change it. The second slide chair was also broken but the break was new and it had probably occurred during the passage of the derailed train. The left-hand stock rail was 7 mm above both of these slide chairs and unsupported by them. These are clearly shown in the photograph.

22. There was some side cutting on the ccss-side stock rail but it was not great and there was a loss of head of the stock rail of 3 mm. It was the insertion of the half sole plates, and particularly that on the sleeper prior to the point ends, that had raised the left-hand stock rail above the slide chairs so that it was excessively above the level of the switch blade under traffic.
