RAILWAY ACCIDENT

REPORT ON THE COLLISION

20th March 1961

CANNON STREET STATION

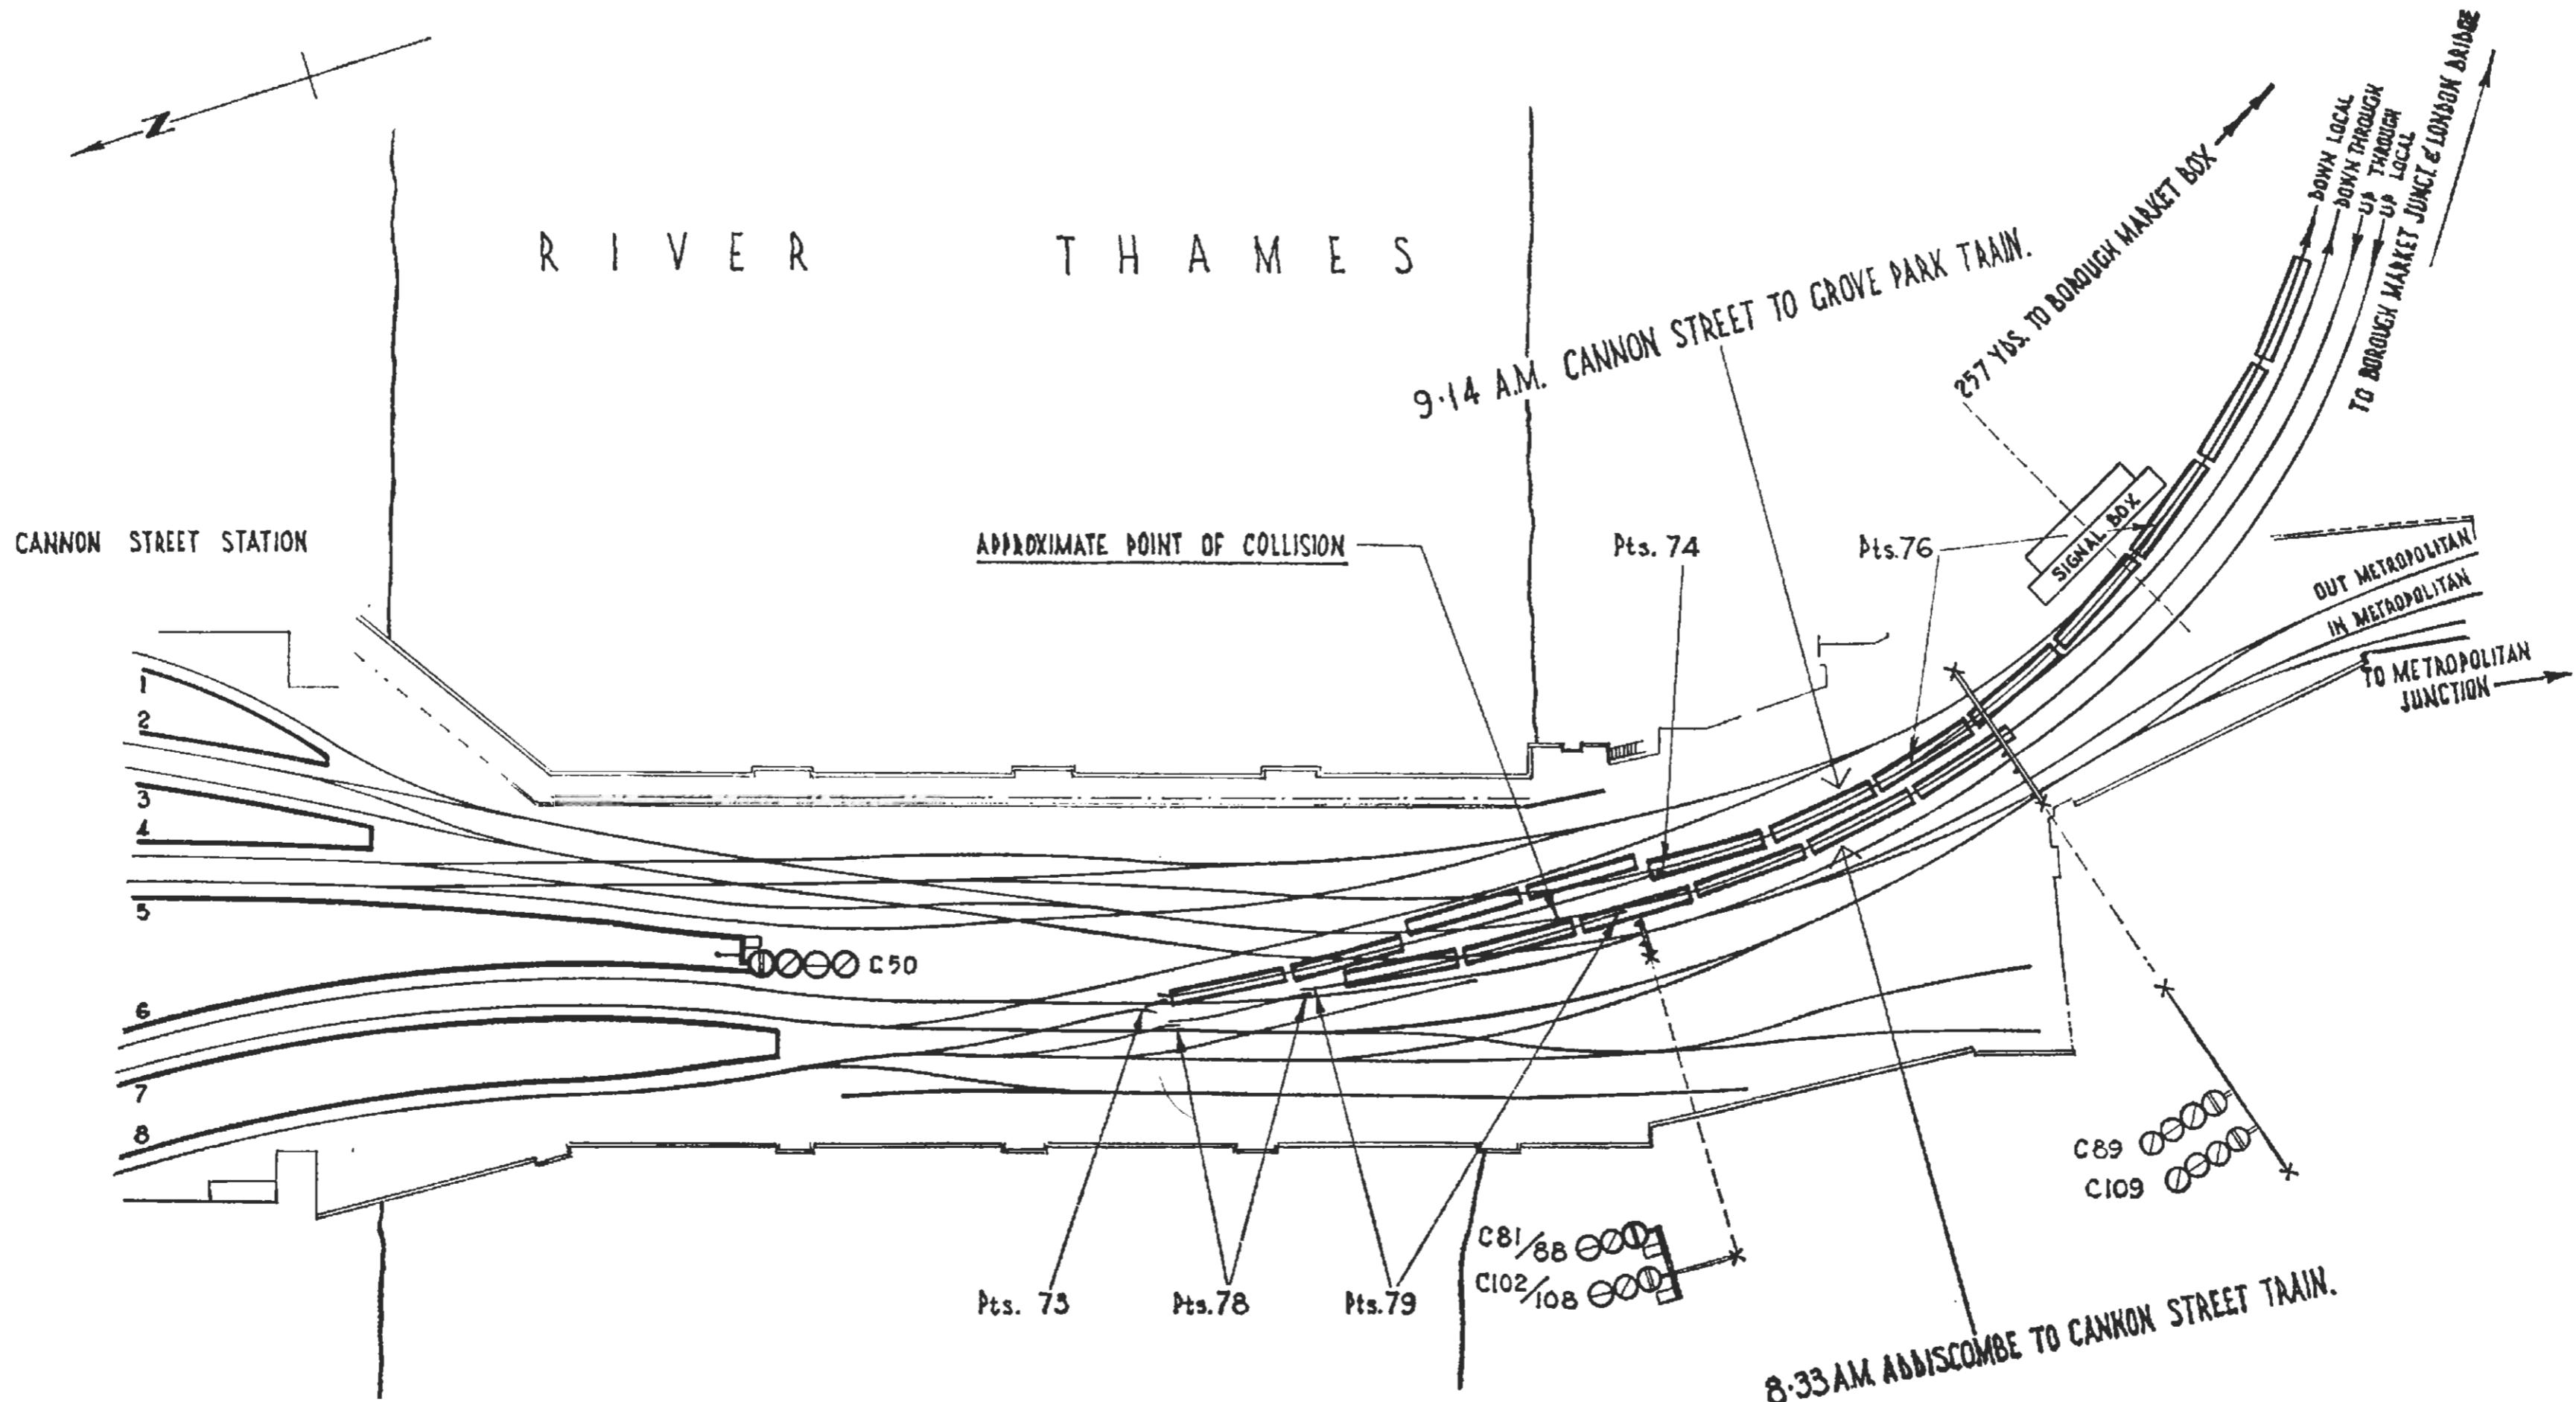
CANNON STREET - COLLISION ON 20th MARCH 1961

The sketch opposite shows the relevant parts of the railway, and the two trains involved in the collision, after they had come to rest.
