LONDON ELECTRIC RAILWAY.

18th February, 1925.

I have the honour to report, for the information of the Minister of Transport, in accordance with the Order of the 20th January, the result of my Inquiry into the circumstances of a collision, which occurred at about 8.40 a.m. on January 19th, near Charing Cross, on the London Electric Railway.

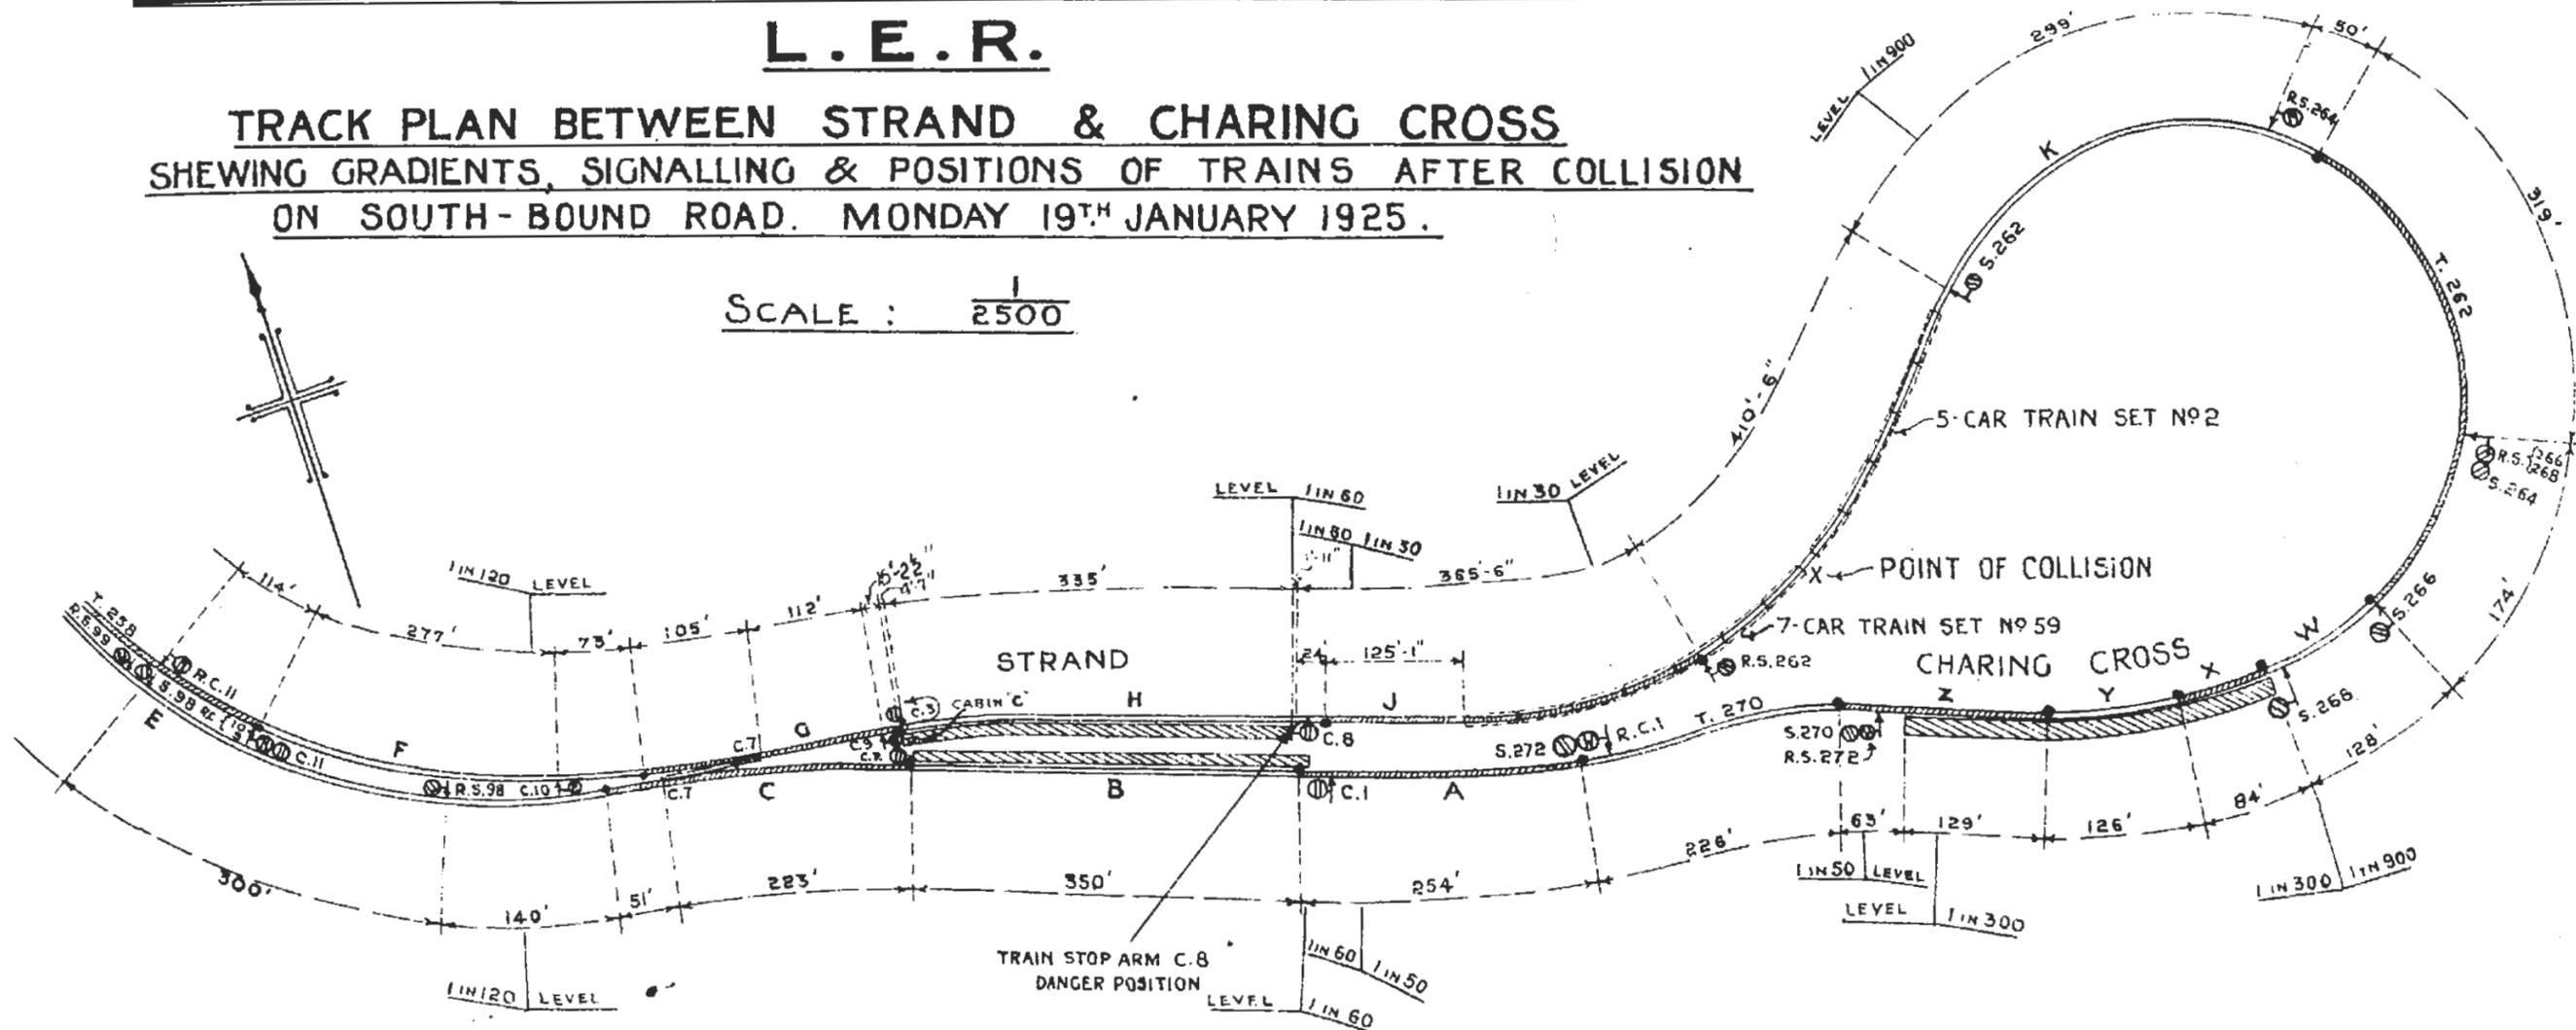
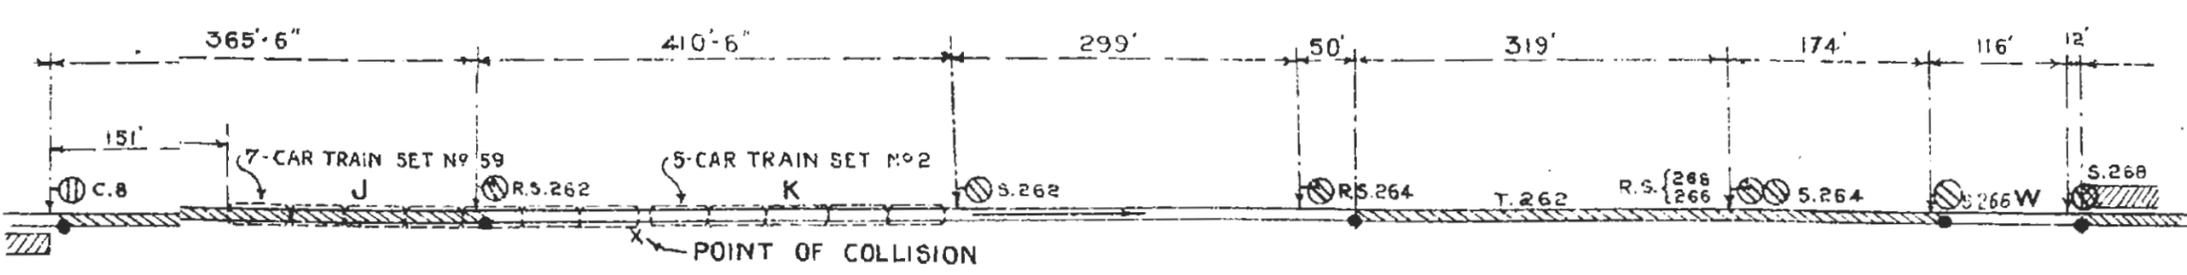
TRACK PLAN BETWEEN STRAND & CHARING CROSS SHEWING GRADIENTS, SIGNALLING & POSITIONS OF TRAINS AFTER COLLISION ON SOUTH-BOUND ROAD. MONDAY 19TH JANUARY 1925.

The collision took place on the loop line between Strand and Charing Cross Stations. The two trains involved were No. 2, a five-car set, which was standing at the first automatic signal beyond Strand Station, and No. 59, a seven-car set, which, shortly after leaving Strand Station on the south-bound road, collided with the rear of the standing train.

had already pulled off the usual running signal levers, including, therefore, that of the south-bound starting signal, so as to restore the frame to its normal running condition. This signal, however, did not clear when the lever was pulled, and Heley was aware that it was being held at danger by train No. 2 standing at automatic signal No. 262. He knew this by seeing the occupied condition of the track in question, and also realised that No. 59 train had not reached the track joint ahead of the south-bound starting signal, so that it had not, therefore, arrived at the point where it would, by short circuiting J track, hold the starting signal to danger behind it. Heley then left the signal cabin and went to the north-bound platform to see whether No. 5 train was going away under its own power or was being propelled. When he returned he found that No. 59 train had left, and therefore assumed that the starting signal had cleared. As a fact it had not done so, and No. 59 train came into collision with No. 2, which was still standing at automatic signal No. 262.

The immediate cause of the accident was the incorrect assumption on the part of the station and train staff at Strand Station that the section of line ahead of the starting signal was clear when the train left the station. The circumstances in which this signal was originally passed in the danger position have already been explained in the foregoing summary of evidence, from which it will be clear, in conjunction with the description, that when once this signal had been passed, the normal safeguard against following collisions, provided by the train stop at this location, was rendered inoperative should the train subsequently, as this one did, proceed ahead into an occupied section. There is no instruction in the Company's Regulations which literally applies to the exact circumstances of this case, but it is clearly covered by the spirit of their Regulations regarding the passing at danger of a controlled automatic signal which is presumed to have failed, and therefore to be incorrectly exhibiting a danger aspect. These regulations read as follows:—

(1) Position of south-bound Strand starting signal. There is always the possibility of the reverse movement over the crossover road at this station being required, with a train of any length, in an emergency such as arose in this case, and moreover, the use of seven-car trains is likely, I understand, to increase. It would therefore

be advisable to move this starting signal out a sufficient distance to allow a margin for the longest train used on the line to stand between it and the track circuit joint in rear, and I understand that it is the Company's intention to make this alteration.
