MINISTRY OF TRANSPORT

# RAILWAY ACCIDENT

## **Report on the Failure of an Overbridge that occurred on 10th May 1965 at Clapham Junction**

IN THE  
SOUTHERN REGION  
BRITISH RAILWAYS

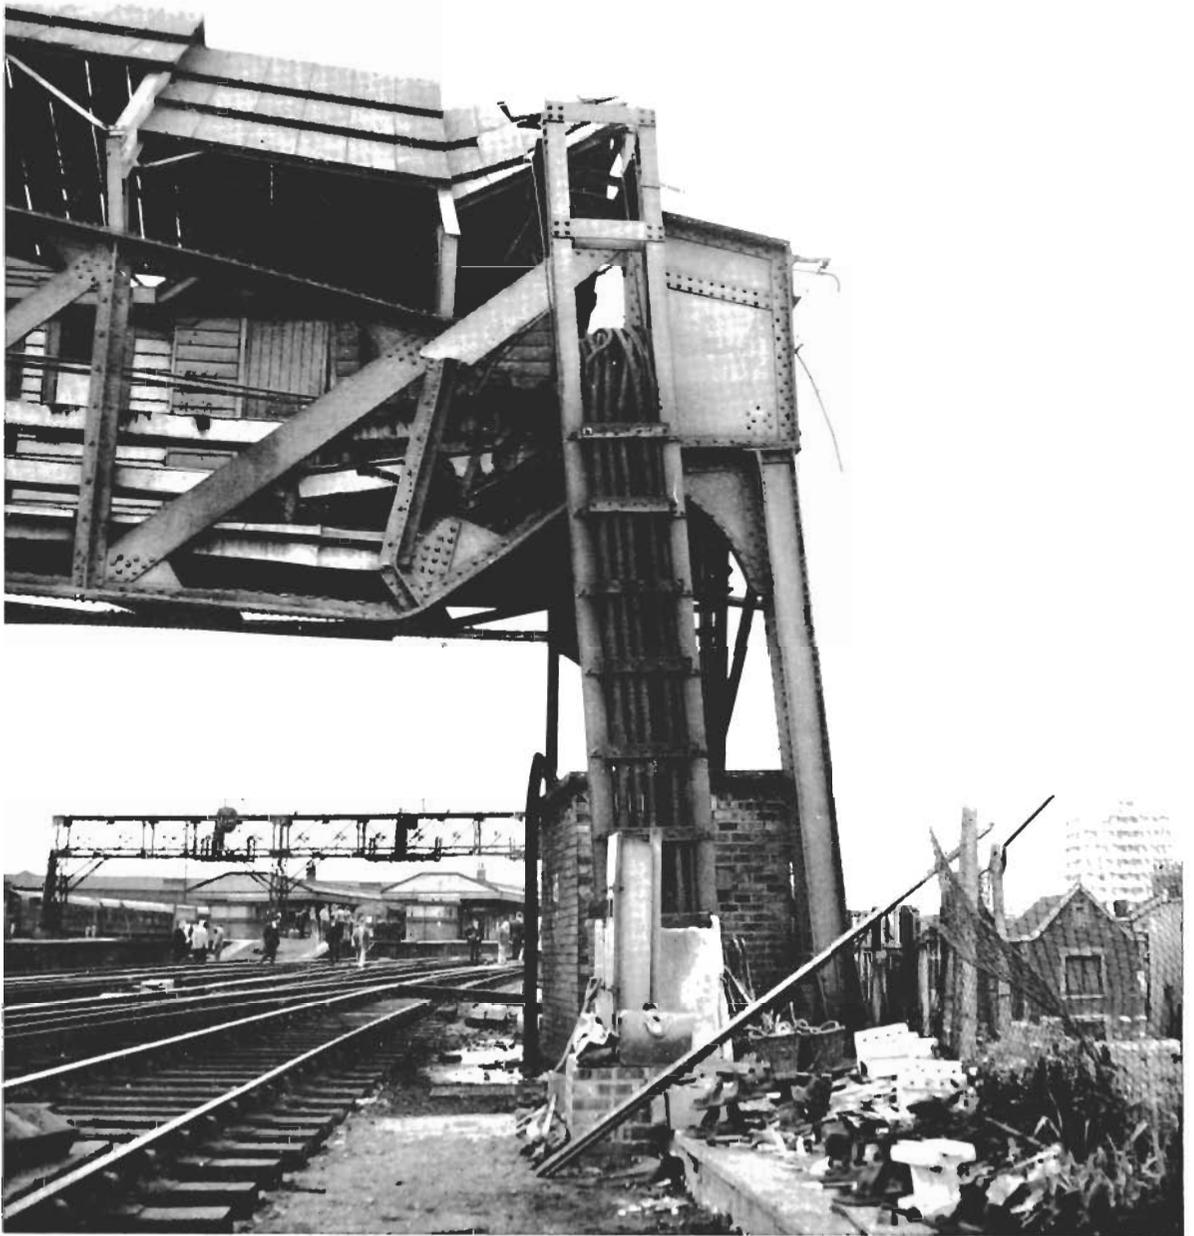
The bridge which is some 60 years old and comprises two 120 ft long main girders spans the Up and Down Windsor Through and Local lines, the two Kensington lines and three sidings. As a result of very heavy corrosion an end diagonal tension member in the London side girder failed, and the girder jack-knifed and fell some 4ft at a point about 9 ft from the end bearing; it thus became foul of some of the running tracks below it. It was only the stiffness of the end panel joints and the strength of other members that prevented the girder's complete collapse. Photograph 1 shows the result of the failure.

Photograph No. 1  
The bridge at Clapham Junction after the failure.

In the meantime, the Chief Civil Engineer arranged for a 75 ton diesel-hydraulic crane to be sent from Nine Elms Motive Power Depot and this was used to support the girder and prevent it from falling further. Steel trestling, of a type developed for use by the Army, was positioned under the fractured portion and the girder was gradually raised by jacks. Helped by fine weather, this work was completed by 06.00 hrs on Tuesday, 11th May, when all the passenger running lines, except the Up Windsor Local line, were reopened for traffic, trains being passed at restricted speed. The Up Windsor Local Line was reopened for traffic that evening, and all the speed restrictions were removed on Tuesday, 18th May.

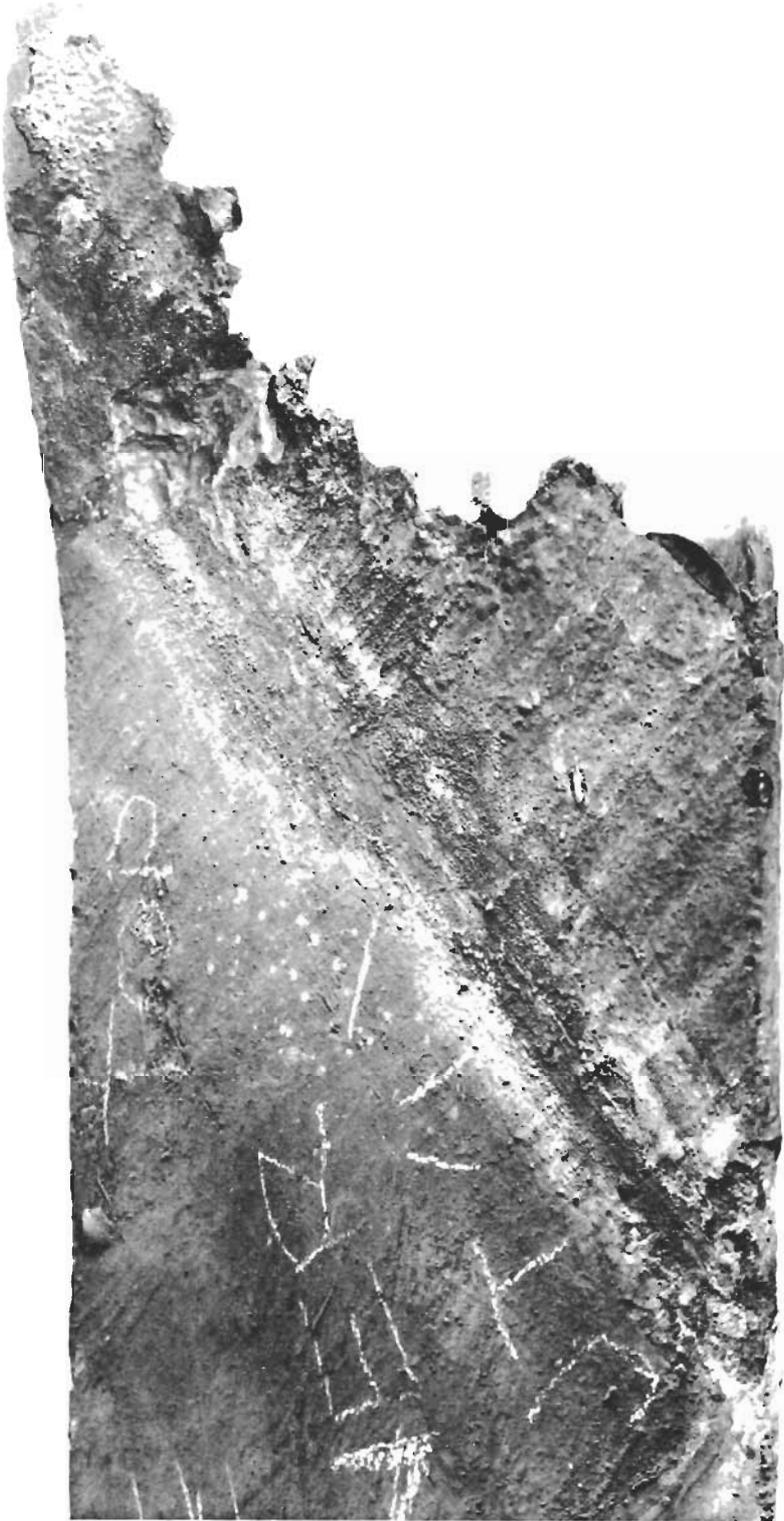
distance above it. The Upper edge of the gusset plate was heavily corroded and had the appearance of a spongy mass of rust flakes some of which had dropped from the diagonals. Throughout their length there was little evidence of paint on the inside surfaces of the diagonals which were rusting throughout. When struck with a hammer some distance from the gusset plate much rust fell away. The photographs 2-6 show the extent of the corrosion and photograph 2 shows where the deck abutted the diagonal.

Photograph No. 2  
Outer face of inner plate of end diagonal member.

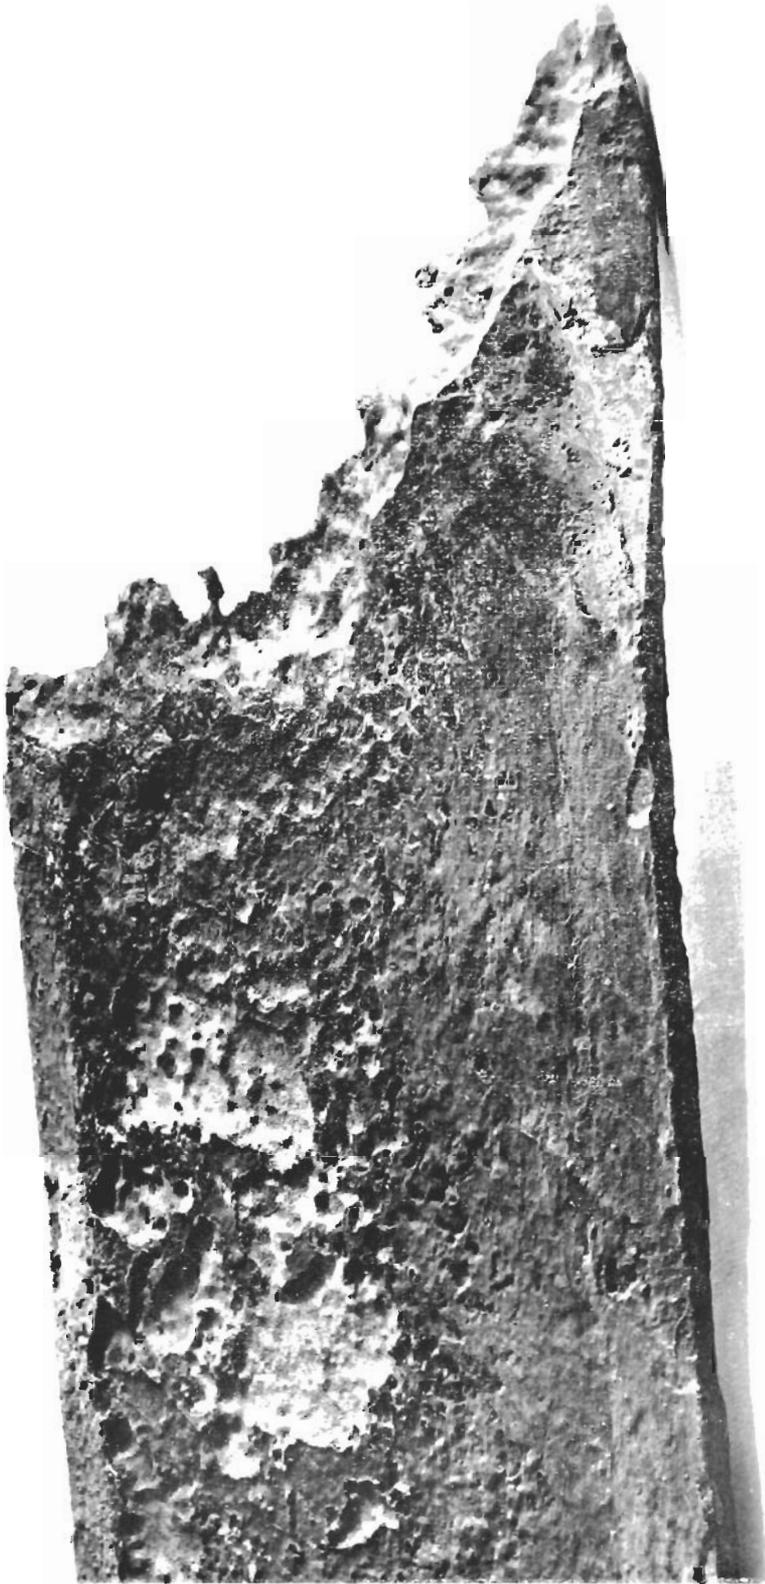
11. An examination of the diagonal member that failed indicated that there was probably an almost unbroken skin of paint on the outside surface of the outer plate, although there was evidence of corrosion holes right through this plate at the point of fracture which was along the upper edge of the gusset plate to which it was attached. The inner surface of this plate bore no evidence of paint and was very severely corroded along the edge of the gusset plate and for some distance above it. The outer surface of the inner plate bore no evidence of paint near the line of fracture, which was below the level of the deck, where there was deeply pitted corrosion over an area of about 6 sq ins. The inner surface of this plate was practically completely corroded away at the line of fracture and, again, the corrosion extended for some

12. The effective sectional area over which the two plates were intact was found to be only about 1.13 sq ins, as against the sectional area of 14 sq ins when new; of the 1.13 sq ins, about 1.0 sq ins was in the outer plate and about 0.13 sq ins in the inner plate. The theoretical stress in the intact metal was therefore of the order of 40 tons/sq in, as against its designed stress of 3.75 tons/sq in.

Photograph No. 3  
Inner face of inner plate of end diagonal member.

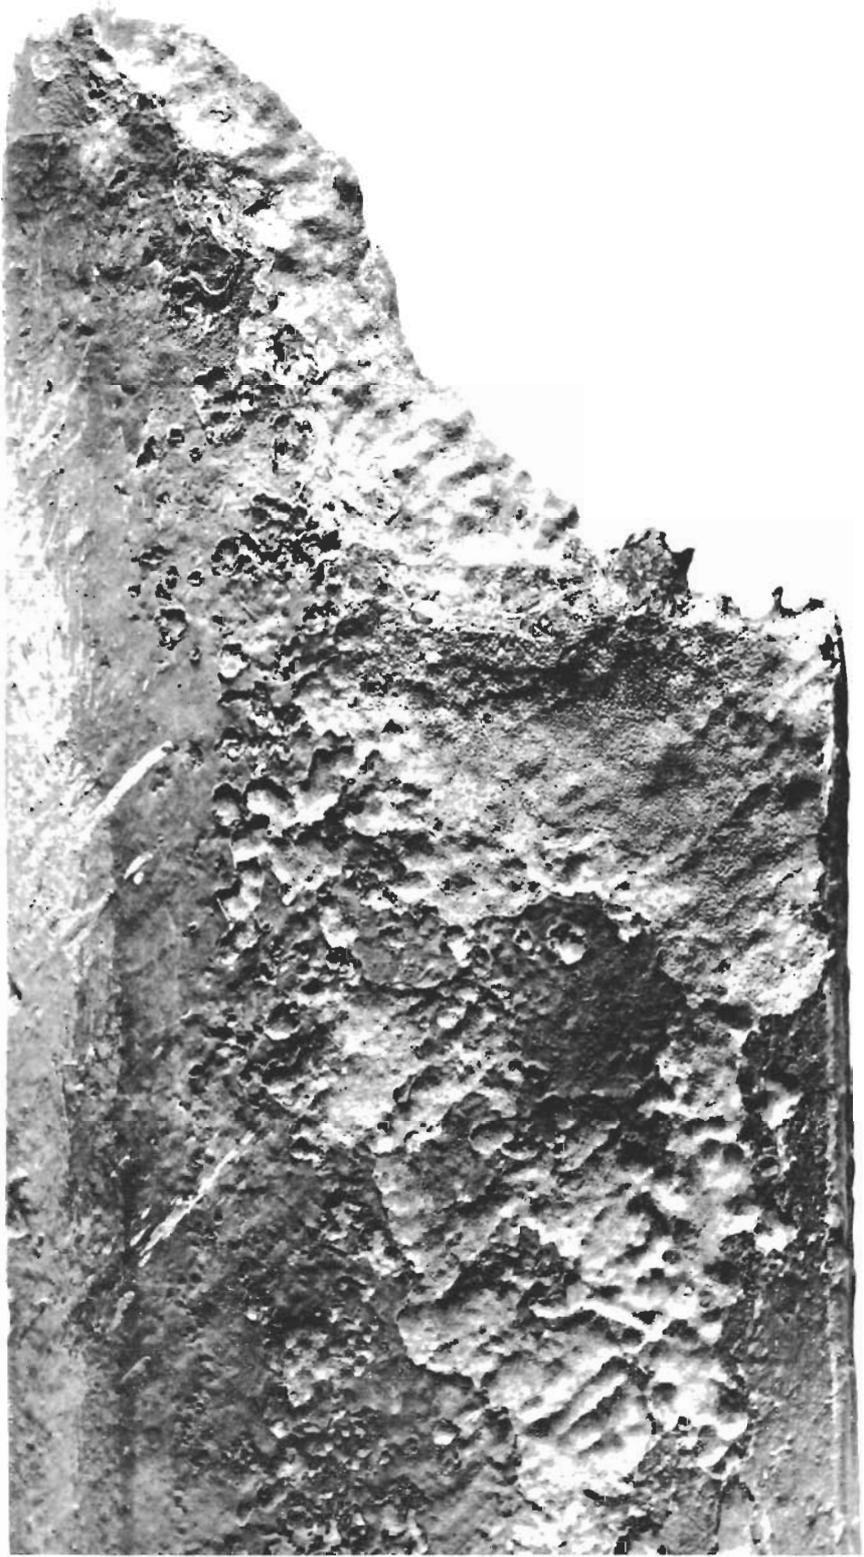
Photograph No. 4  
Inner face of outer plate of end diagonal member.

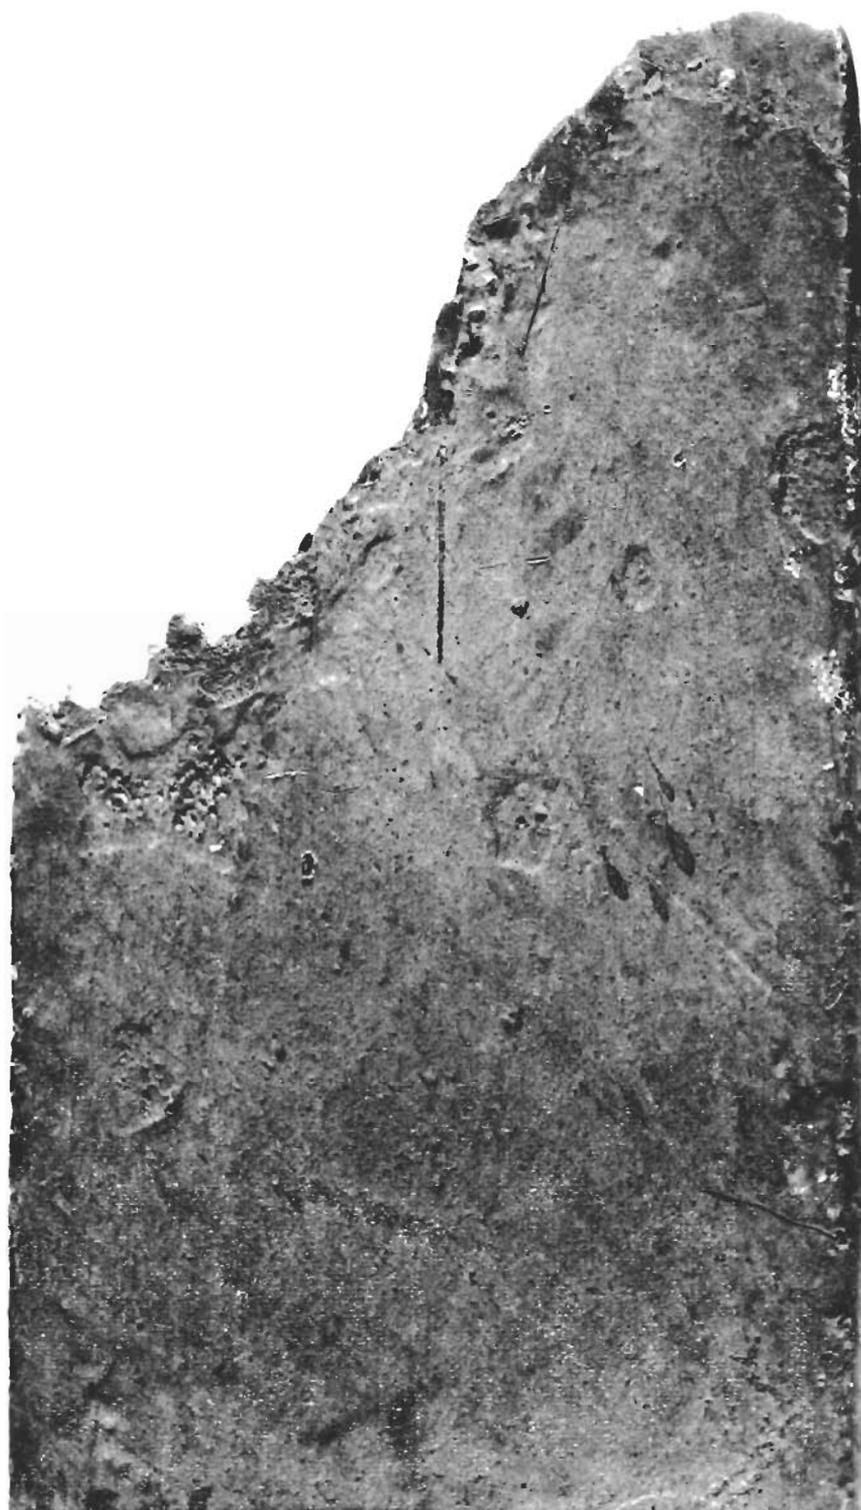
Photograph No. 5  
Outer face of outer plate of end diagonal member.

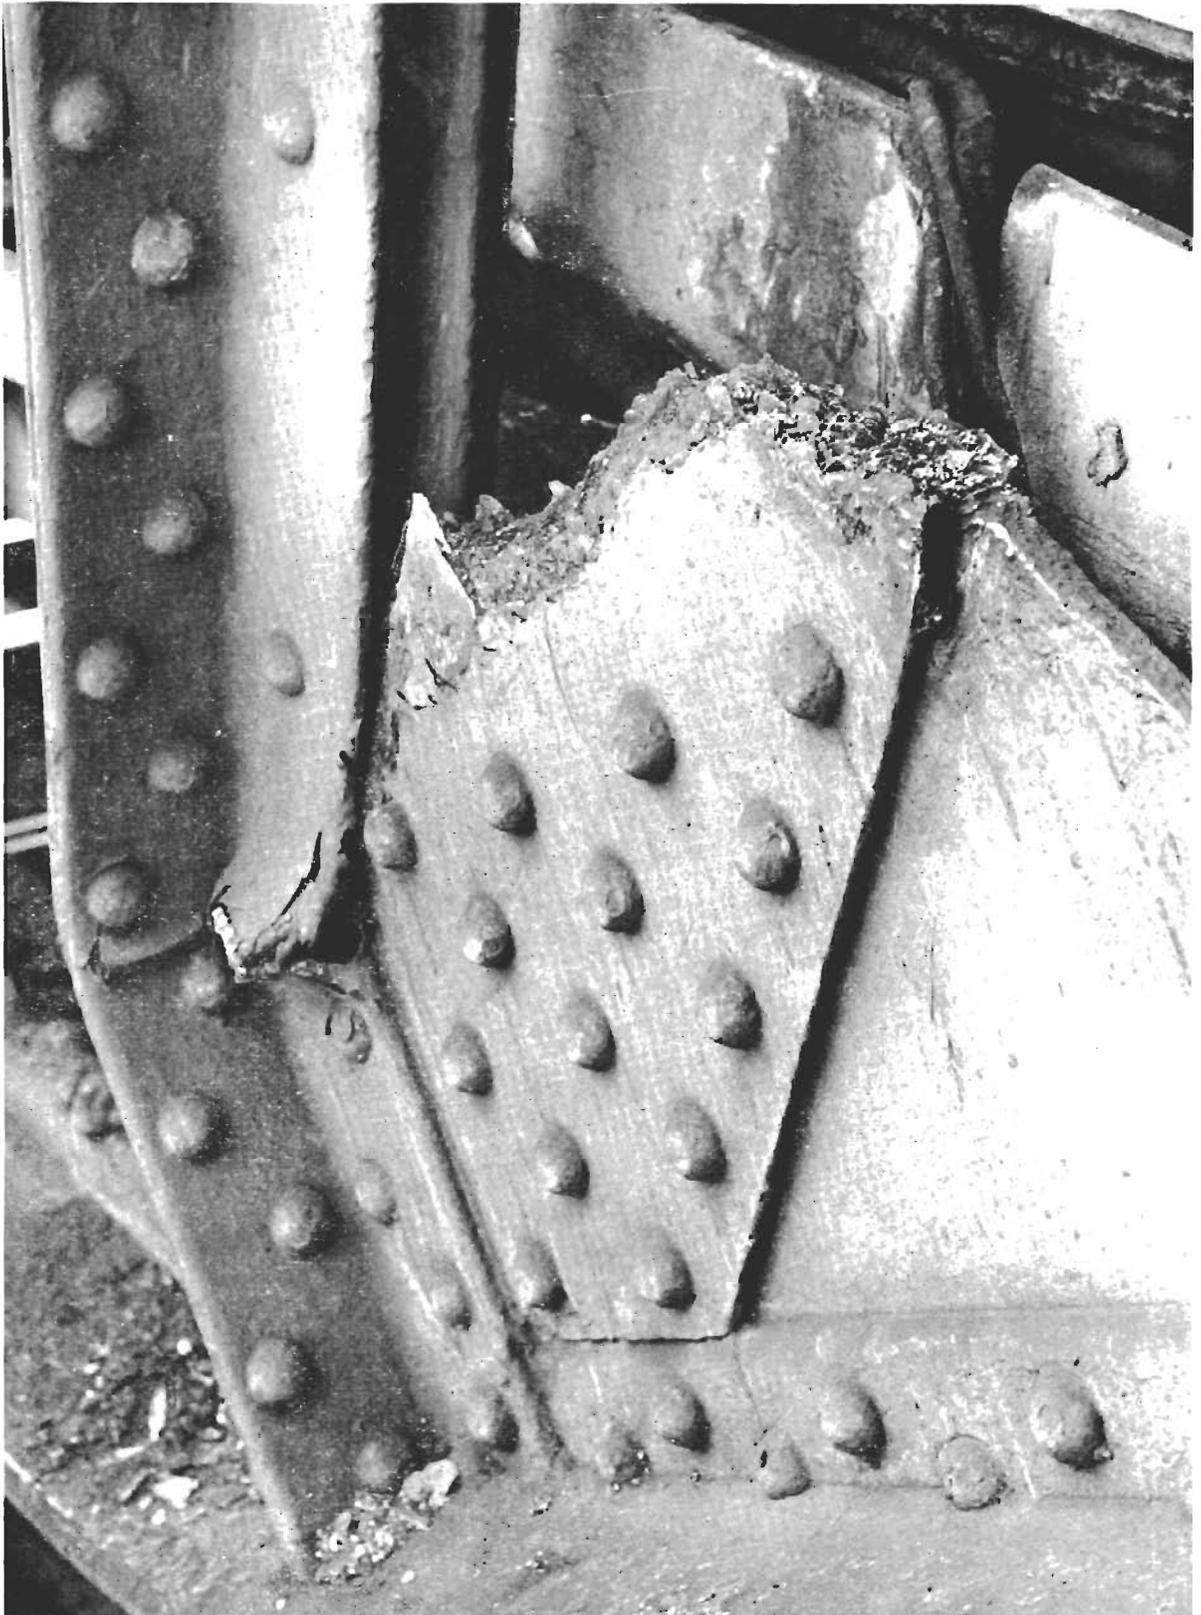
Photograph No. 6  
Gusset plate and remainder of end diagonal member of connection.

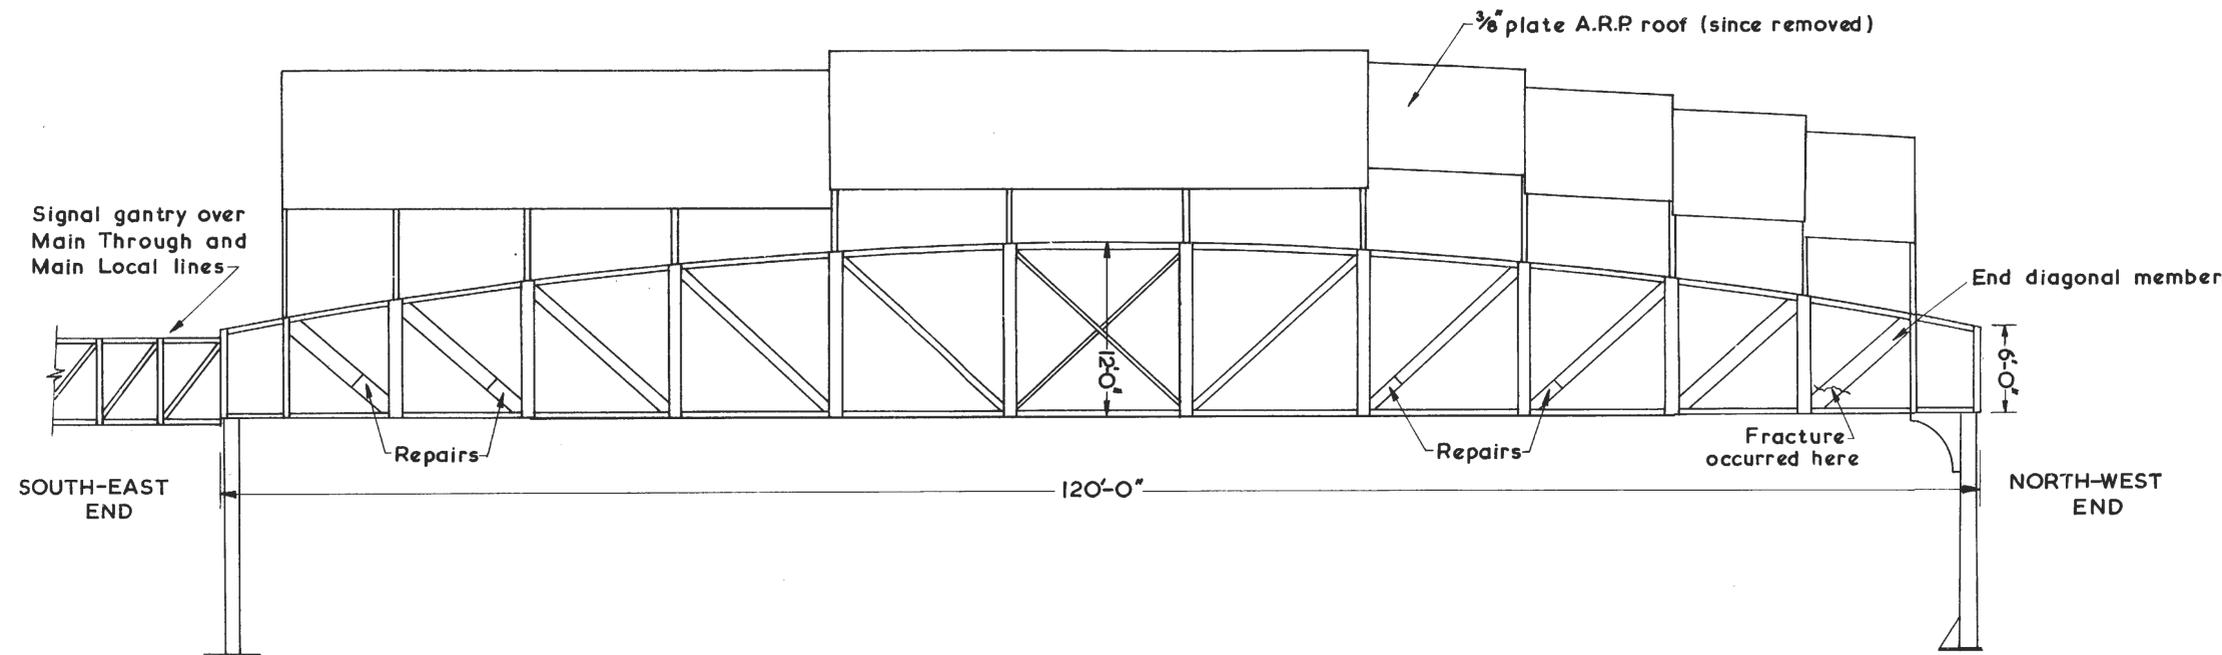
**ELEVATION**  
 LOOKING TOWARDS THE COUNTRY  
 SCALE:  $\frac{1}{8}$ " = 1"

6. Sheet 2 of the drawings shows the girder that failed. The top and bottom chords each comprise two 5 in x 5 in x ½ in angles and a 16 in x ½ in flange plate: the vertical members two pairs of two 5 in x 5 in x ½ in angles, the angles in each pair being rivetted together: and the diagonal tension members two flats of various sizes, those in the end panels being 14 in x ½ in. Inserted between the two angles and the two pairs of angles of the top and bottom flanges and vertical members respectively at the appropriate corners of each panel are ½ in thick gusset plates, through which the angles and pairs of angles are rivetted together. Each plate of the diagonal tension member is rivetted to an outside surface of the gusset plates, and there is thus an air space of ½ in between the plates. It was the diagonal member of the north-west end panel of the London side girder that failed.

MAIN GIRDER IN OVERLINE BRIDGE No.S14B
