MINISTRY OF TRANSPORT

RAILWAY ACCIDENT

REPORT ON THE COLLISIONS

CONNINGTON

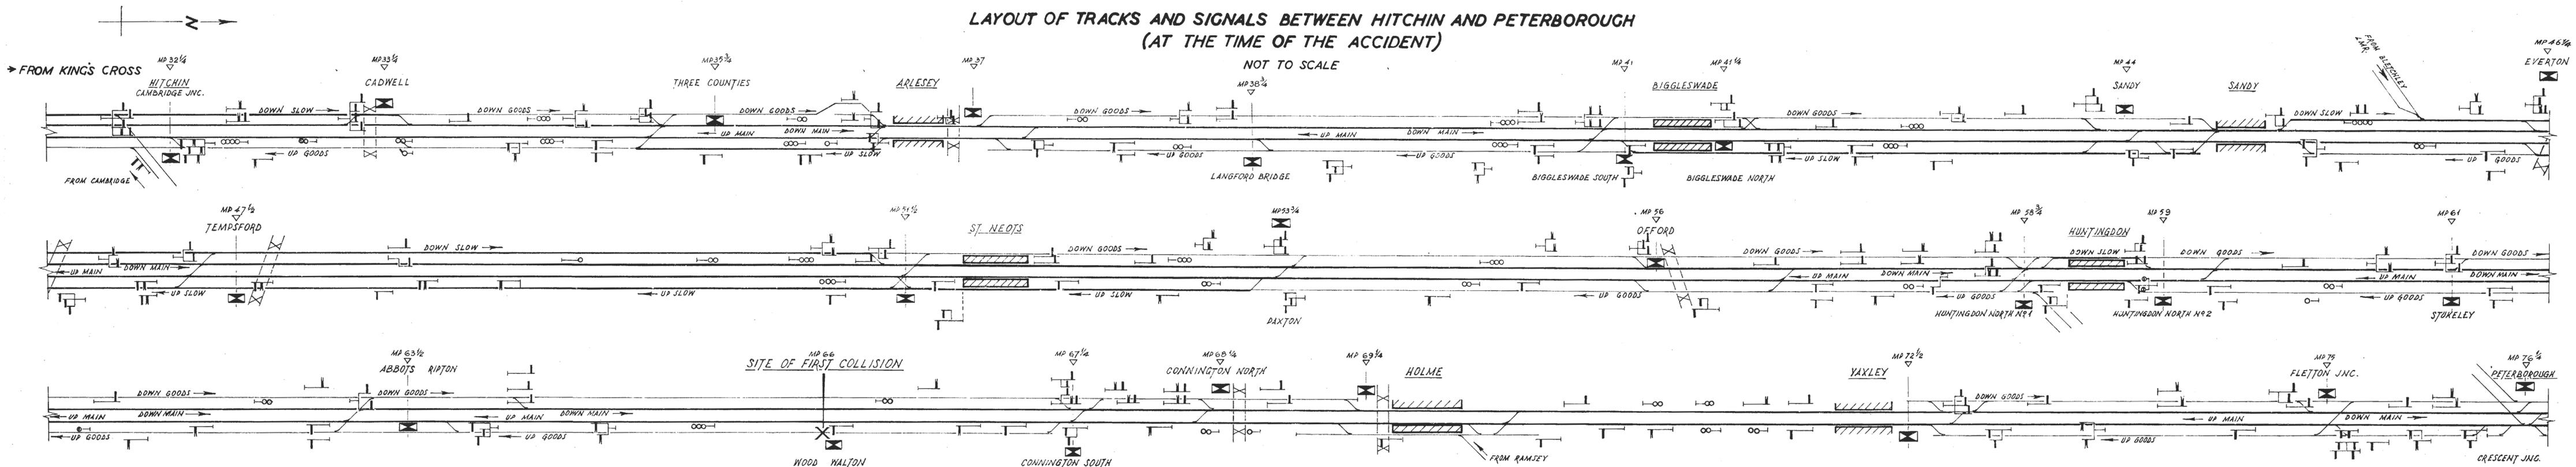
LAYOUT OF TRACKS AND SIGNALS BETWEEN HITCHIN AND PETERBOROUGH (AT THE TIME OF THE ACCIDENT)

1. The Great Northern section of the East Coast route between King's Cross and Doncaster runs roughly North and South. The plan shows the general layout of this line between Hitchin and Peterborough and the signalling at the time of the accident. It will be seen that there are generally four tracks and that these are from East to West, the Up Goods (or Slow), Up Main, Down Main and Down Goods (or Slow). There are, however, a number of bottlenecks where there are only two tracks, such as at Arlesey and Sandy, and between Yaxley and Holme, and others where there are three tracks, such as at Huntingdon and between Connington South and North boxes.

2. Some of the lines that lie outside the main lines are classified as "slow" lines; passenger and goods trains are run on them under the Absolute Block Regulations and, on some, goods trains may be run under the Permissive Block Regulations. Others are termed "goods" lines; normally they are worked under the Permissive Block Regulations and are used only by goods trains, but passenger trains are sometimes run on them and then the Absolute Block Regulations are applied. On the approach side of a bottleneck, the outside line is invariably classified as a goods line, to enable goods trains to be accumulated on it and to be passed quickly forward when the opportunity arises. The Up outside line between Connington South and Abbots Ripton is a goods line, and it continues as a goods line to Huntingdon. It will be noted that

whilst some of the outside lines are slow lines or goods lines throughout their length, others change their designation at intermediate boxes. For instance, the Up outside line between Huntingdon and Sandy starts as a goods line, becomes a slow line at Paxton, and then again becomes a goods line at Everton: the Down outside line between Sandy and Connington North starts as a slow line, becomes a goods line at St. Neots, again becomes a slow line through Huntingdon and finally becomes again a goods line beyond Huntingdon.

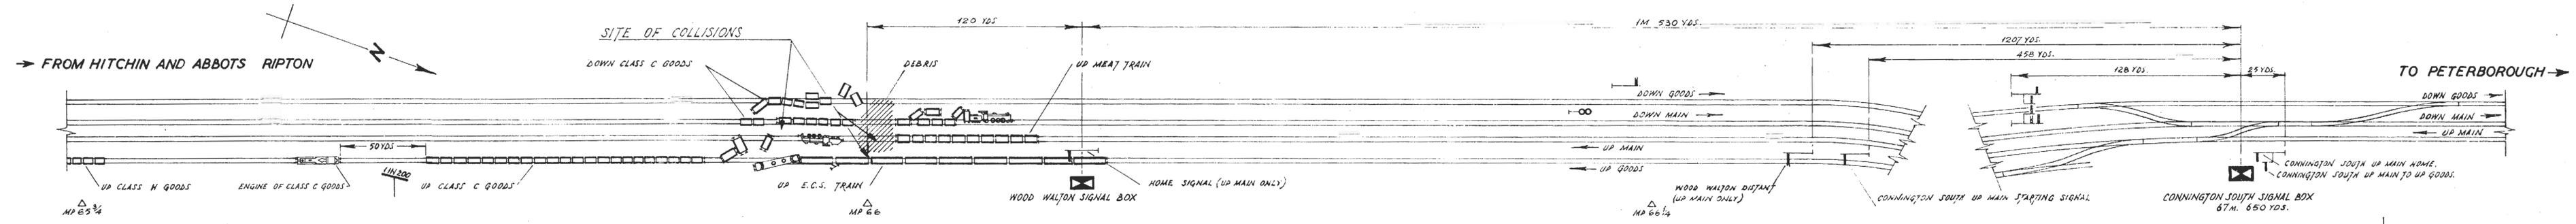
LAYOUT AT CONNINGTON SOUTH AT SITE OF ACCIDENT
NOT TO SCALE

5. The lower part of the plan shows in greater detail the arrangements at Connington South and also the layout of the lines to the site of the accident. It will be seen that most of the signals are semaphores, as is the case on the rest of the section between Hitchin and Peterborough. It will also be noted that there are home and starting signals on the Up Main line, and that the home signal on the Up Goods line is the section signal and that there is no call-on signal. The Connington North Up home signal is a colour light signal, and it acts as an Up outer distant for Connington South.

6. The signal box at Connington South is close to the Up Main line, and the Up home signals are only 25 yards from the box. There is consequently no berth track circuit at these signals. The Down home signals, the back lights of which form the signalman's fog mark, are 128 yards from the box. Throughout this section of the line, block instruments of the 3-position type are in use on the main and slow lines, and non-recording permissive type instruments are used on the goods lines.
