MINISTRY OF TRANSPORT

RAILWAY ACCIDENT

Report on the Collision that occurred on 20th September 1966 near Connington

IN THE
EASTERN REGION
BRITISH RAILWAYS

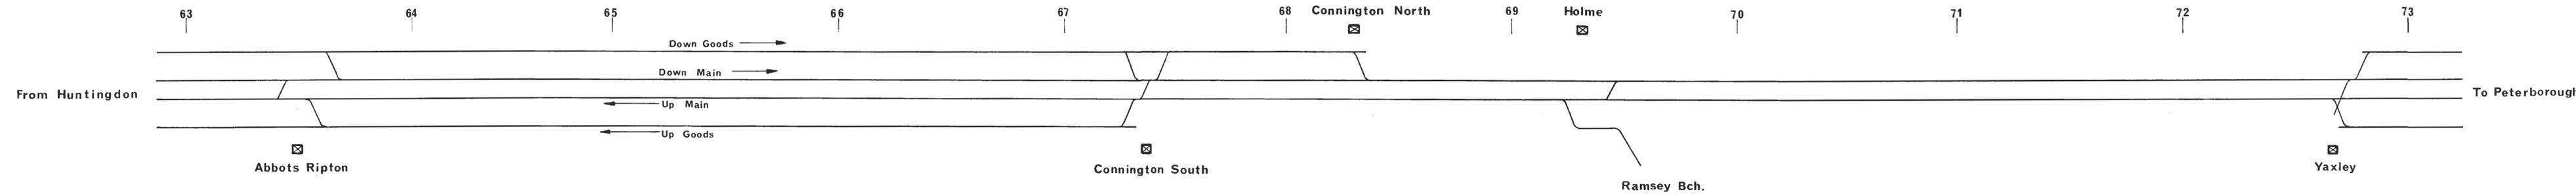
FIG.1. RUNNING LINE DIAGRAM

1. The East Coast Main line between King's Cross and Peterborough runs roughly north and south. Figure 1 shows the layout of this line between Abbots Ripton, 4 miles 49 ch. north of Huntingdon, and Yaxley, 3 miles 56 ch. south of Peterborough. It will be seen that north of Yaxley there are four tracks and that these are, from east to west, the Up Goods, the Up Main, the Down Main and the Down Goods. Between Yaxley and Connington North there are only two tracks, while at the scene of the collision, between Connington North and South, there are three, the Up Main, the Down Main, and the Down Goods. South of Connington South the line again reverts to four tracks.

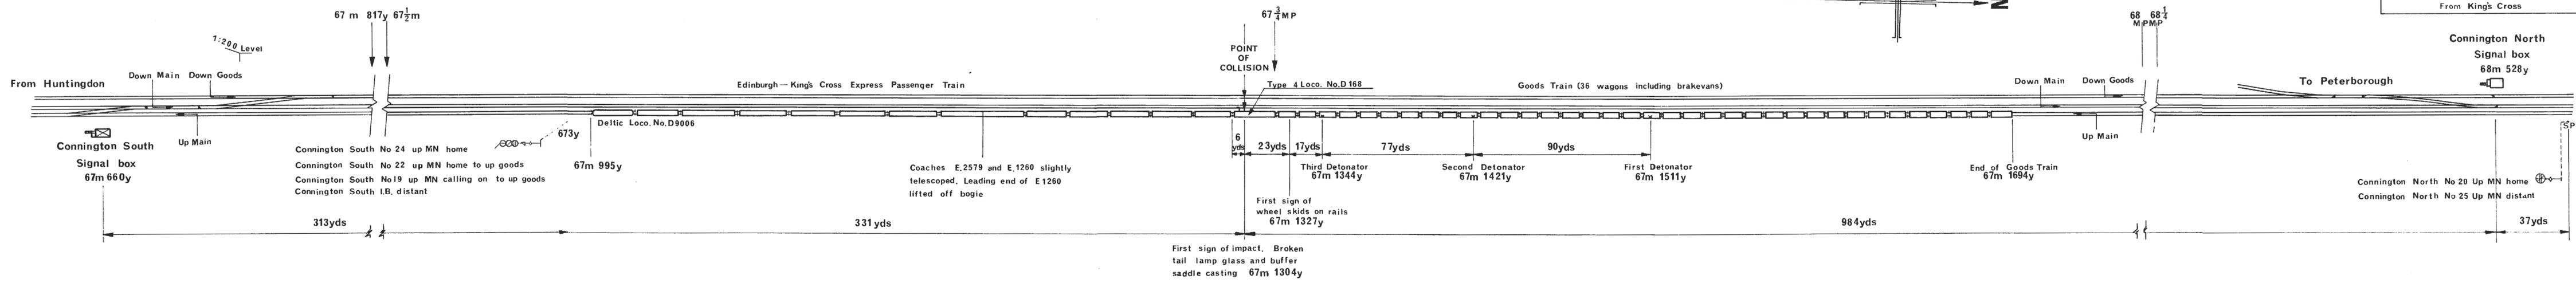
**FIG.2. SITE PLAN SHOWING TRACK AND SIGNAL LAYOUT
BETWEEN CONNINGTON NORTH AND SOUTH,
POINT OF COLLISION AND POSITION IN WHICH
TRAINS CAME TO REST**

2. The Up Main line on which the collision occurred is level between Connington North and South, and then rises steadily at a gradient of 1 in 200 to Abbots Ripton. Figure 2 shows the layout of the lines between Connington North and South and also the locations of the signals on this section of the Up Main line. Connington North Up Main Home, which is combined with Connington South Up Main Distant as a three-aspect colour light signal, is located 37 yards to the north of the signalbox, and Connington South Home, also a colour light signal, is located 1315 yards south of the North box and 313 yards to the north of the South box. There are berth track circuits at both these signals. Throughout this section of the line, absolute block instruments of the three position type are in use on the Main lines.
