MINISTRY OF TRANSPORT

RAILWAY ACCIDENT

REPORT ON THE COLLISION

26th December 1962

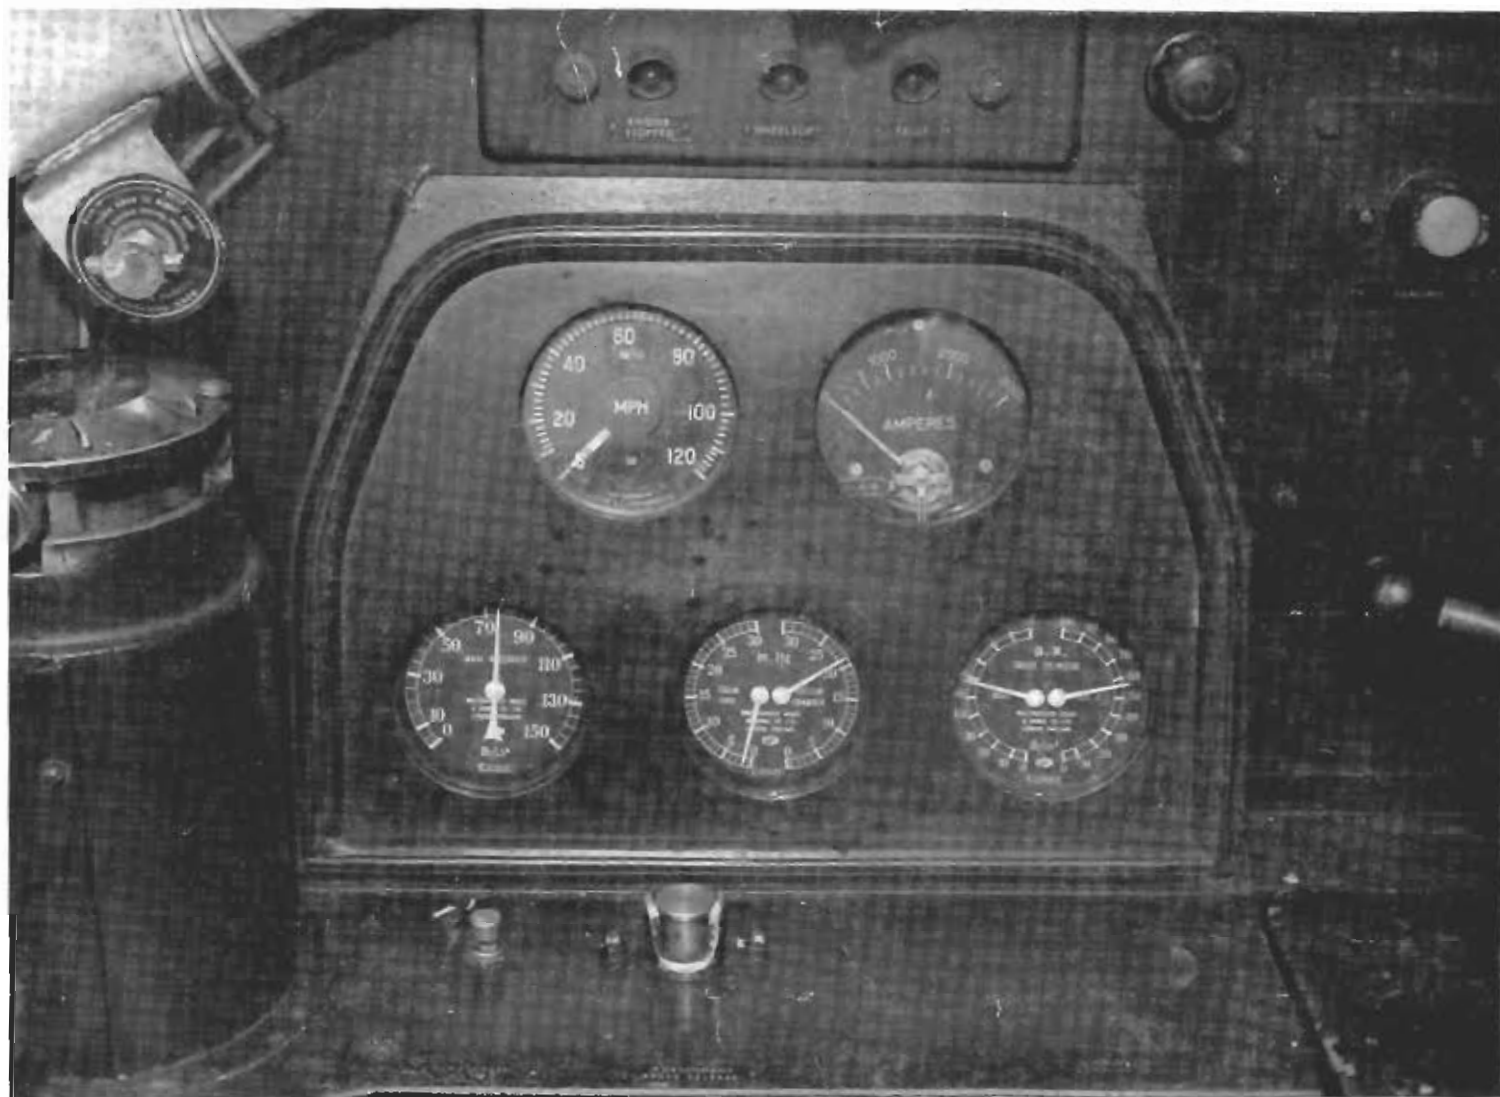
Instrument Panel of Diesel Locomotive.

11. The diesel locomotive had a driving compartment at each end and the driving position in each is on the left-hand side. Each compartment was equipped with a speedometer on an instrument panel situated in front of the driving seat. A photograph of the panel is reproduced opposite. It will be observed that there are no graduations between the 0 and 10 m.p.h. marks on the speedometer and that there is no figure against the latter mark.

50. The speedometers in the driving cabs at both ends of the diesel locomotive on the Mid-day Scot were thoroughly tested. It was found that they read between 1 m.p.h. and 2 m.p.h. high in the working range from 5 m.p.h. to 15 m.p.h. At 20 m.p.h. the error did not exceed 1 m.p.h. in any of the tests.

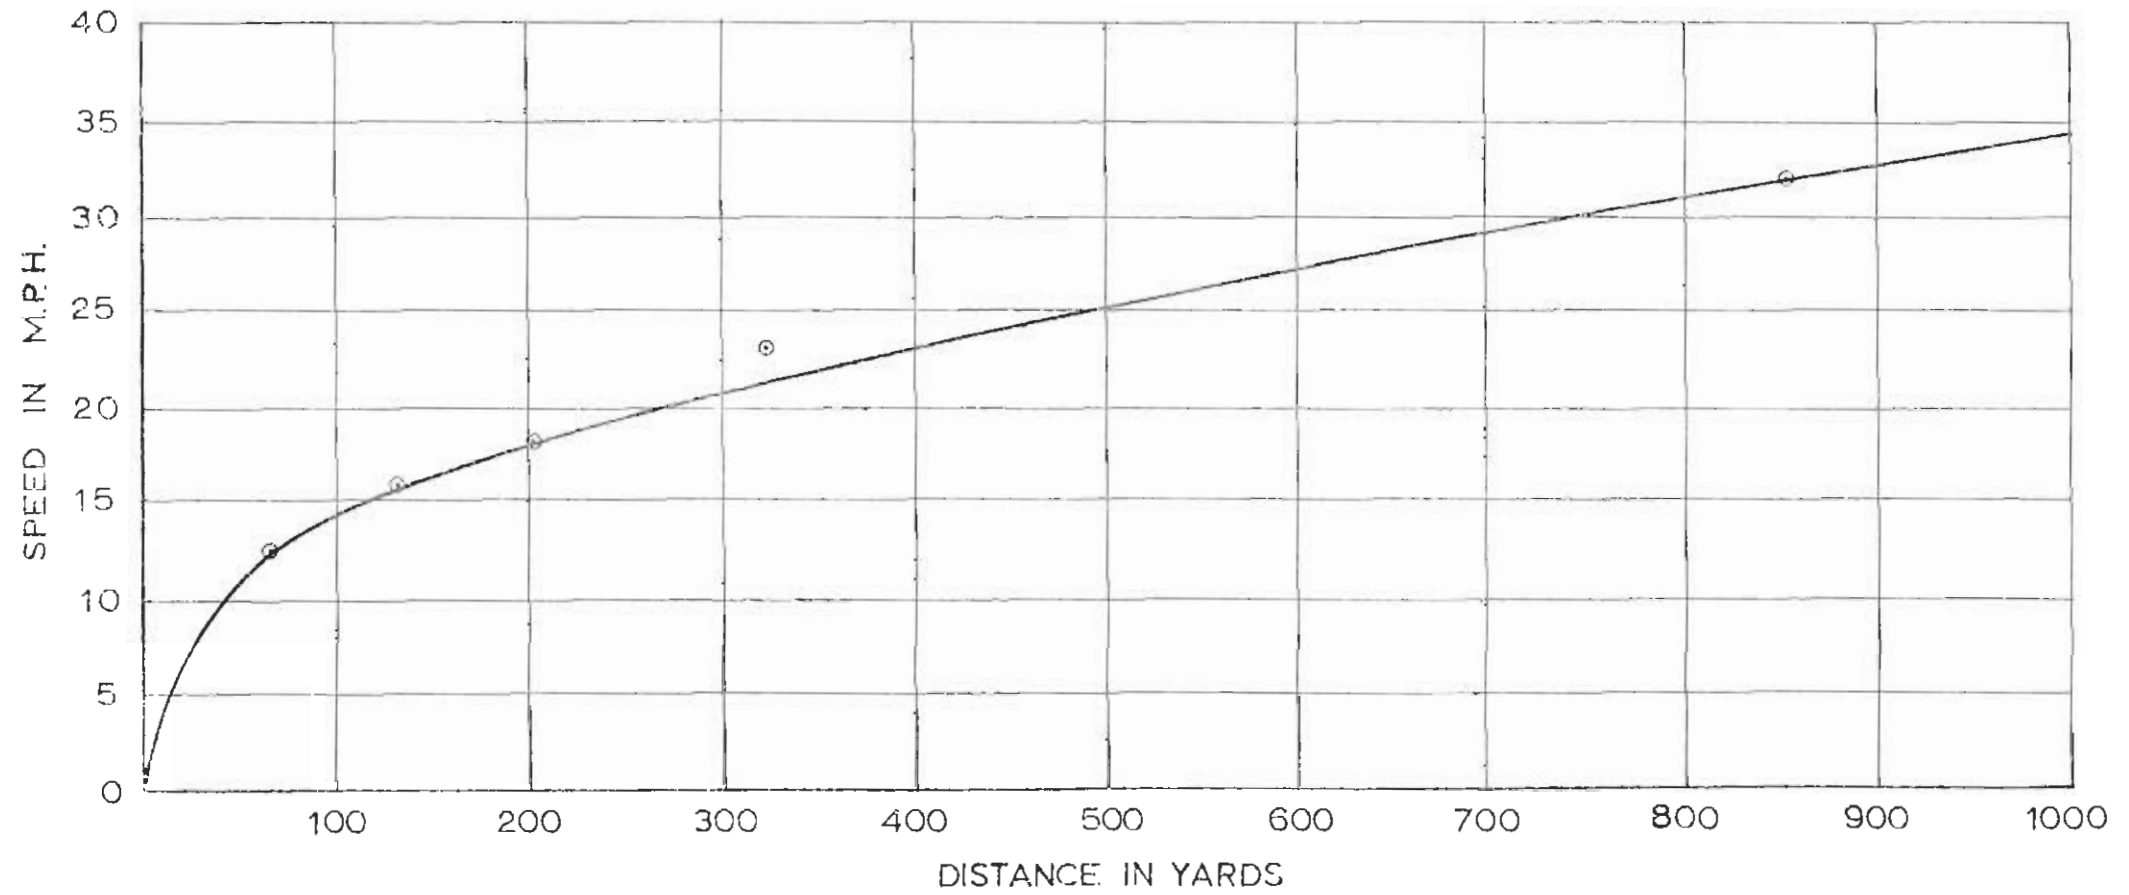
APPENDIX A

46. I carried out some acceleration and braking tests with a train similar in composition and weight to the Glasgow train, and hauled by a similar type of engine. The results are shown in the graphs in Appendices A and B.
