RAILWAY ACCIDENT

Report on the Derailment that occurred on 28th June 1971 at Copyhold Junction near Haywards Heath

IN THE
SOUTHERN REGION
BRITISH RAILWAYS

DERAILMENT AT COPYHOLD JUNCTION HAYWARDS HEATH

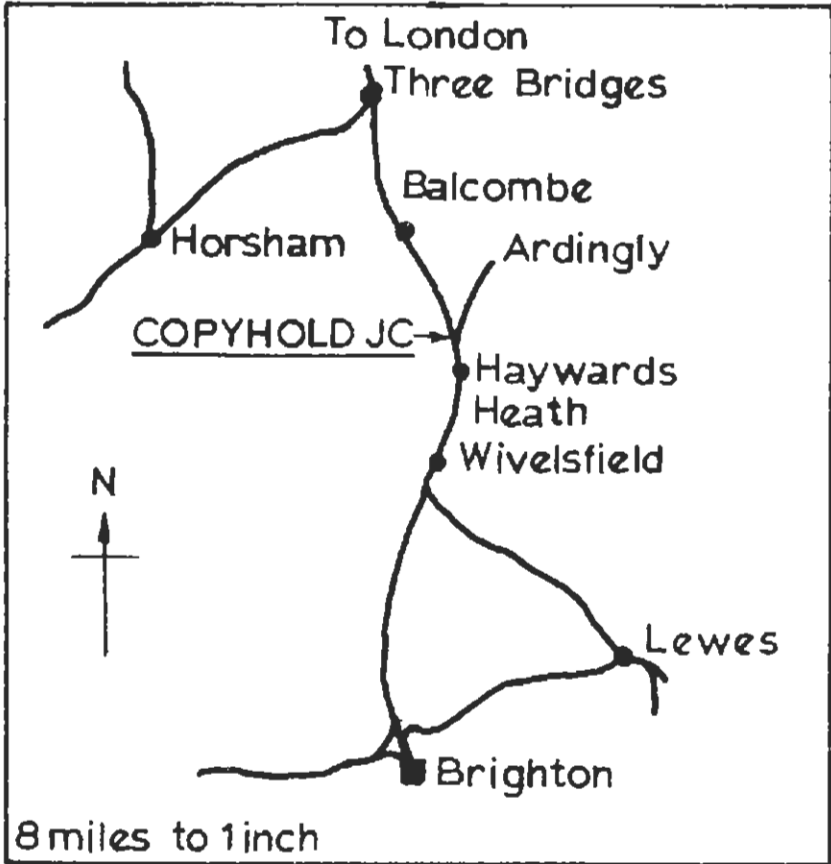
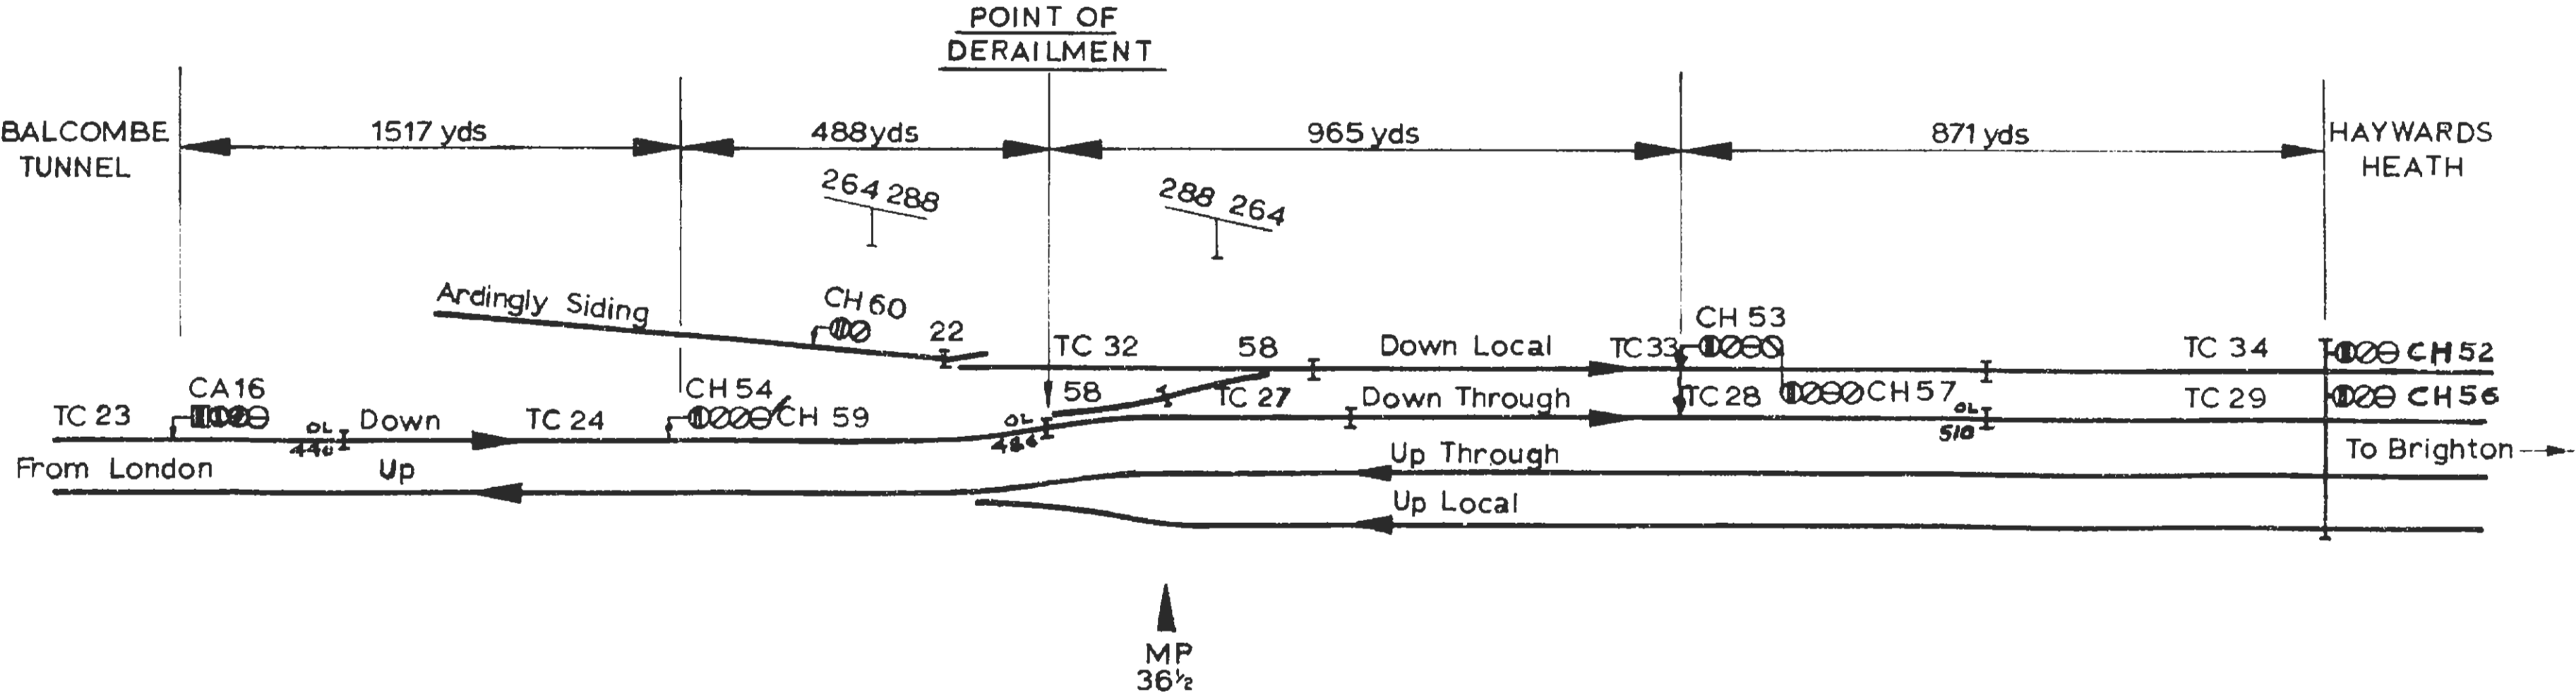
LOCATION DIAGRAM

4. Those points and signals relevant to the accident are shown on the diagram opposite. When signal CH 54 is cleared for a movement over 58 points the route is approached locked as soon as TC 23, beyond the overlap of Signal CA 18, is occupied and remains so locked until Signal CH 54 is replaced to Red by the occupation of TC 27, beyond the signal.
