RAILWAY ACCIDENT

Report on the Derailment
that occurred on
27th September, 1967
at Foxhall Junction, Didcot

IN THE
WESTERN REGION
BRITISH RAILWAYS

DERAILMENT AT FOXHALL JUNCTION, DIDCOT. WESTERN REGION. 27th SEPTEMBER 1967.

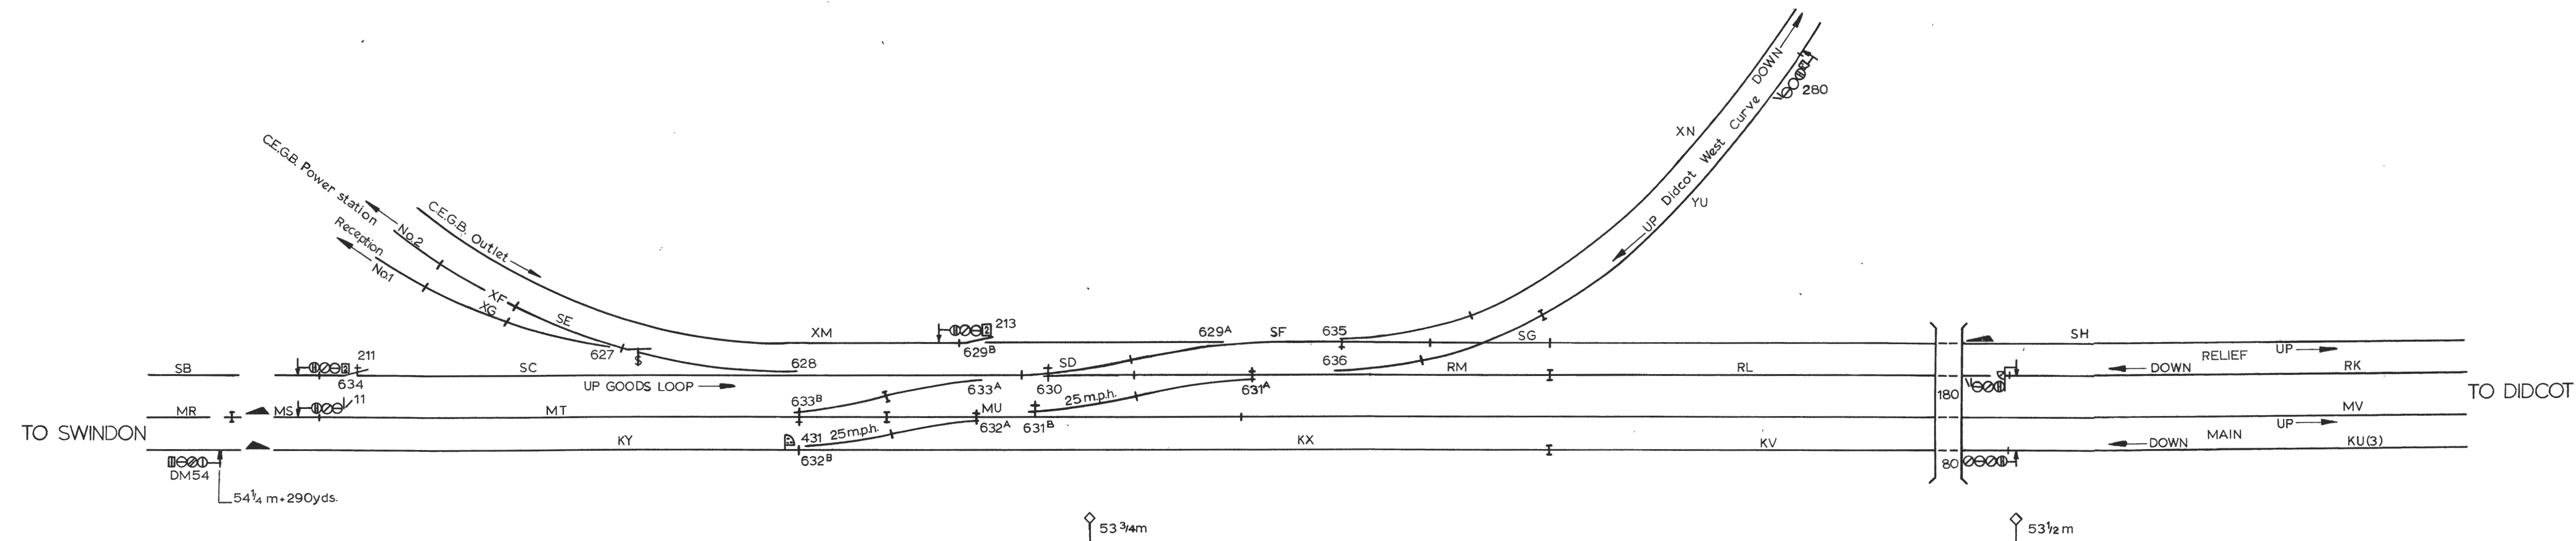
FIG. I. FOXHALL JUNCTION TRACK AND SIGNALLING LAYOUT

31. *Mr. K. W. Pearce*, the Divisional Civil Engineer, London Division, confirmed that the track layout at Foxhall Junction at the time of the accident was as shown in Figure I, that there was a permanent speed restriction of 25 m.p.h. over both the crossover Down Relief to Up Main line and Up Main to Down Main line and that the speed limit 'cut out' sign which indicated this was in position on the approach to the first crossover. He confirmed that the speed limit over the facing connection into the C.E.G.B. Power Station sidings was also 25 m.p.h., and that the maximum speed permitted on the Down Relief line between Reading and Foxhall Junction was 60 m.p.h.

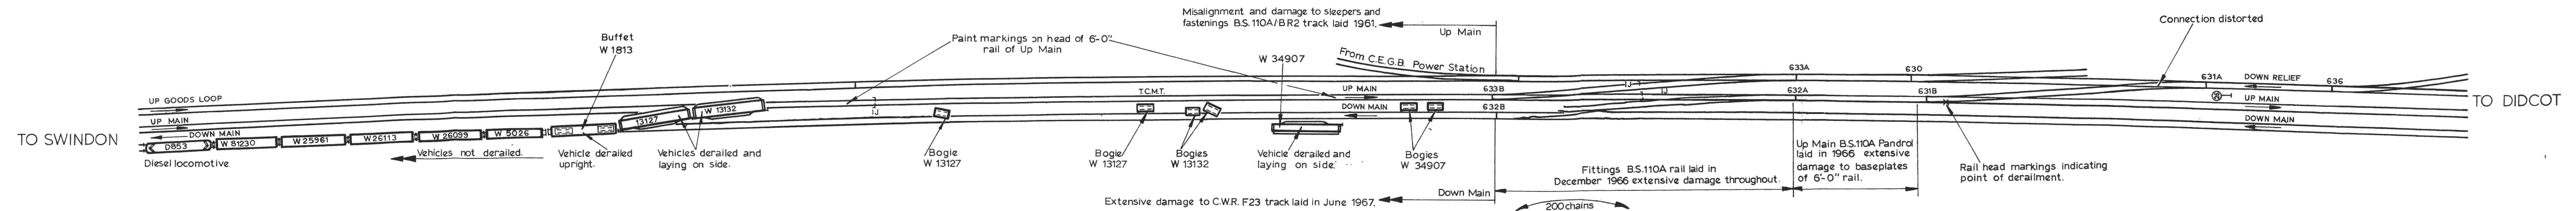
FIG. II. SITE PLAN SHOWING INITIAL POINT OF DERAILMENT, POSITION WHICH TRAIN CAME TO REST, AND DETAILS OF DAMAGE TO TRACK

6. The second and third vehicles from the rear were almost certainly derailed on the crossover Up Main to Down Main line, overturning to the right and being dragged along the "six foot" rail of the former line after losing their bogies. The 4th vehicle from the rear traversed both crossovers without becoming derailed but was finally dragged off the Down Main line by the 2 overturned vehicles which were still attached to it. Figure II shows the positions in which the coaches and locomotive of the train came to rest.

8. The two crossovers Down Relief to Up Main and Up Main to Down Main were extensively damaged and the track of the Up and Down Main lines destroyed for some 360 yards. The signalling equipment associated with the crossovers was also severely damaged.
