RAILWAY ACCIDENTS

REPORT ON THE COLLISION

25th August 1958

EASTBOURNE STATION

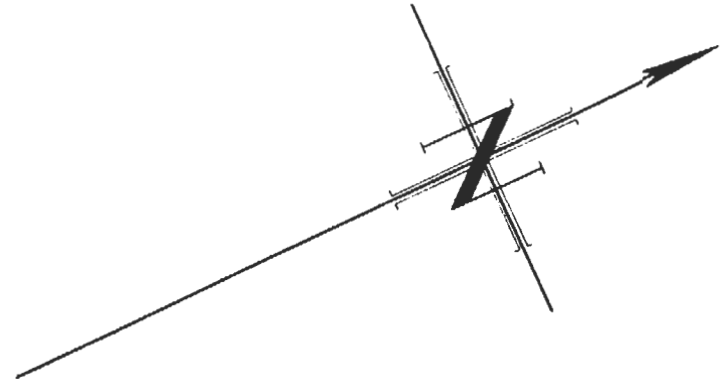
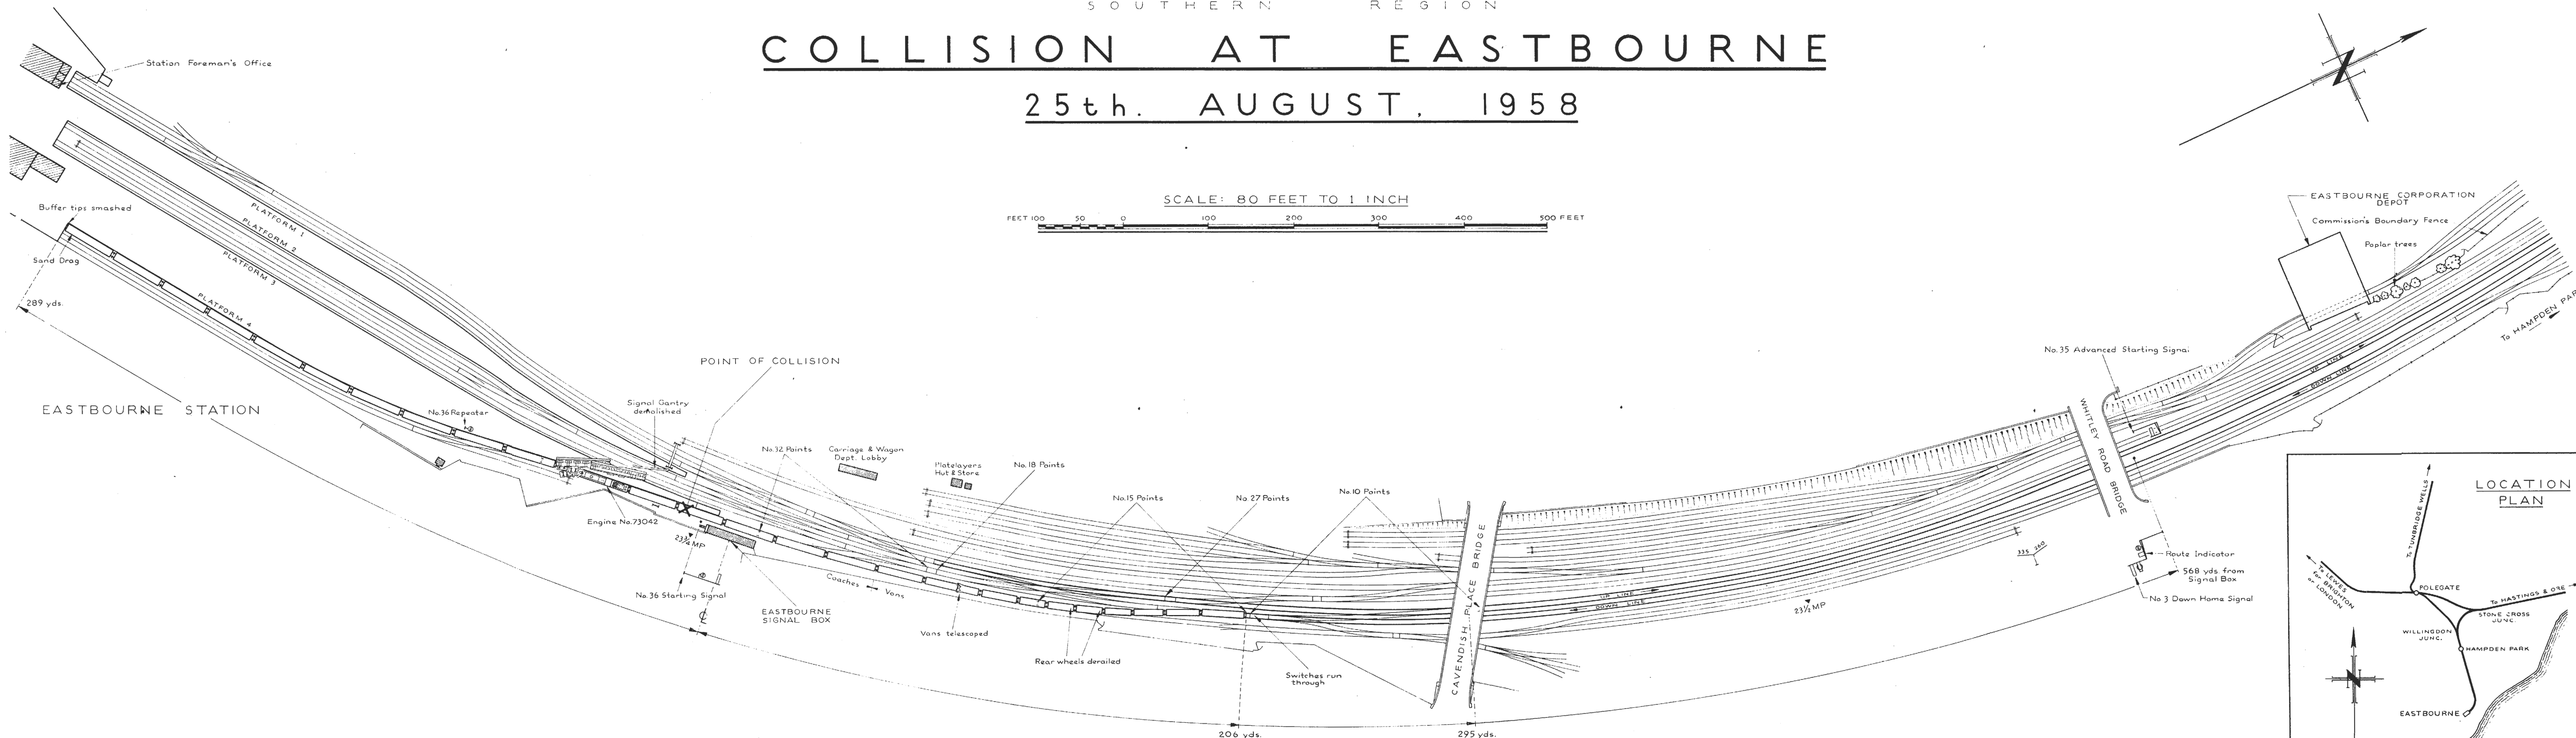
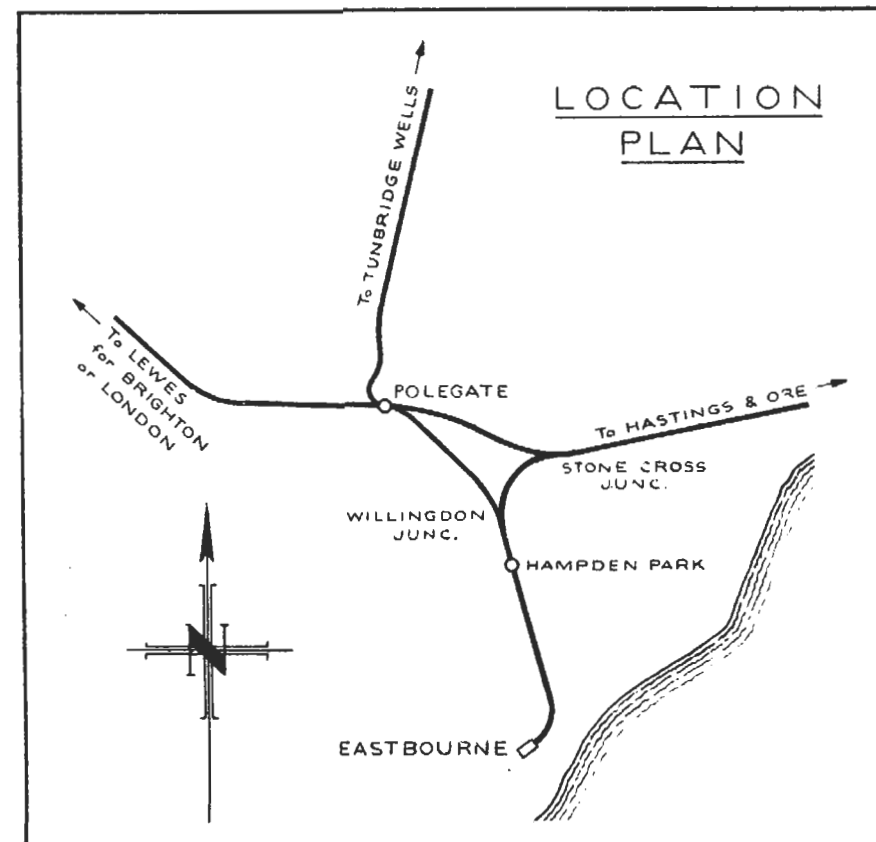
COLLISION AT EASTBOURNE

13. The impact was such that the steam engine smashed the front of the leading motored coach and pushed the body off the bogies into the air against the signal gantry, which was dislodged and brought down. The rear end of the coach was at the same time forced into the one behind which it penetrated for about one-third of its length. The forward movement of the engine under the two, interlocked, coach bodies continued for 137 ft. beyond the point of collision, with the bodies rising in the air until they fell on their sides on to the platform. The two bogies of the first coach and the leading bogie of the second coach were carried forward in a jumbled mass by the engine. The electric train, which did not have the brakes applied, was pushed back about 16 feet over the sand drag and against the buffer stops, the full compression of all buffers allowing another 10 feet of movement at the London end of the train. Motorman C. Brock did not leave the driving compartment; he must have seen the steam train bearing down upon him only at the last moment, and he must have been killed instantly when the collision occurred.

14. The main force of the collision seems to have been absorbed by the two leading coaches as the body of the third coach was not seriously damaged though the underframe was bent; most of the other coaches suffered some damage to underframes, head stocks and buffers, but little to the bodywork.

15. The weight and constructional strength of the steam engine kept it close to the track alignment, though it became derailed. The front end and the smoke box were much damaged, and the bogie centre and support beam were fractured, and the motion and the right side of the main frame bent, but the boiler was more or less intact as was the cab. The leading wheels of the first coach were derailed and the coach was buffer-locked with the engine; interior damage to this coach was however comparatively slight, and the effect of the collision on the other passenger coaches also was small. There was much heavier damage at the rear end of the seventh vehicle, a bogie van, and the body of the eighth one, a 6-wheeler, was riven and displaced from the frame. Appreciable damage was also suffered by the eleventh and twelfth 4-wheeled vans which were partially derailed, and had wrenched bodywork and bent buffers. The ninth, tenth and thirteenth vans were affected to a lesser degree, but the last 3 vehicles were intact.
