RAILWAY ACCIDENTS

REPORT ON THE COLLISION
which occurred on
11th July 1951 near
FISHGUARD and GOODWICK
in the
WESTERN REGION
BRITISH RAILWAYS

HEAD-ON COLLISION AT FISHGUARD & GOODWICK

11th JULY, 1951

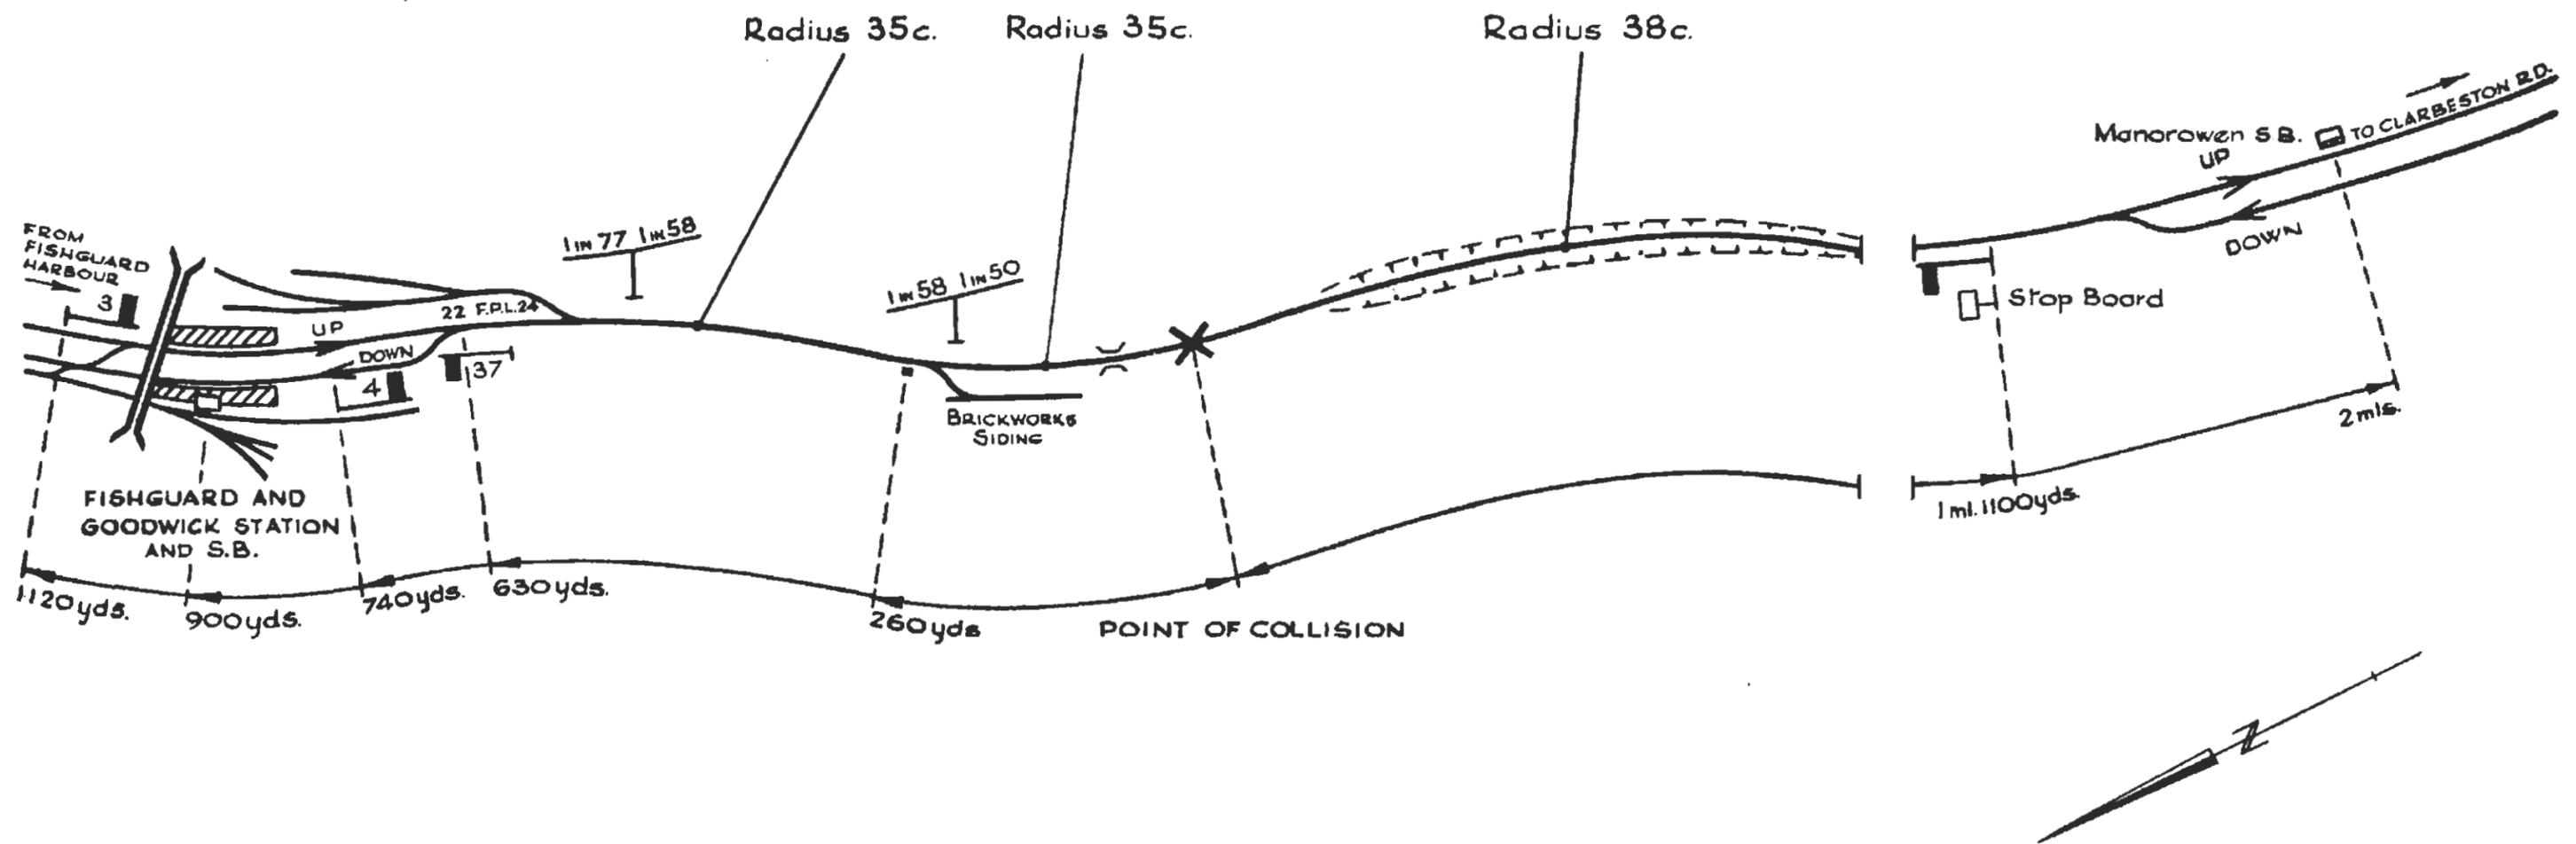
1. The main line to Fishguard Harbour has two or more tracks, except for the short length of single line which begins at Manorowen Junction and runs in a northerly direction for 2½ miles to Fishguard and Goodwick Station whence there are three running lines to Fishguard Harbour half-a-mile further ahead. The single line falls steeply towards Fishguard and Goodwick Station with a ruling gradient of 1 in 50 for 1½ miles; it is also curved for most of its length, and a speed restriction of 40 m.p.h. is in force. The general layout and the position of the relevant signals etc., is shown on the accompanying drawing.

Manorowen :—	
Signal box	2 miles South
“Stop” board	1 mile 1,100 yards South
POINT OF COLLISION	
Fishguard and Goodwick :—	
Ground frame at entrance to brick works siding ..	260 yards North
No. 22 facing points	630 ” ”
No. 4 Up starting signal	740 ” ”
Front of auto-train engine before leaving station ..	890 ” ”
Signal box	900 ” ”
No. 3 Up home signal	1,120 ” ”

3. The points and signals at Fishguard and Goodwick are worked from the signal box on the Down platform. There are no special features, except that No. 3 Up Home is not interlocked with No. 22 Down facing points but only with their facing point lock No. 24. There are no trap points or sand drag protecting the single line from movements in the Up direction.

22. This accident was due to the serious mistakes of an engine driver who broke the most fundamental rule of single line working by starting without the train staff, as well as passing a signal at danger. Trap points or a sand drag at the Up exit from Fishguard and Goodwick Station would have prevented the accident and I recommend provision of either of these safeguards if the practice is continued of accepting Up trains into the platform when the single line ahead is occupied by a Down train. It would also be desirable to fix a subsidiary signal under the Up Home so that the signaller could call trains forward without resort to hand signals or to unlocking facing points as occurred on this occasion. The present instruction in Fishguard and Goodwick box regarding acceptance, with its reference to working into a terminal single line station, is clearly inappropriate, and, as there does not appear to be any suitable general regulation to cover this case, I suggest that a special instruction be issued.
