REPORT ON THE COLLISION

5th August 1951 at

FORD STATION

SOUTHERN REGION

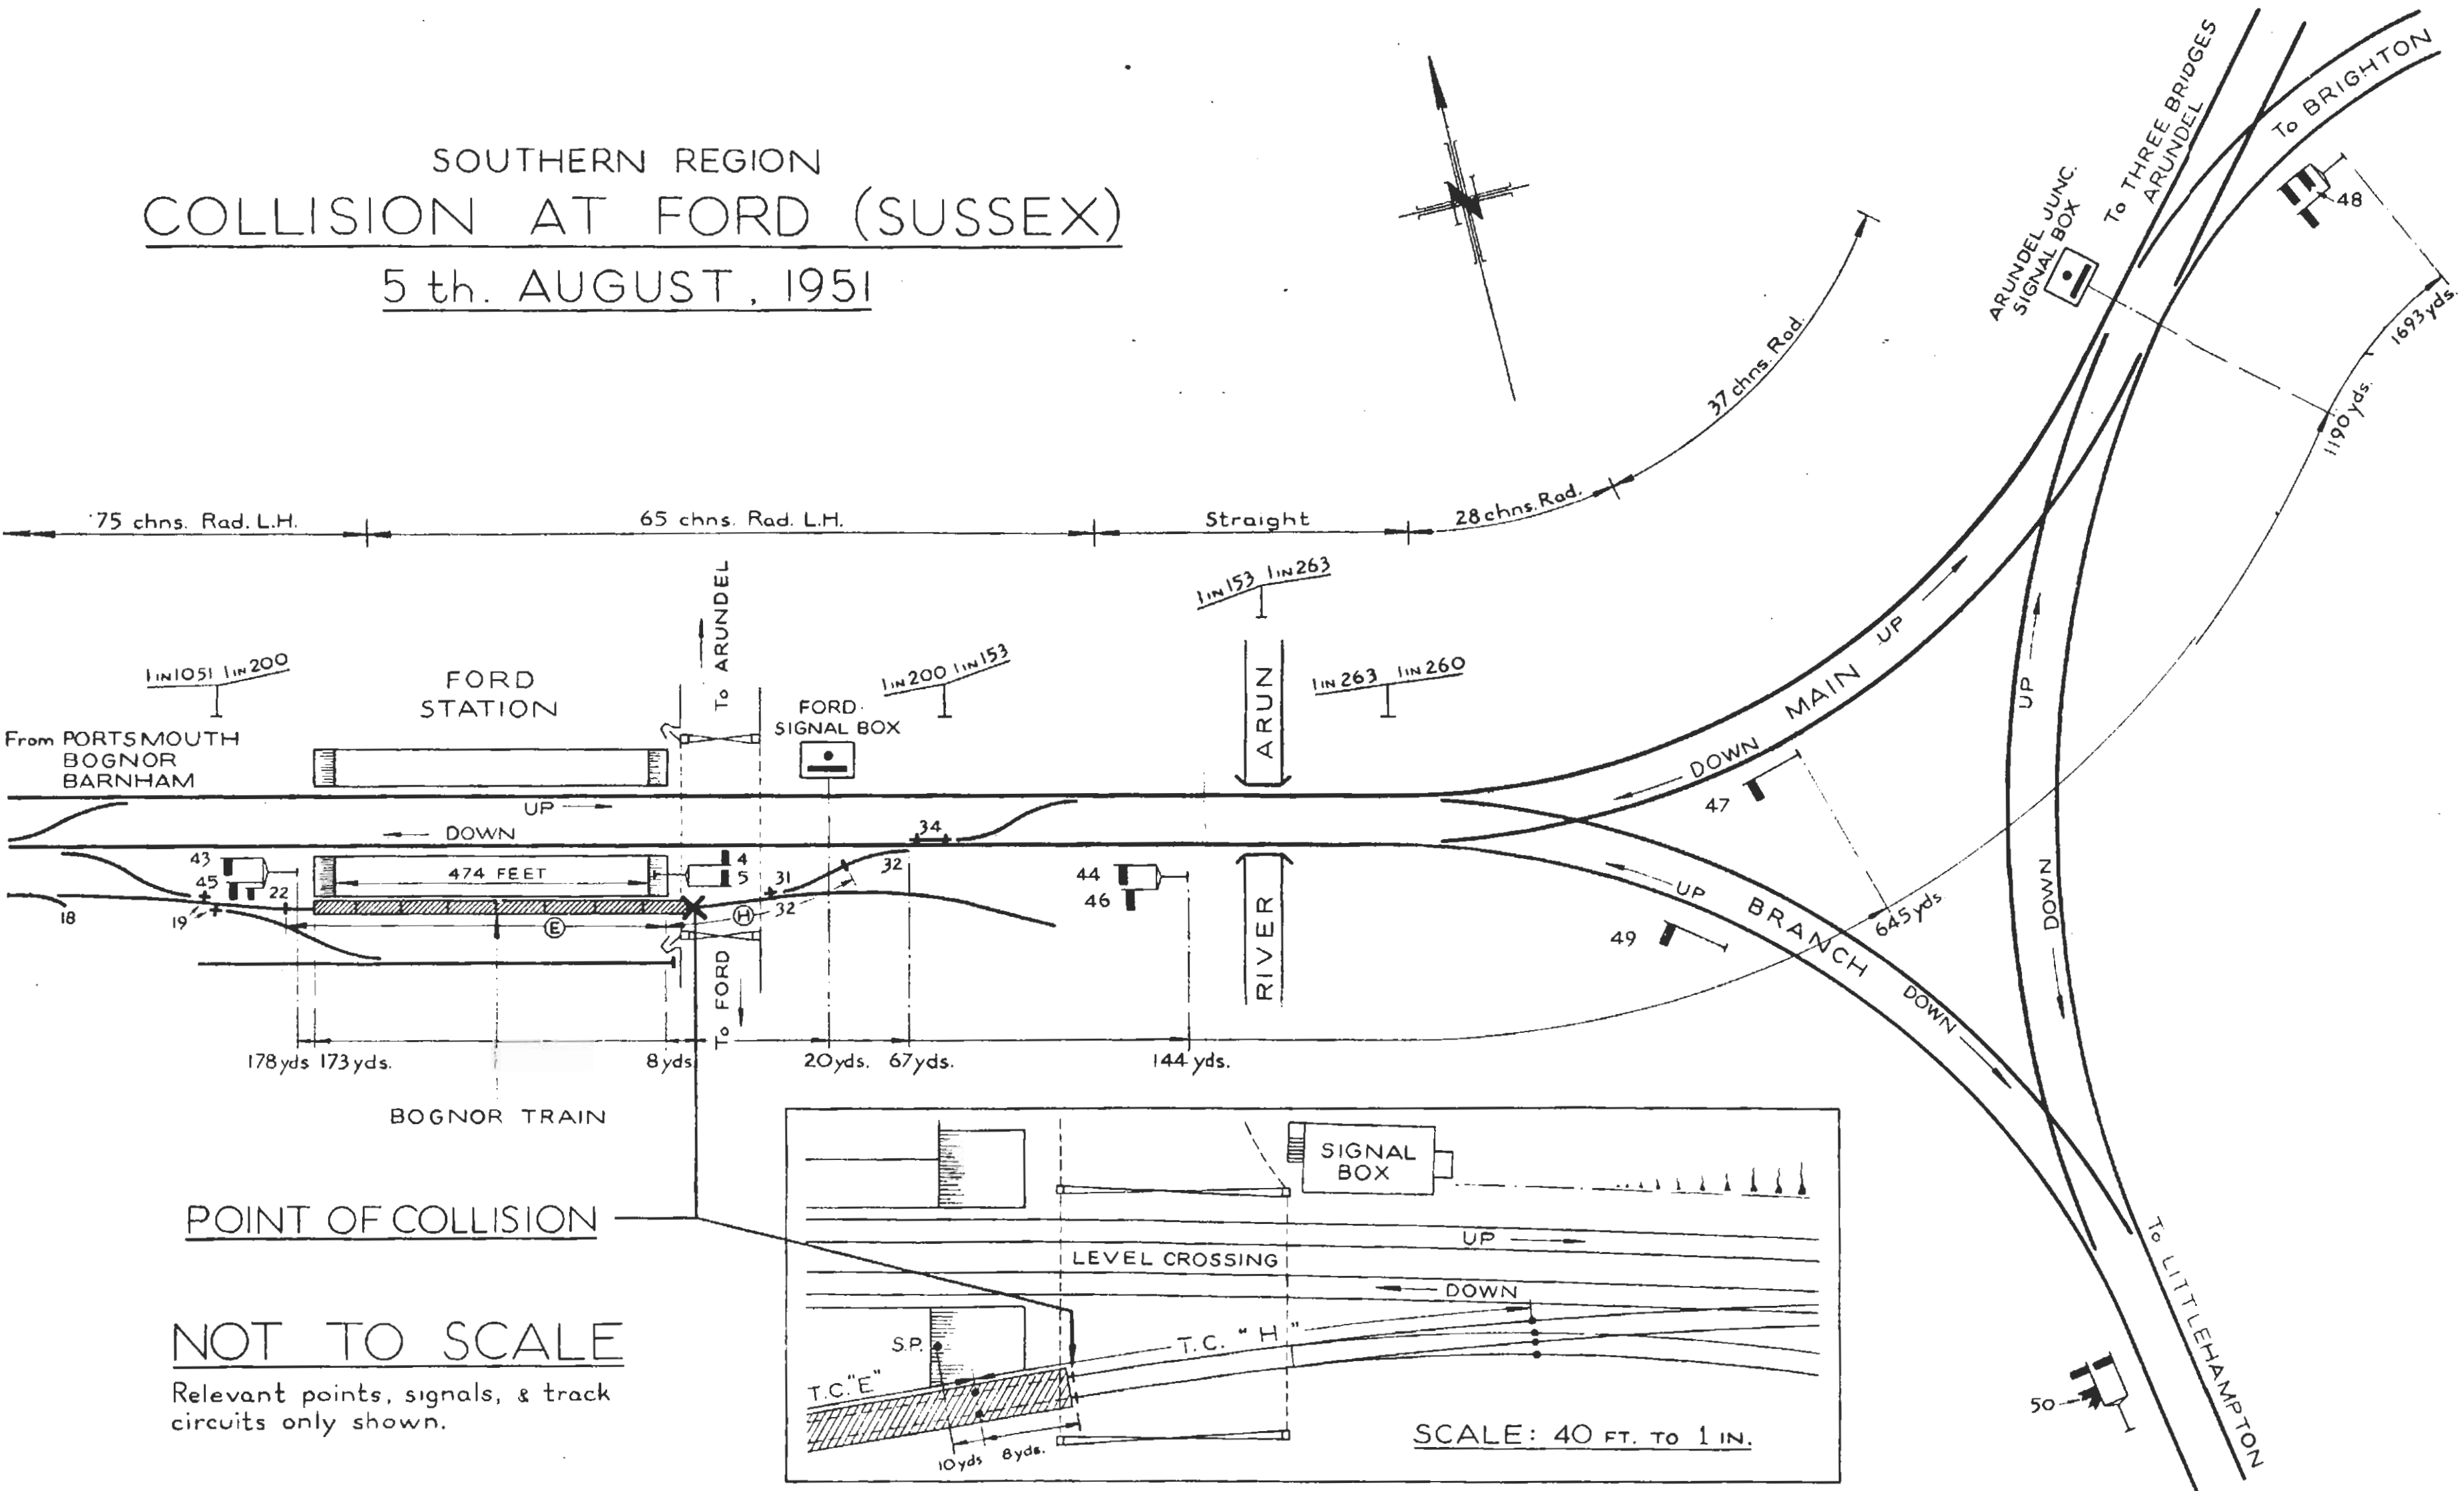
SOUTHERN REGION COLLISION AT FORD (SUSSEX)

POINT OF COLLISION

Relevant points, signals, & track circuits only shown.

3. The relevant signals and track circuits are shown on the drawing. The features of the controls and interlocking at Ford, so far as they affect this accident, are :—
