DEPARTMENT OF TRANSPORT

# RAILWAY ACCIDENT

**Report on the Collision that  
occurred on 23rd February 1979  
at Hampton Court Junction**

IN THE  
SOUTHERN REGION  
BRITISH RAILWAYS

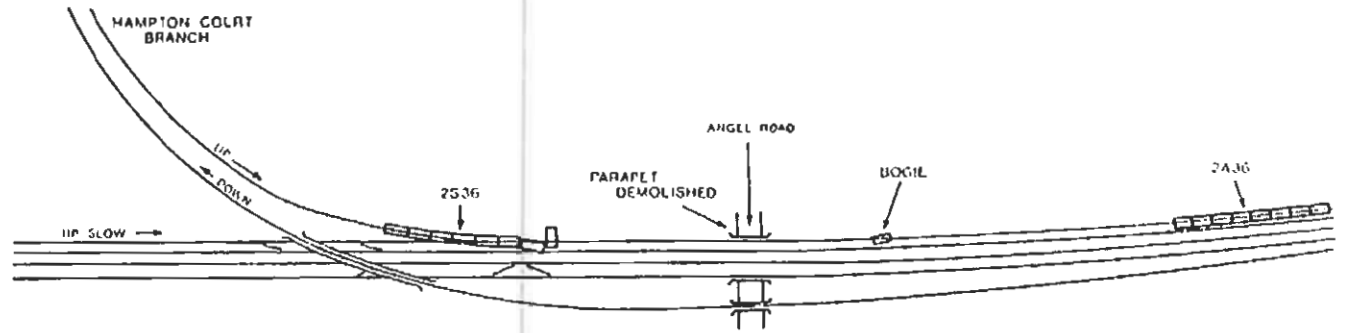
Figure 1 HAMPTON COURT JUNCTION, POSITION OF TRAINS AFTER ACCIDENT (Not to scale)

9. The Hampton Court train struck the sixth car of the Alton train and scraped the sides of the sixth, seventh and eighth cars. The leading car came to rest with its front end at the bottom of an embankment some 50 yards beyond the point of collision and with its rear end foul of the Up Fast line some 12 ft above the ground. The second car remained coupled to it but it was leaning to its off side foul of the Up Fast line with one pair of wheels of its trailing bogie derailed. The remainder of the train was undamaged. The leading car was severely damaged at its leading off-side end, and its bogies and underframe equipment were extensively damaged. Both body ends of the second car were pushed in, the body sides were creased and the floor was buckled. There was extensive damage to its bogies, underframe and interior equipment. Only the leading body end and jumper cables of the third car were damaged.

10. The left body sides of the rear three coaches of the Alton train were damaged by the collision. The frames of both bogies of the seventh car were bent and there was minor interior damage. Both bogies of the rear car were severely damaged and the rear bogie was torn off and came to rest some 240 yards beyond the point of collision. The tail of the train came to rest 840 yards beyond the point of collision.

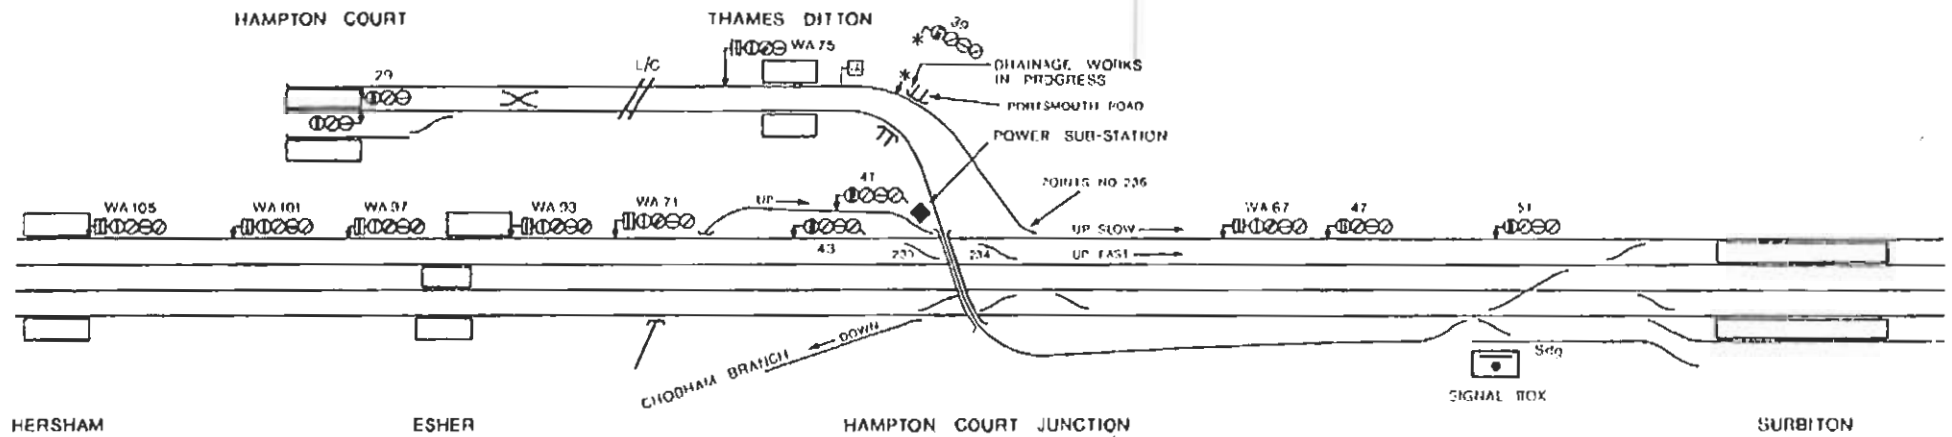
Figure 2 SIGNALLING DIAGRAM (Not to scale)

2. All the lines are signalled under the Track Circuit Block Regulations with 4-aspect colour-light signals on the Main lines and a mixture of 2, 3 and 4-aspect signals on the Branch. The signalling is controlled from Surbiton Signal Box. The locations of the signals, all of which are equipped with the standard British Railways Automatic Warning System (AWS), are shown in Figure 2. All the lines are electrified at 660 volts DC on the conductor rail system.

6. Signal S39 will only display a Proceed aspect if points No. 236 are reversed and signal S43 is at Danger and free of approach locking, or points No. 230 or No. 234 are reversed. Both signals are approach locked as soon as their aspect has cleared. If Signal S39 is replaced to Danger after a route has been set from it, a route cannot be set from Signal S43 until two minutes have elapsed to release the approach locking. Signal lamps are of a double filament variety with automatic changeover should one filament fail. If there is a complete failure of Signal S39, then Signal WA75 will automatically revert to Danger.
