RAILWAY ACCIDENT

REPORT ON THE COLLISION

21st April 1963

KING'S LANGLEY

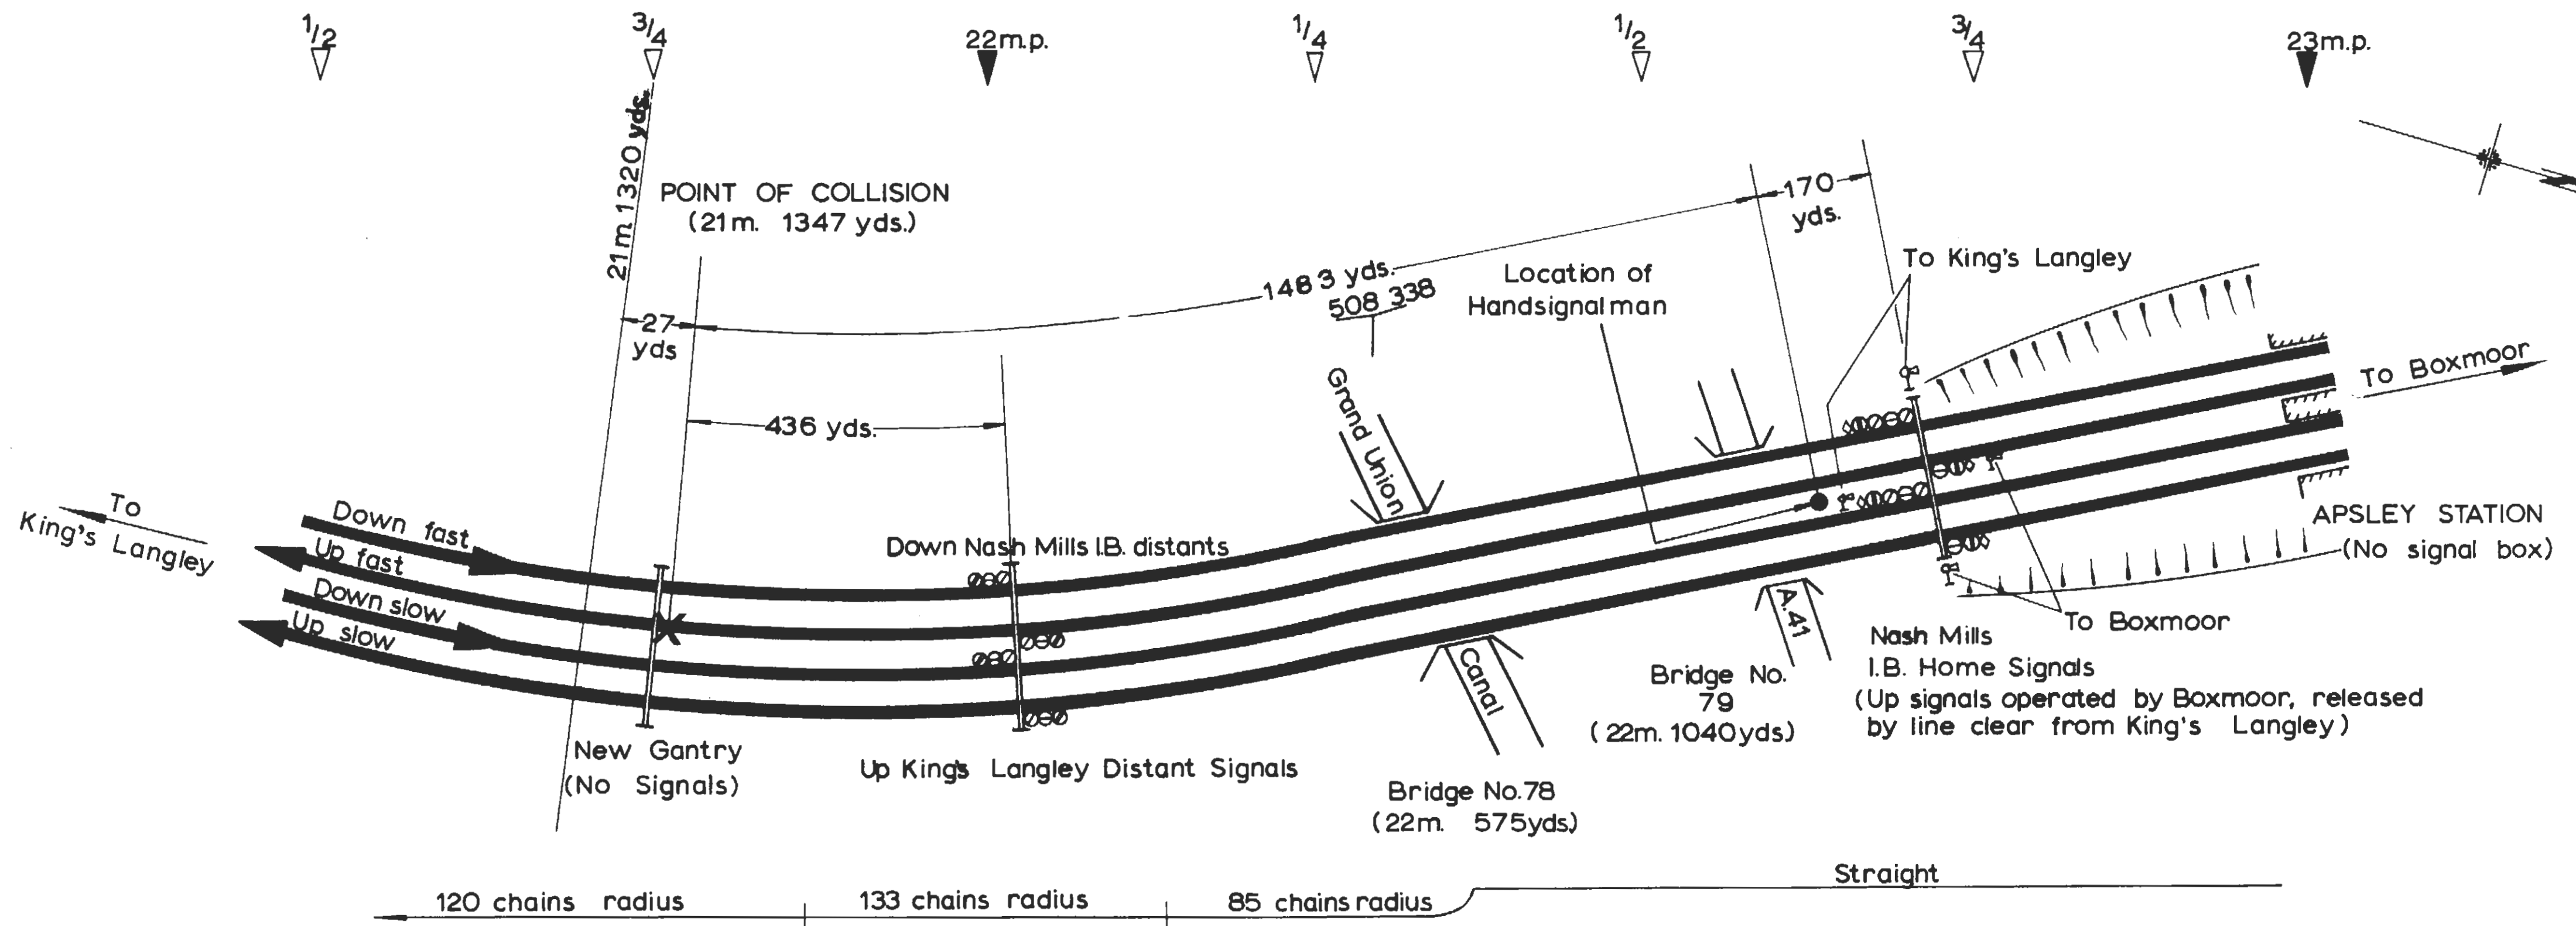
FIGURE 1. - DETAIL OF SITE AND SIGNALLING

7. The collision occurred 1653 yards South of Nash Mills I.B. signals, and details of the site are given in the accompanying diagram. The relevant distances to Euston and to the point of collision are:—

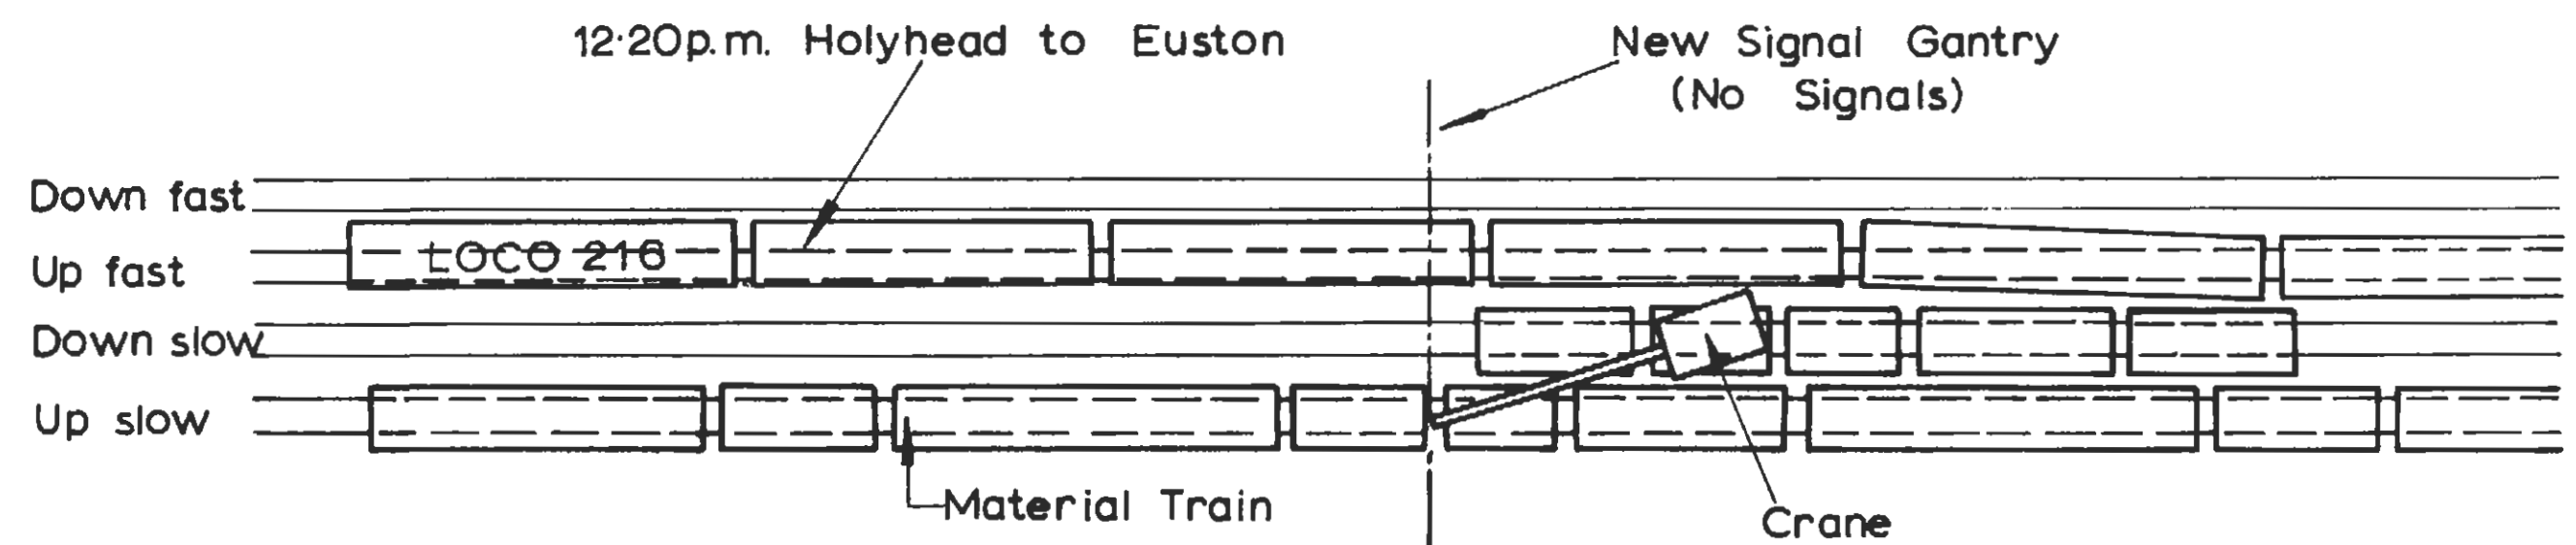
FIGURE 3. DETAIL AT POINT OF COLLISION (21 mls. 1347 yds.)

The left side of the nose of the diesel engine hit the tail counterpoise of the crane a glancing blow at a speed of about 20 m.p.h. and the resulting side thrust was sufficient to burst the offside rail causing the derailment of the engine and four leading coaches of the train which ran on for approximately 75 yards before coming to a stand foul of the Down Fast line. The derailed vehicles remained upright with couplings intact. Fortunately, apart from a member of the restaurant car staff who fell and injured his leg, nobody on the passenger train was hurt.

13. It had a tail radius of 11 feet, and when standing on the Down Slow line at the angle to which it was slewed when the collision took place the tail corner of the superstructure would have been almost directly above the near side rail of the adjacent Up Fast line and about 6 feet above it.
