**RAILWAY ACCIDENT**

**REPORT ON THE COLLISION**

**10th August 1961**

**LEEDS CITY STATION**

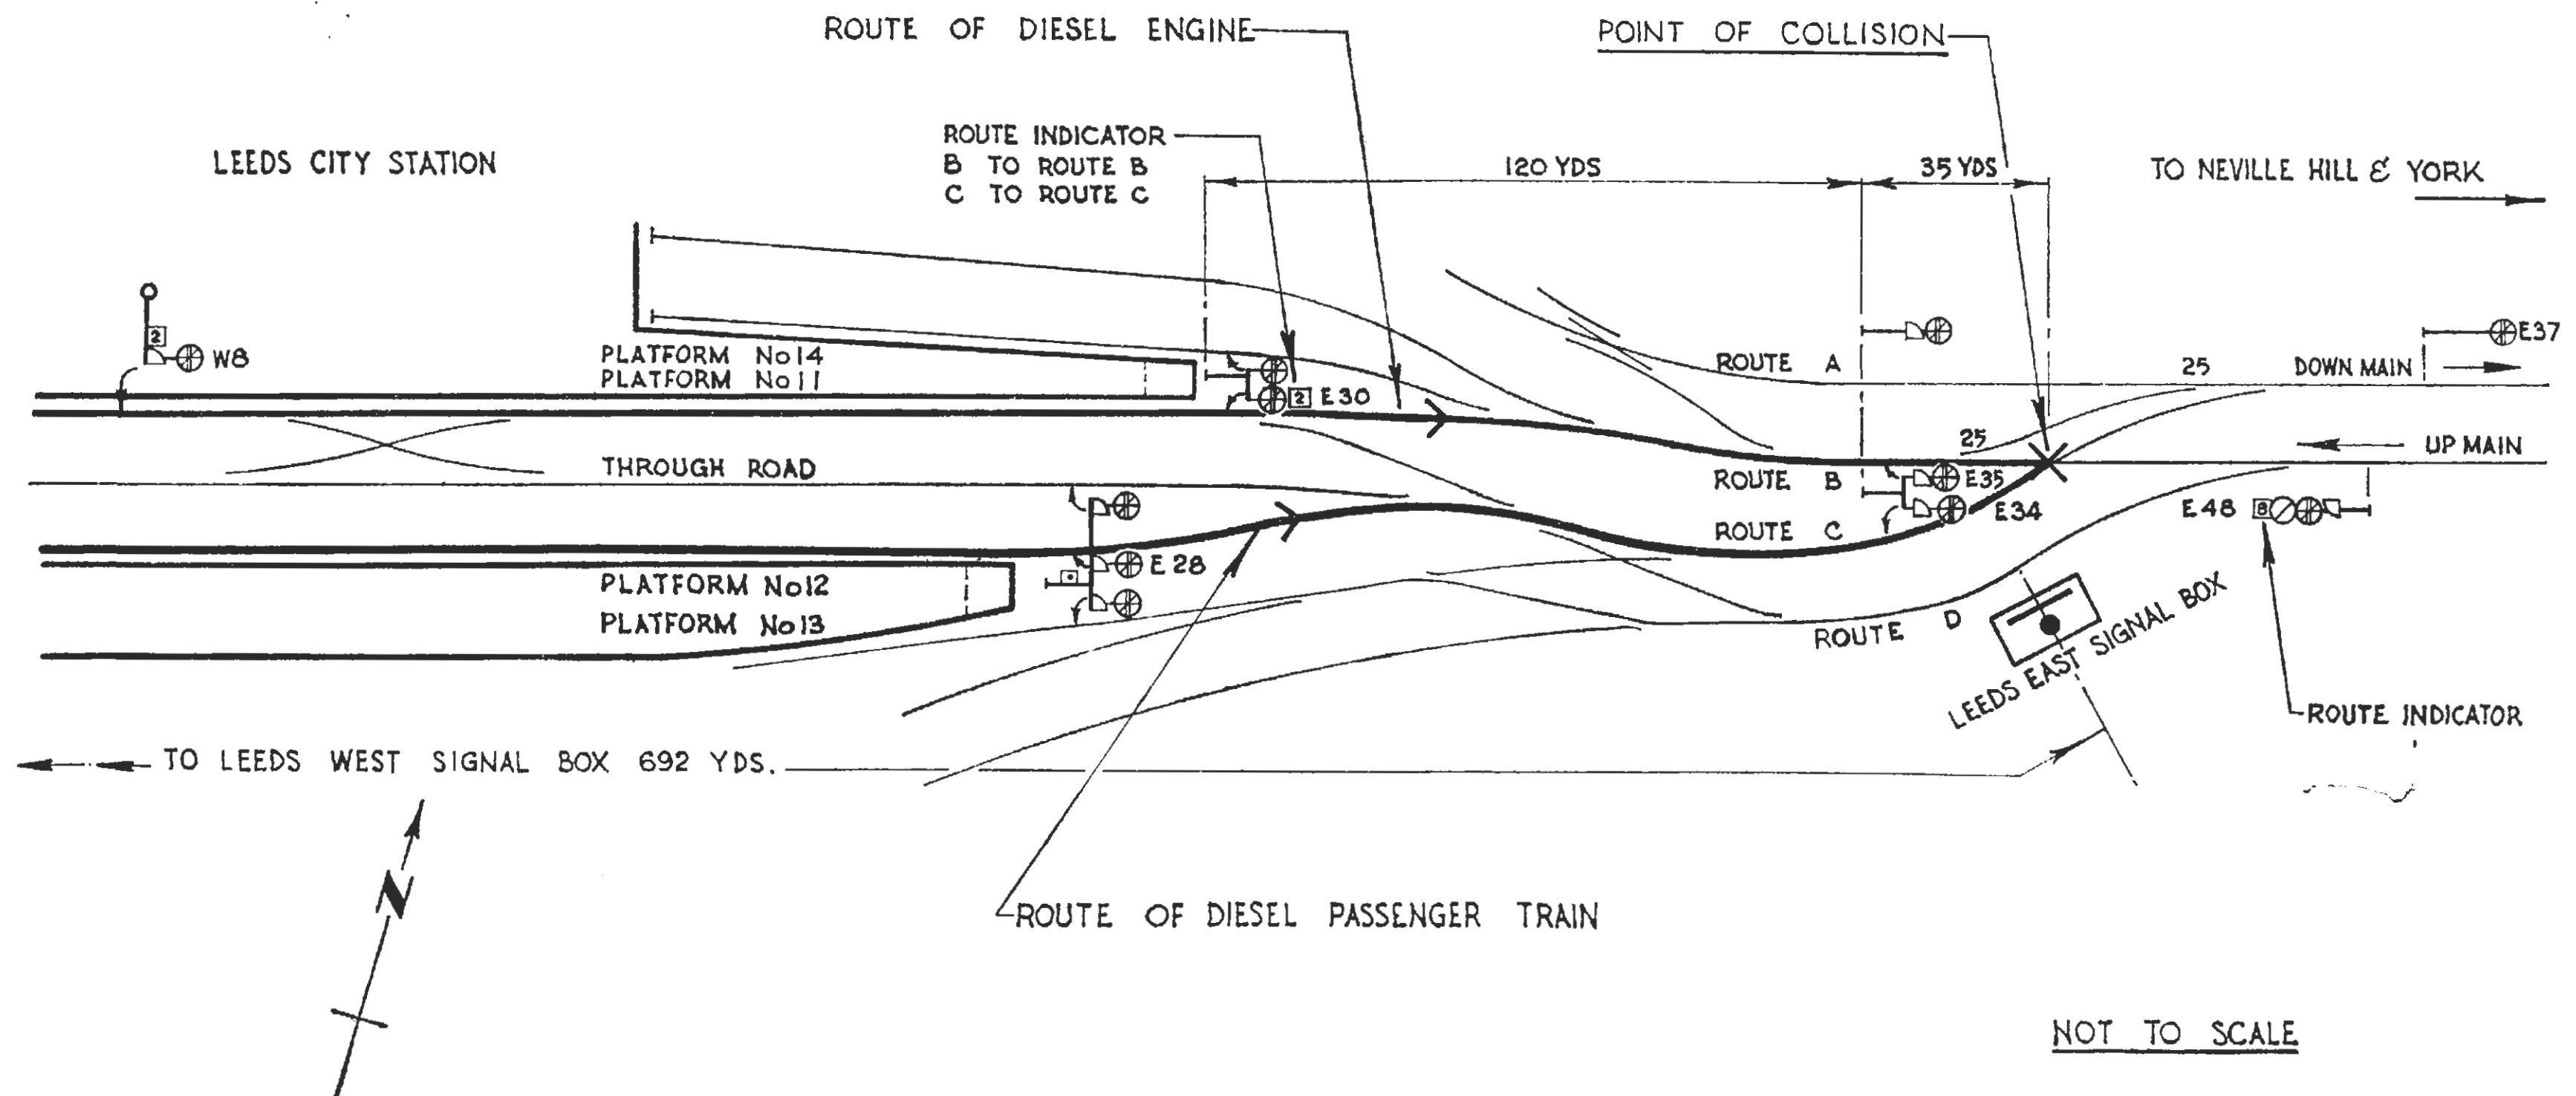
2. The layout of the lines at the east end of Leeds City station, and the position of the signals relevant to this accident and of the Leeds East signal box are shown in the sketch opposite.

4. As shown on the sketch, there are four routes at the east end of Leeds City station and they are known as A, B, C and D. The routes that are mainly relevant to this case are B and C. Movements from No. 11 platform to the Down main line can be made by either route B or route C. In the former case they are controlled by signal No. 30 with the letter B in its route indicator, and by signal No. 35; in the latter case by signal No. 30 with the letter C and signal No. 34. Movements from No. 12 platform to the Down main line must be made by route C and they are controlled by signals No. 28 and 34. Signals No. 34 and 35 are situated 120 yards beyond signal No. 30. They are bracketed on one post which is situated between routes B and C; signal No. 34 is to the left of route C and is slightly higher than No. 35 which is to the right of route B. It will be seen that these two signals protect the converging junction of routes B and C the fouling point of which is 35 yards beyond the signals when crossover No. 25 is set for the straight route (see paragraph 5).

6. From the footplate of a diesel engine moving along platform line No. 11, signals No. 34 and 35 come into clear view from a point well on the approach side of signal No. 30, and they remain in view while the engine passes along route B.

7. There are emergency detonator placers on all the routes operated by stirrups in the lever frame in the East box. On account of the layout, the detonator placer on route B is almost opposite signal No. 35; that on route C is just beyond signal No. 34.

24. This is the third occasion within the last two years in which mistakes of this nature have been made at signals No. 34 and 35. In the earlier two cases, signal No. 35 at Clear was misread for signal No. 34 which was passed at Danger. Under a scheme for the amalgamation of the Leeds City and Central Stations, this area will be entirely re-signalled, and, as in all modern colour light signalling installations, the signals will be placed immediately to the left of the lines to which they refer and as close as possible to the driver's eye level. The re-signalling is, however, unlikely to be undertaken in the immediate future, and I am glad to report that early steps are to be taken to re-position signal No. 35 further away from signal No. 34 and to the left of Route B.
