RAILWAY ACCIDENTS

REPORT ON THE COLLISION

4th December 1957

ST. JOHNS STATION

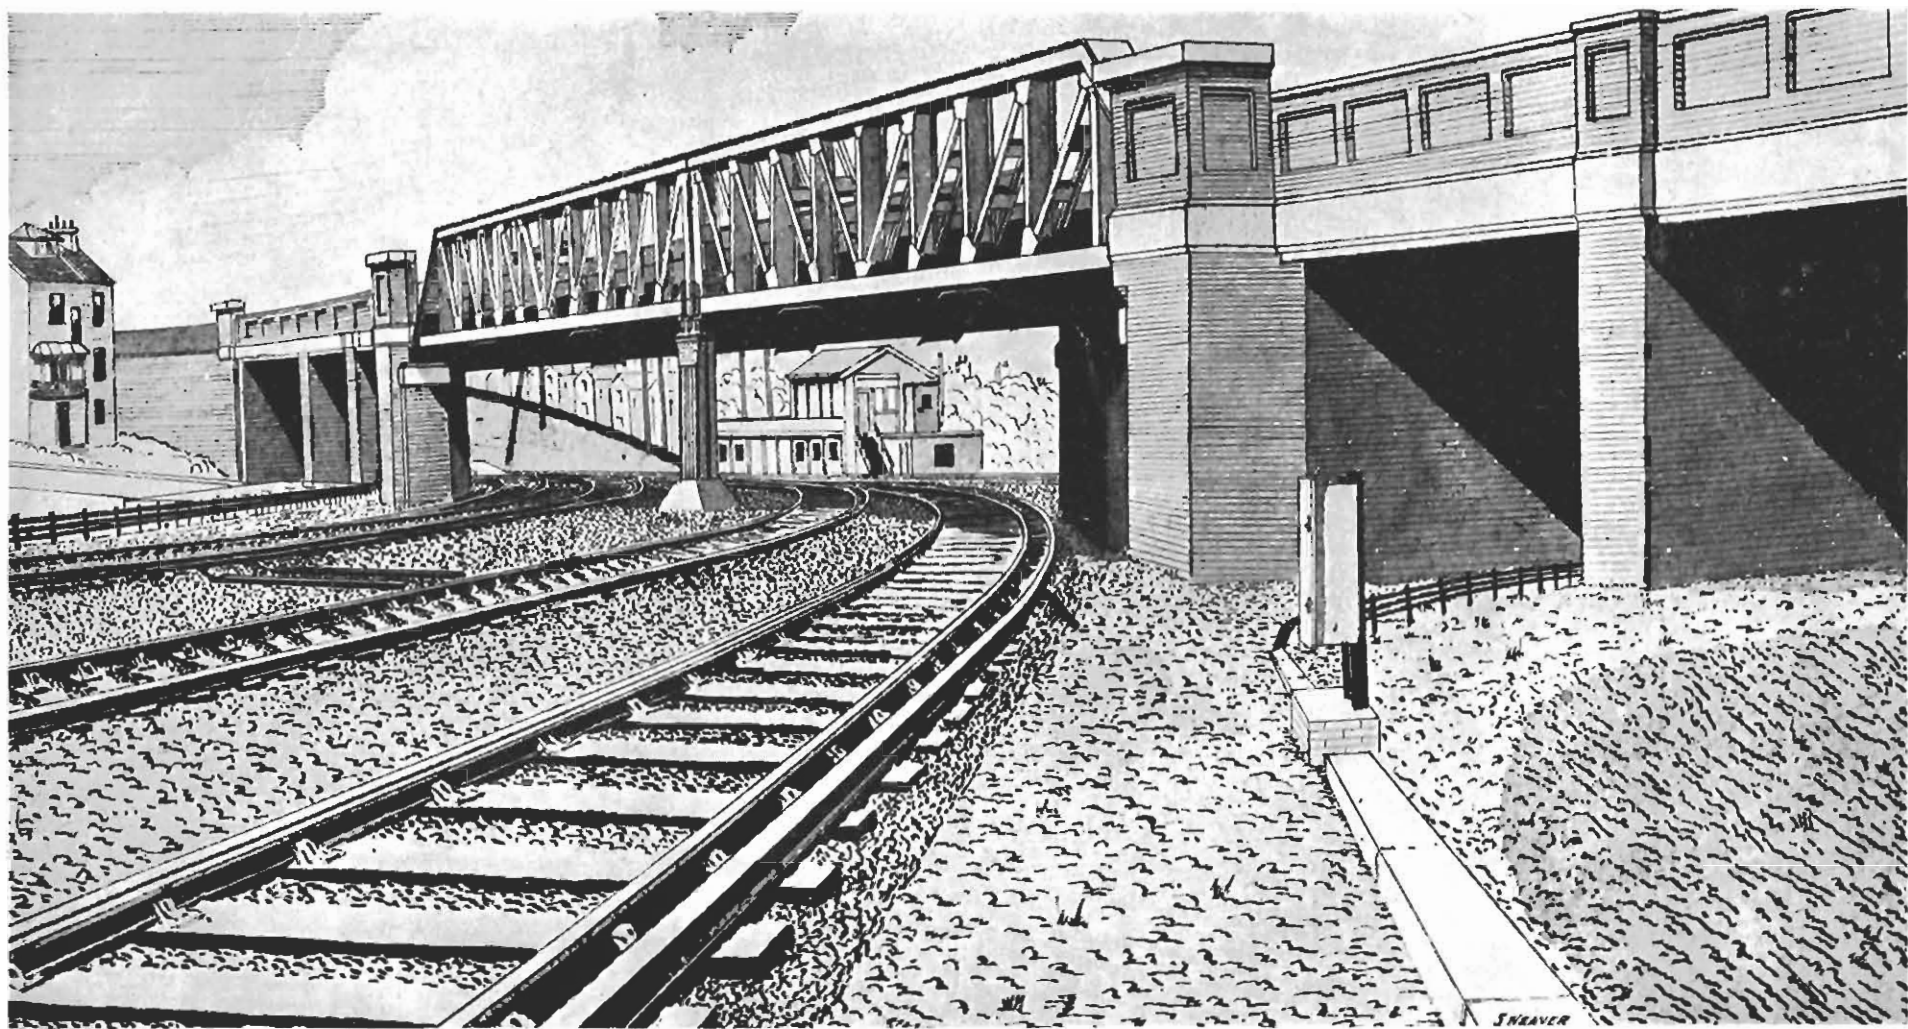
BRIDGE No. 111. VIEWED FROM COUNTRY SIDE.

8. Since much of the damage to the coaches of the Ramsgate train was caused by the fall of the bridge girders, a brief description of the bridge itself is desirable.

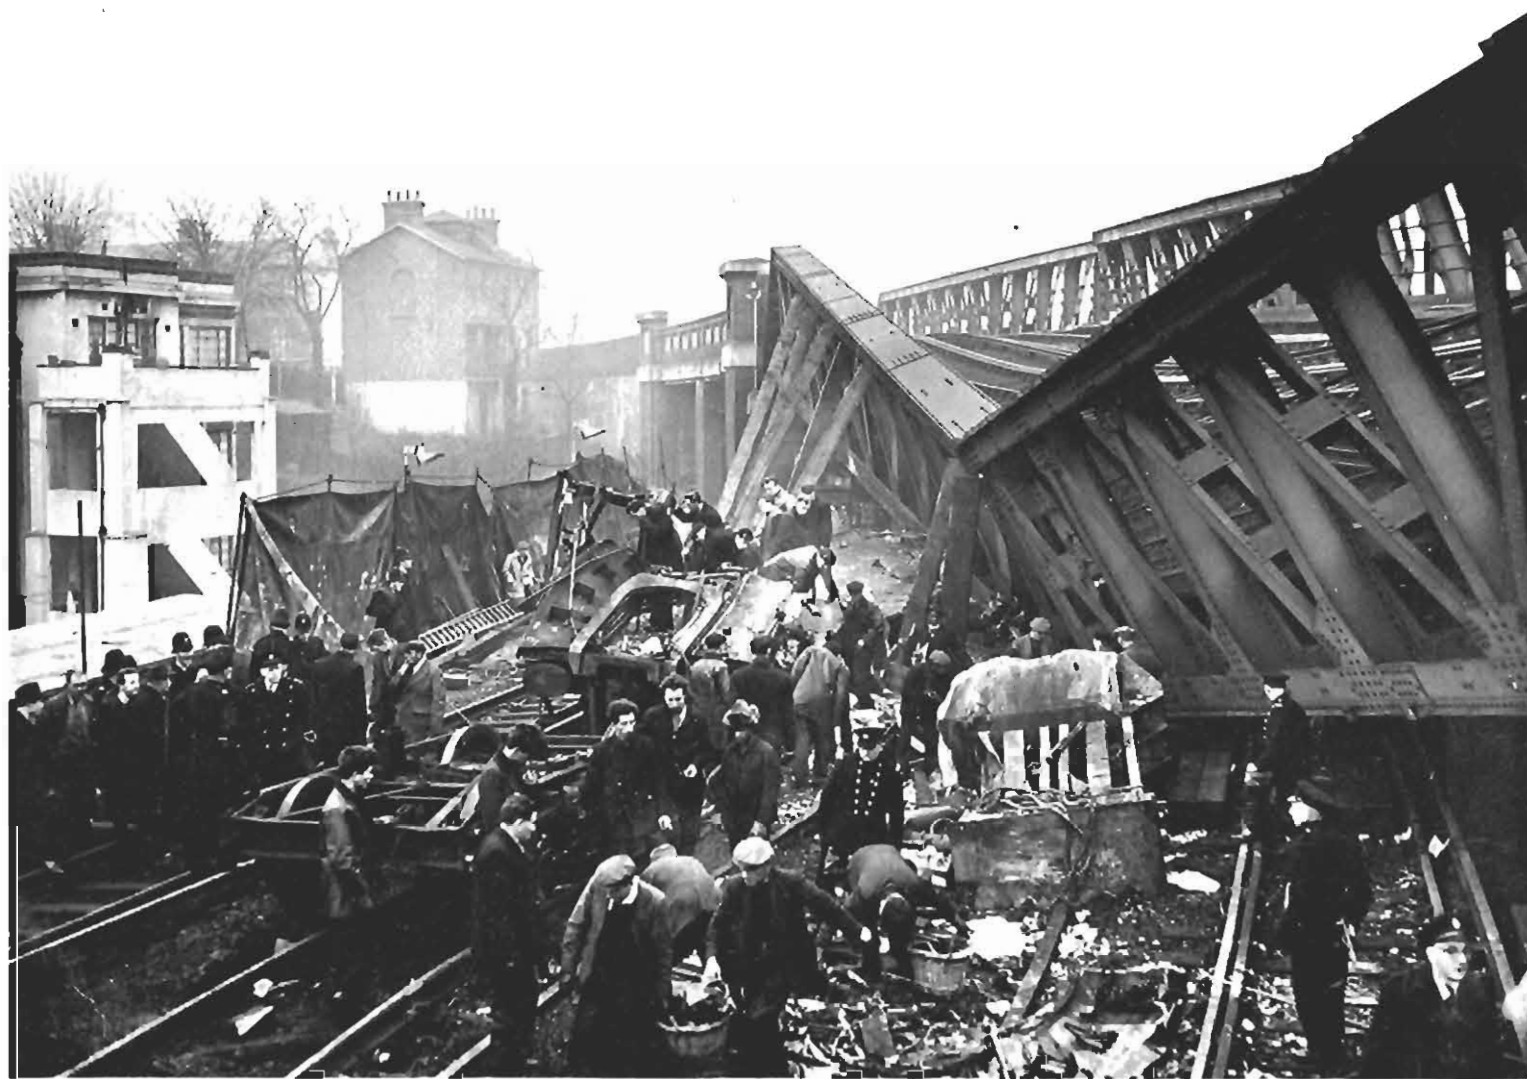
BRIDGE No. 111. AFTER THE ACCIDENT.

The stanchion supporting the inner ends of the two London side girders consisted of a pair of steel columns close together, each fabricated of rolled steel joists. The stanchion supporting the girders on the country side, which was knocked over, was a single and stouter column, also built up from steel joists, and it carried a dead load of approximately 120 tons—see Fig. 4. Its length parallel to the track and its width were 5 ft. 0 ins. and 2 ft. 0 ins. respectively. With the cast iron cap and fabricated base the height of the column was 15 ft. 0 ins. above the heavy and deep concrete foundation to which it was secured by four 1½ ins. bolts. The weight of the column and its fabricated concrete-filled base was approximately 14½ tons.

9. There was no doubt that the first blow on the column had been struck by the left hand corner of the tender, and it appeared that the blow had been centred about 7 ft. 5 ins. above rail level.

As a result, the column was pushed out, head foremost, shearing the four 1½ ins. bolts which attached the cast iron cap, and shearing one and breaking in tension the other three 1½ ins. bolts securing the base to the concrete foundation. The column was then projected forward, probably by the underframe of the leading coach, and it was found on its side in the position shown by Fig. 2 and the photograph, with the base some 20 ft. forward from its original position. It was estimated, with the support of calculations, that the horizontal pressure necessary to strike out and throw forward the column in this way might have been between 215 and 280 tons.

Tuesday and Wednesday, 10th and 11th December, were spent in clearing up the site and in making good the damage to the permanent way, including re-ballasting, and the main lines were opened again to traffic at 5.0 a.m. on Thursday, 12th December, after an interval of approximately 7½ days; the ordinary passenger services were then resumed, but with such a long interruption there was a heavy accumulation of freight traffic and it was several days before the freight situation became normal. The Nunhead-Lewisham line overhead was re-opened with a temporary bridge at 6.0 a.m. on Monday, 13th January. This bridge will serve until a new permanent bridge can be constructed.

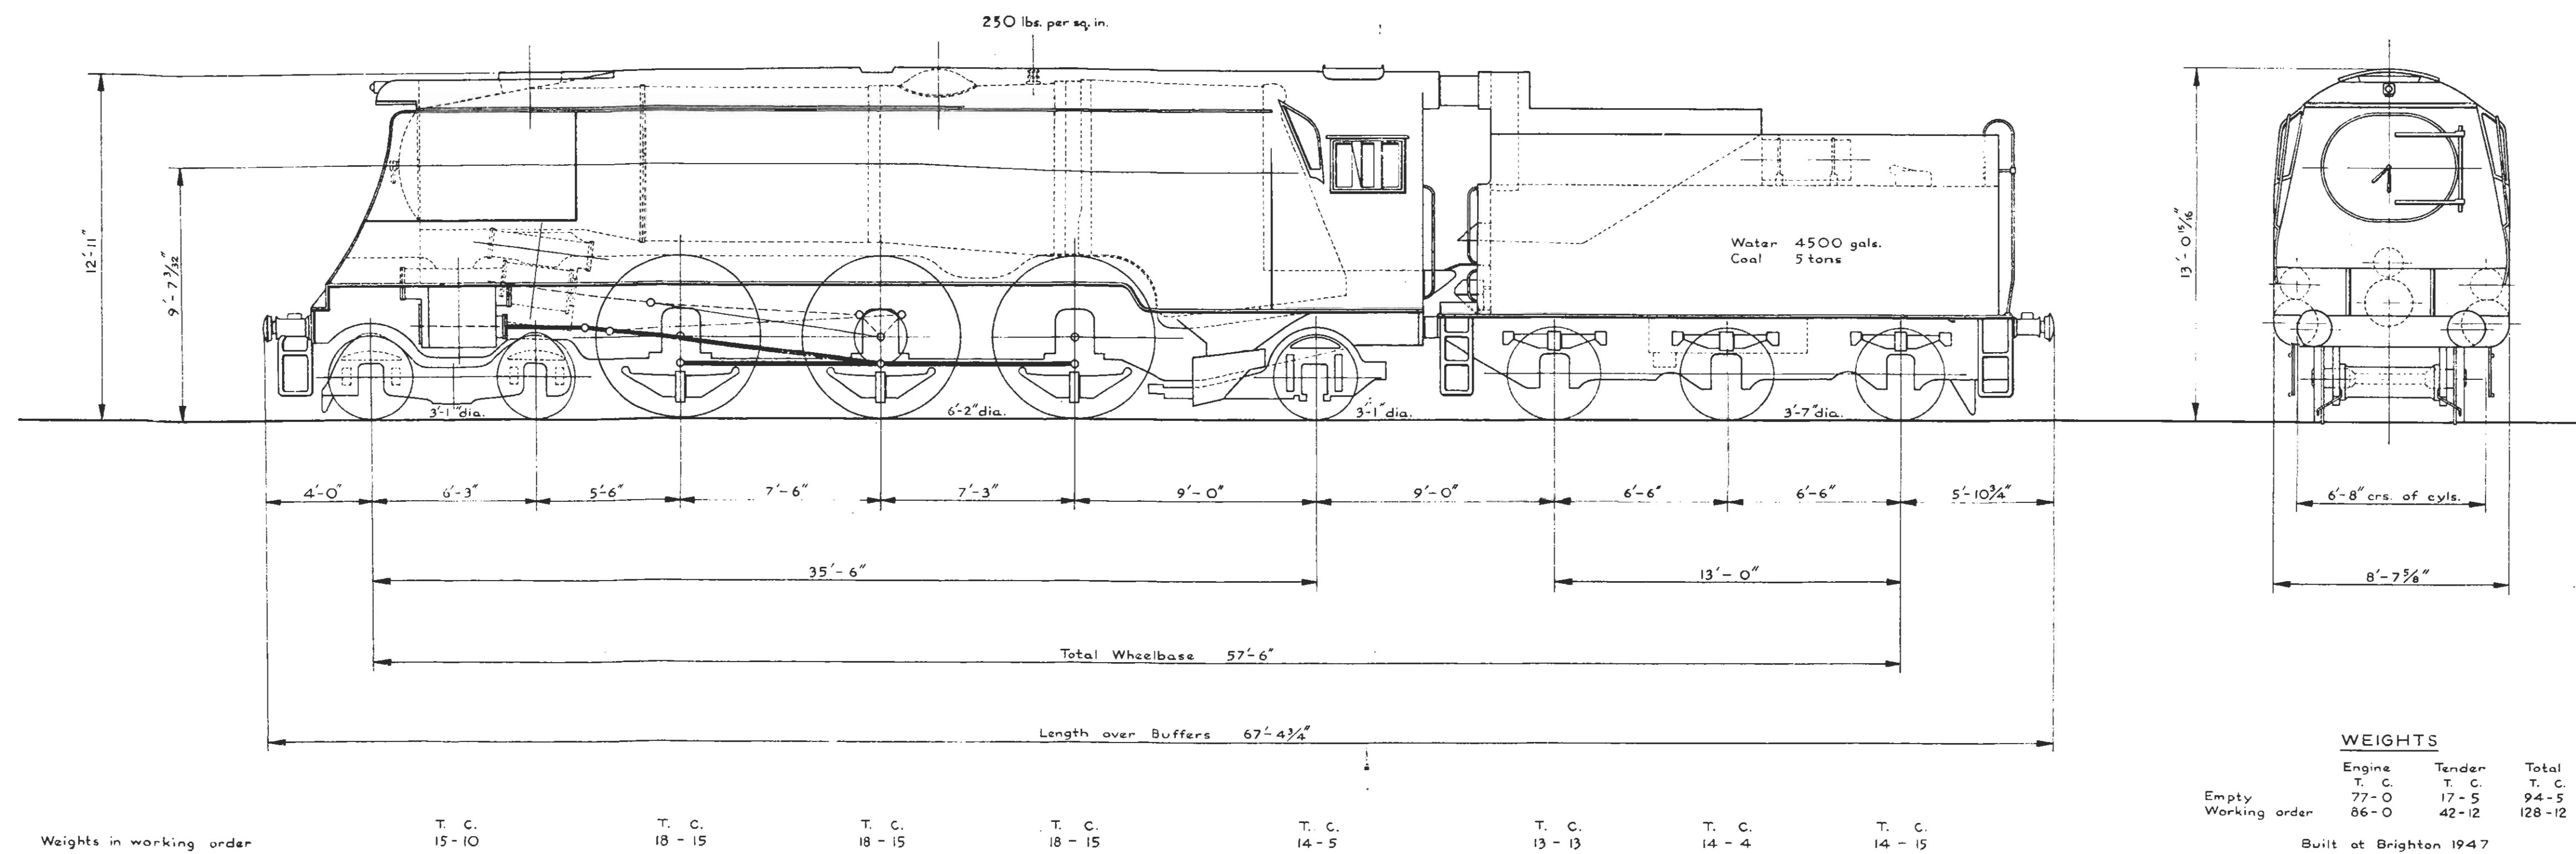
FIG. 3 ENGINE No. 34066 — BATTLE OF BRITAIN CLASS

33. From these results it will be noted that, in fog with visibility less than 80 yards, a driver of a "Battle of Britain" class engine would not see any of these four signals at all, because they would be obscured by the boiler before even their "glow" became visible.

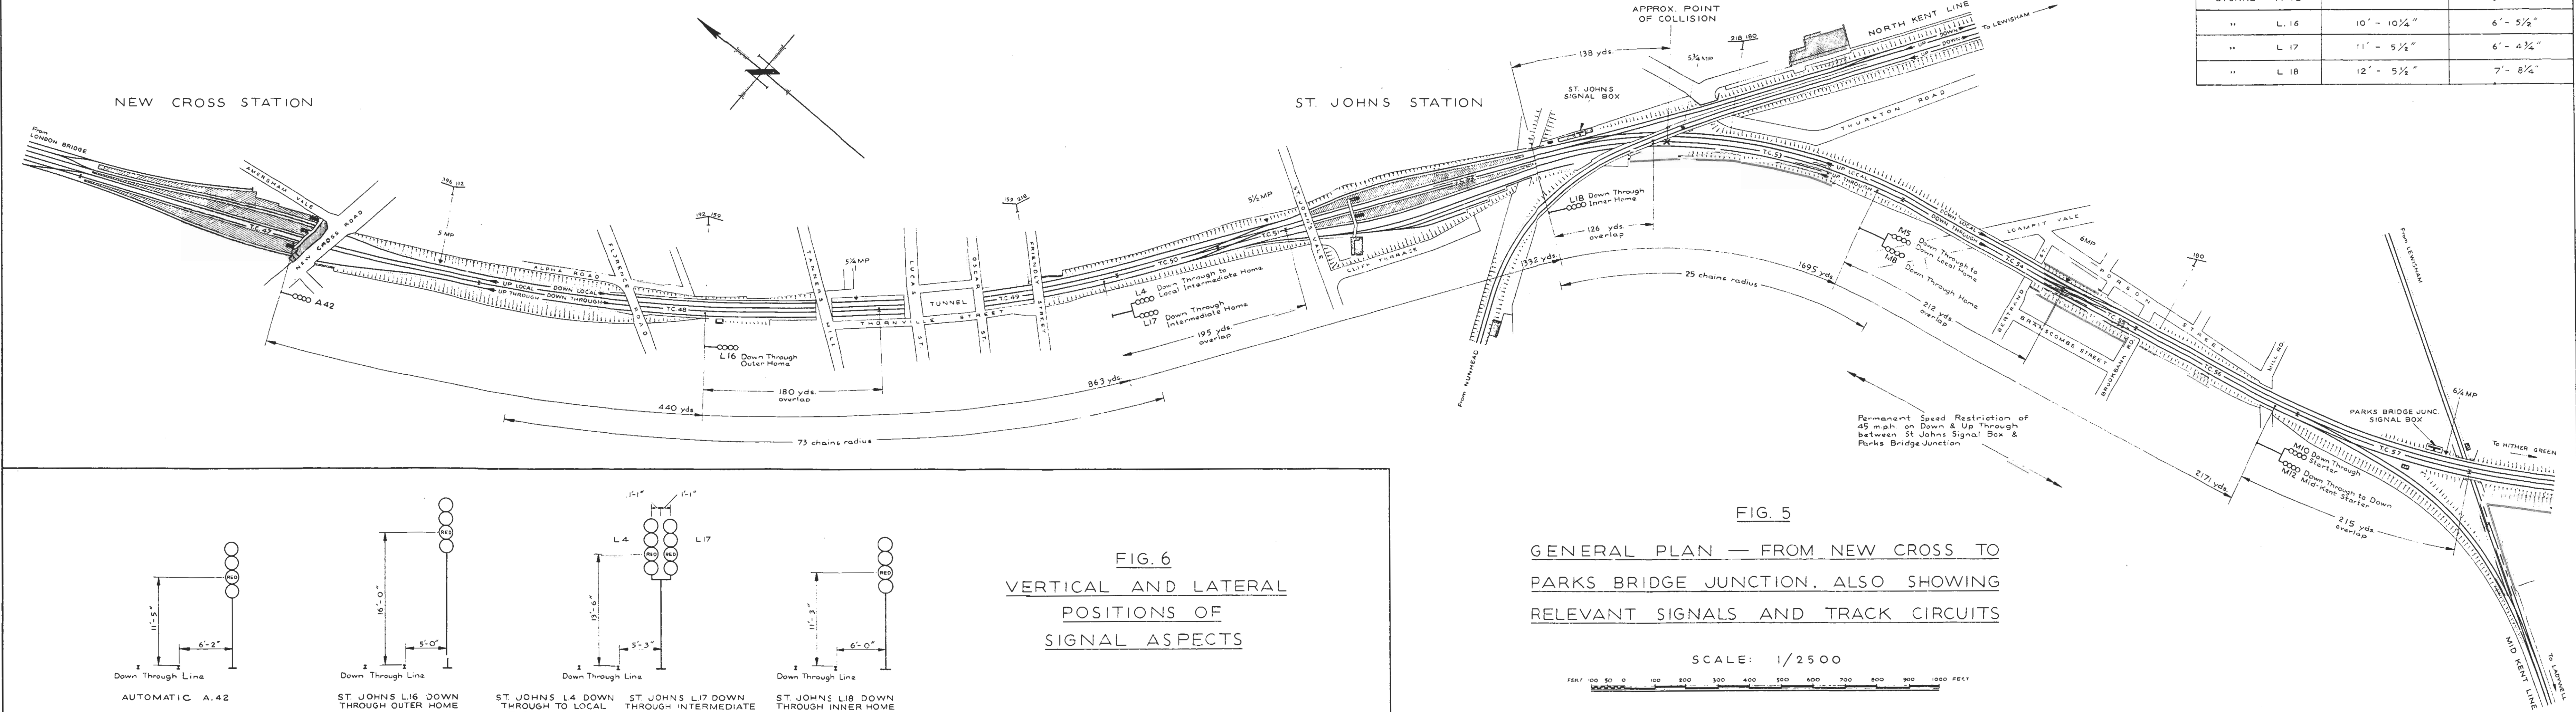
FIG. 5
GENERAL PLAN — FROM NEW CROSS TO
PARKS BRIDGE JUNCTION, ALSO SHOWING
RELEVANT SIGNALS AND TRACK CIRCUITS

14. Fig. 5 is a general plan of the route from New Cross through St. Johns to Parks Bridge Junction; it also shows the relevant signals and track circuits and other information. It will be noted that there is a double line junction at St. Johns, between the Local lines only and the North Kent line via Lewisham, which continues on the straight. At this point the four main tracks begin to curve to the south through the bridge which was brought down, and then become straight for some way ahead. At Parks Bridge there is a double line junction, also facing in the Down direction, between the Through lines only and the Mid Kent line which runs via New Beckenham to Hayes.

26. From the right hand columns of Table 1 and the distances shown on Fig. 5, it will be noted that before signal L.17 can clear to Y to let a train forward to L.18 at R, track circuit No. 52 must be clear, giving a clear distance of 126 yards beyond signal L.18. This distance is termed the overlap, and such comparatively short overlaps are characteristic of this installation where prevailing speeds are moderate and the density of the traffic and the comparatively close headway requires that the signals should be cleared at the earliest possible moment behind a preceding train.

It will be noted from the inset to Fig. 5 that there is plenty of room for the simple signal posts in the wide space between the Down and Up Through line, but none between the Down Through and the Up Local lines, and to have brought the signal aspects to the left of the Down Through would have required fairly elaborate cantilevered gantries. I understand that at the time of installation, when most of the engines were driven from the right hand side, the signals were sited as nearly as possible to the driver's or fireman's eye level in order to give the best view in the prevailing conditions where curvature and overbridges had to be taken into consideration.
