MINISTRY OF TRANSPORT

REPORT ON THE COLLISION

24th July, 1949, at

LONDON BRIDGE

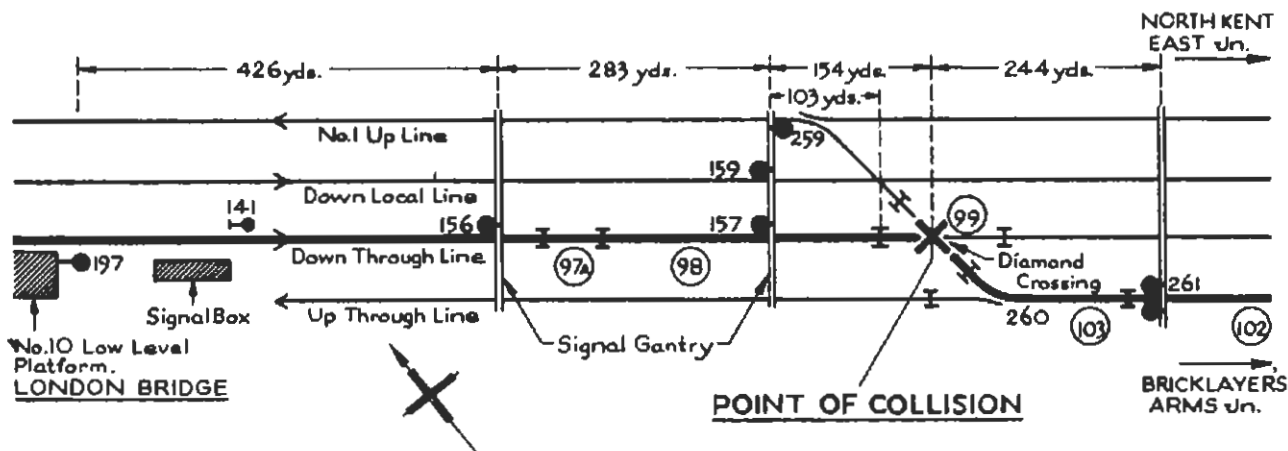
2. The relevant features of the layout, signals and track circuits at London Bridge are shown in the sketch. The approach to the Home signals, over the Up Through line, is straight as also is the line from No. 10 platform on to the Down Through. Gradients are negligible.

3. Multi-aspect colour light signalling is installed. Signals No. 157 and 159 are of the three-aspect type and are mounted on a 16 ft. gantry; they are located 3 ft. and 2 ft. to the left of the Down Through line and Down Local line respectively. Signal No. 156, which requires the two aspect shunt signal No. 141 to be "off" before it can be cleared, is also of the three-aspect type; signal No. 197 has four aspects. The last controlled signals on the Down Through and Down Local lines are Nos. 157 and 159. The next signals on these lines, A6 and A4, and the subsequent signals up to Bricklayers Arms Junction are automatic

The view of signals Nos. 156 and 157 is good, it being possible to see the former from Platform No. 10 and the latter from a point on the Down Through line opposite the signal box. The complicated layout and the intensity of traffic at London Bridge has necessitated the acceptance of reduced overruns ; normally this is not less than 200 yards but beyond signal No. 157 it is 103 yards.
