RAILWAY ACCIDENT

**Report on the Accident that
occurred on 22nd December 1978
at Milford Level Crossing**

IN THE
SOUTHERN REGION
BRITISH RAILWAYS

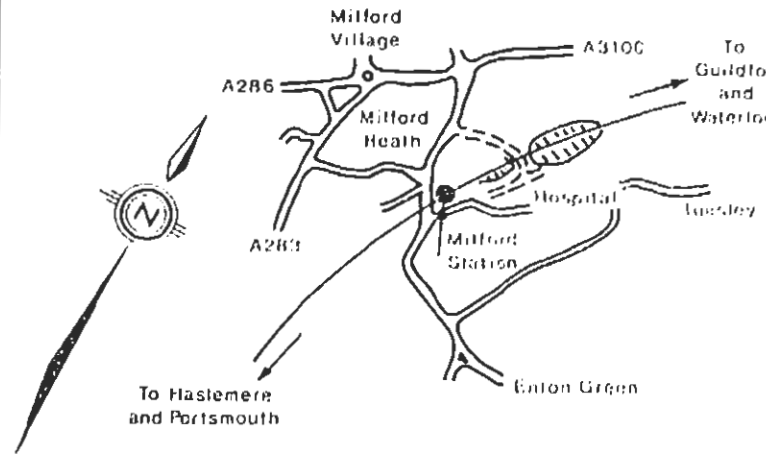
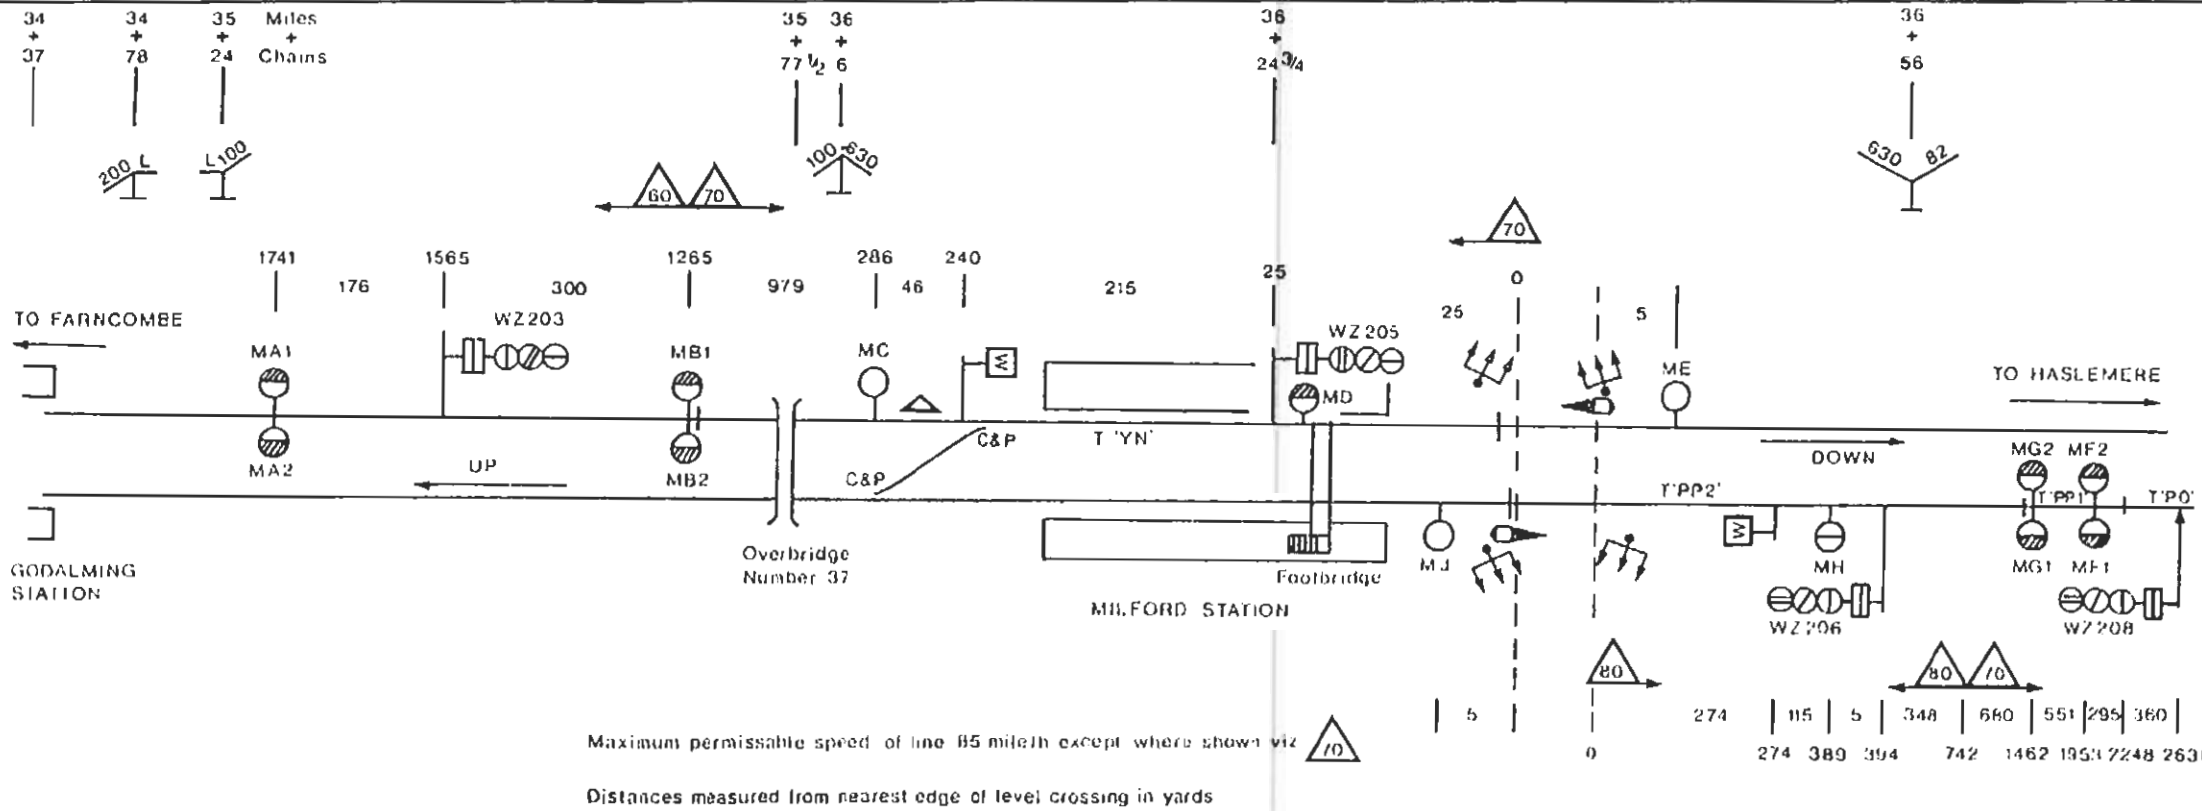
MILFORD PUBLIC LEVEL CROSSING

COLLISION BETWEEN 1122
WATERLOO TO PORTSMOUTH
TRAIN AND CAR REG No
BPH 820H AT APPROX
12.50 ON FRI 22 DEC 78
