RAILWAY ACCIDENT

Report on the Collision that occurred on 1st August 1963 at Norton Bridge

IN THE
LONDON MIDLAND REGION
BRITISH RAILWAYS

1964

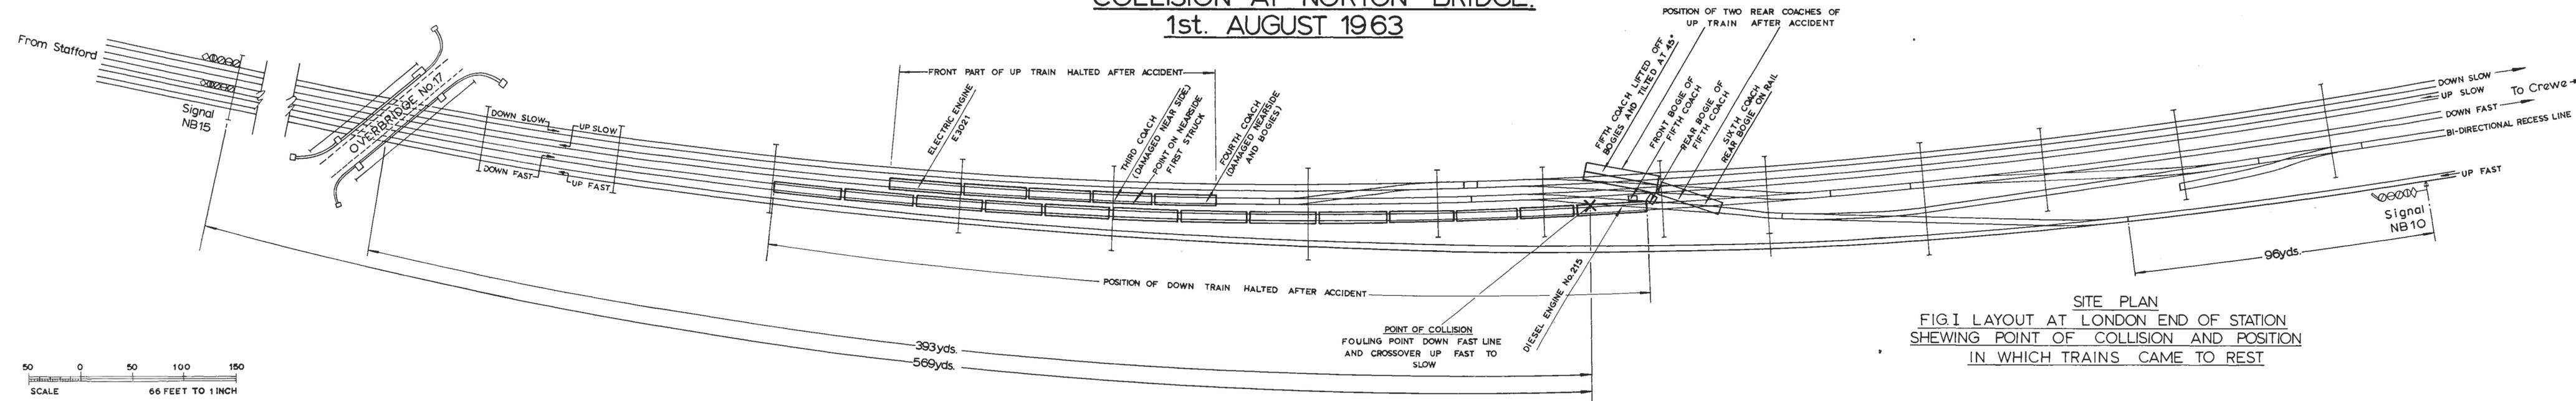
SITE PLAN
FIG. I LAYOUT AT LONDON END OF STATION
SHEWING POINT OF COLLISION AND POSITION
IN WHICH TRAINS CAME TO REST

The driver of the Down train had evidently allowed his attention to wander and, having failed to obey the protecting signal at Danger, he did not brake his train, which was running at about 40 m.p.h., until it was too late to stop short of the other train crossing his path, and his train was still running at some 10-15 m.p.h. when the collision occurred. The driver of the Up train was alert and with commendable presence of mind tried to accelerate his train clear of the junction when he saw the Down train closely approaching it, but he had insufficient time to do so and his train was running at only about 25 m.p.h. when the Down train struck its near side towards the trailing end of its third coach.

Fortunately the driver of the Down train was braking hard at the moment of impact and his engine came to a stand only 55 feet beyond the point of collision and so did not plough through the train crossing its path. The third and fourth coaches of this train were struck only glancing blows and were little damaged, but the coupling between the fourth and fifth coaches parted and the fifth coach, which was the guard's working brake, bore the brunt of the collision, its body being forced up off its derailed bogies, tilted over to an angle of 45°, and badly damaged, while the engine and first four coaches ran on for some 155 yards before coming to a stand. The sixth coach was derailed but was little damaged.

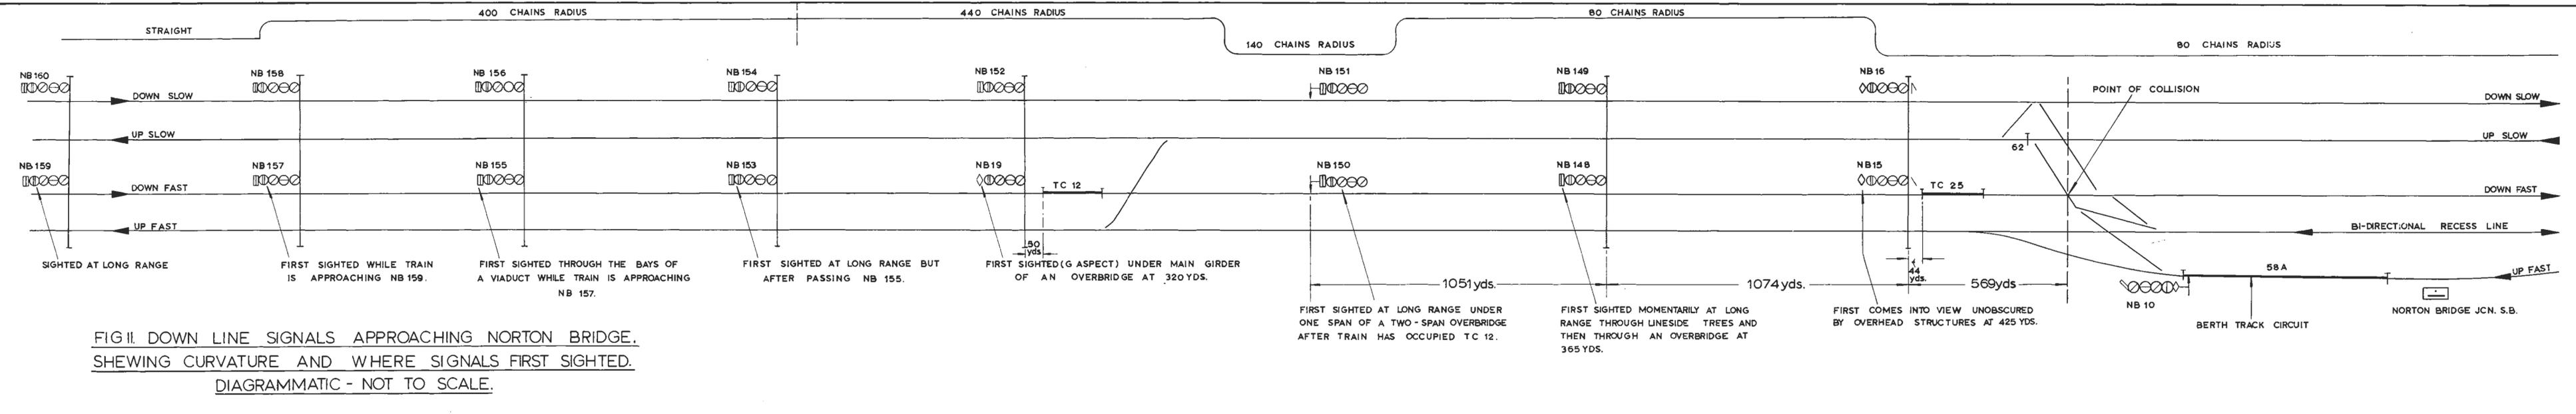
FIG. II. DOWN LINE SIGNALS APPROACHING NORTON BRIDGE.
SHEWING CURVATURE AND WHERE SIGNALS FIRST SIGHTED.
DIAGRAMMATIC - NOT TO SCALE.

the plan shows diagrammatically the signals approaching Norton Bridge in the Down direction from Stafford and the positions of certain track circuits referred to in the Report.

12. Figure II of the Plan shows the curvature of the line and the points at which the Down Fast line signals first come into a driver's view. Points to note are that it is not until after a train has passed signal NB 19 by 50 yards, and has occupied the first track circuit (TC 12) that approach locks signal NB 15 protecting the crossover, that a driver first sees the next signal, NB 150, which is the signal furthest in rear of NB 15 to be affected should that signal be put back to Danger from Green for any reason, such as for a change of route ahead: and that a driver first sees signal NB 15, unobscured by overhead structures, at a range of 425 yards.

13. From signal NB 15 the driver of a train on the Down Fast line cannot see the crossover, which comes into view from just beyond No. 17 overbridge at a range of about 375 yards.

51. The causes of this accident were that the Down train passed signal NB 15 at Danger and that the train's brakes were not thereafter applied until too late for it to be stopped short of the Up train crossing its path.
