RAILWAY ACCIDENT

Report on the collision that occurred on 31st December 1968 at Norwood Junction

IN THE
SOUTHERN REGION
BRITISH RAILWAYS

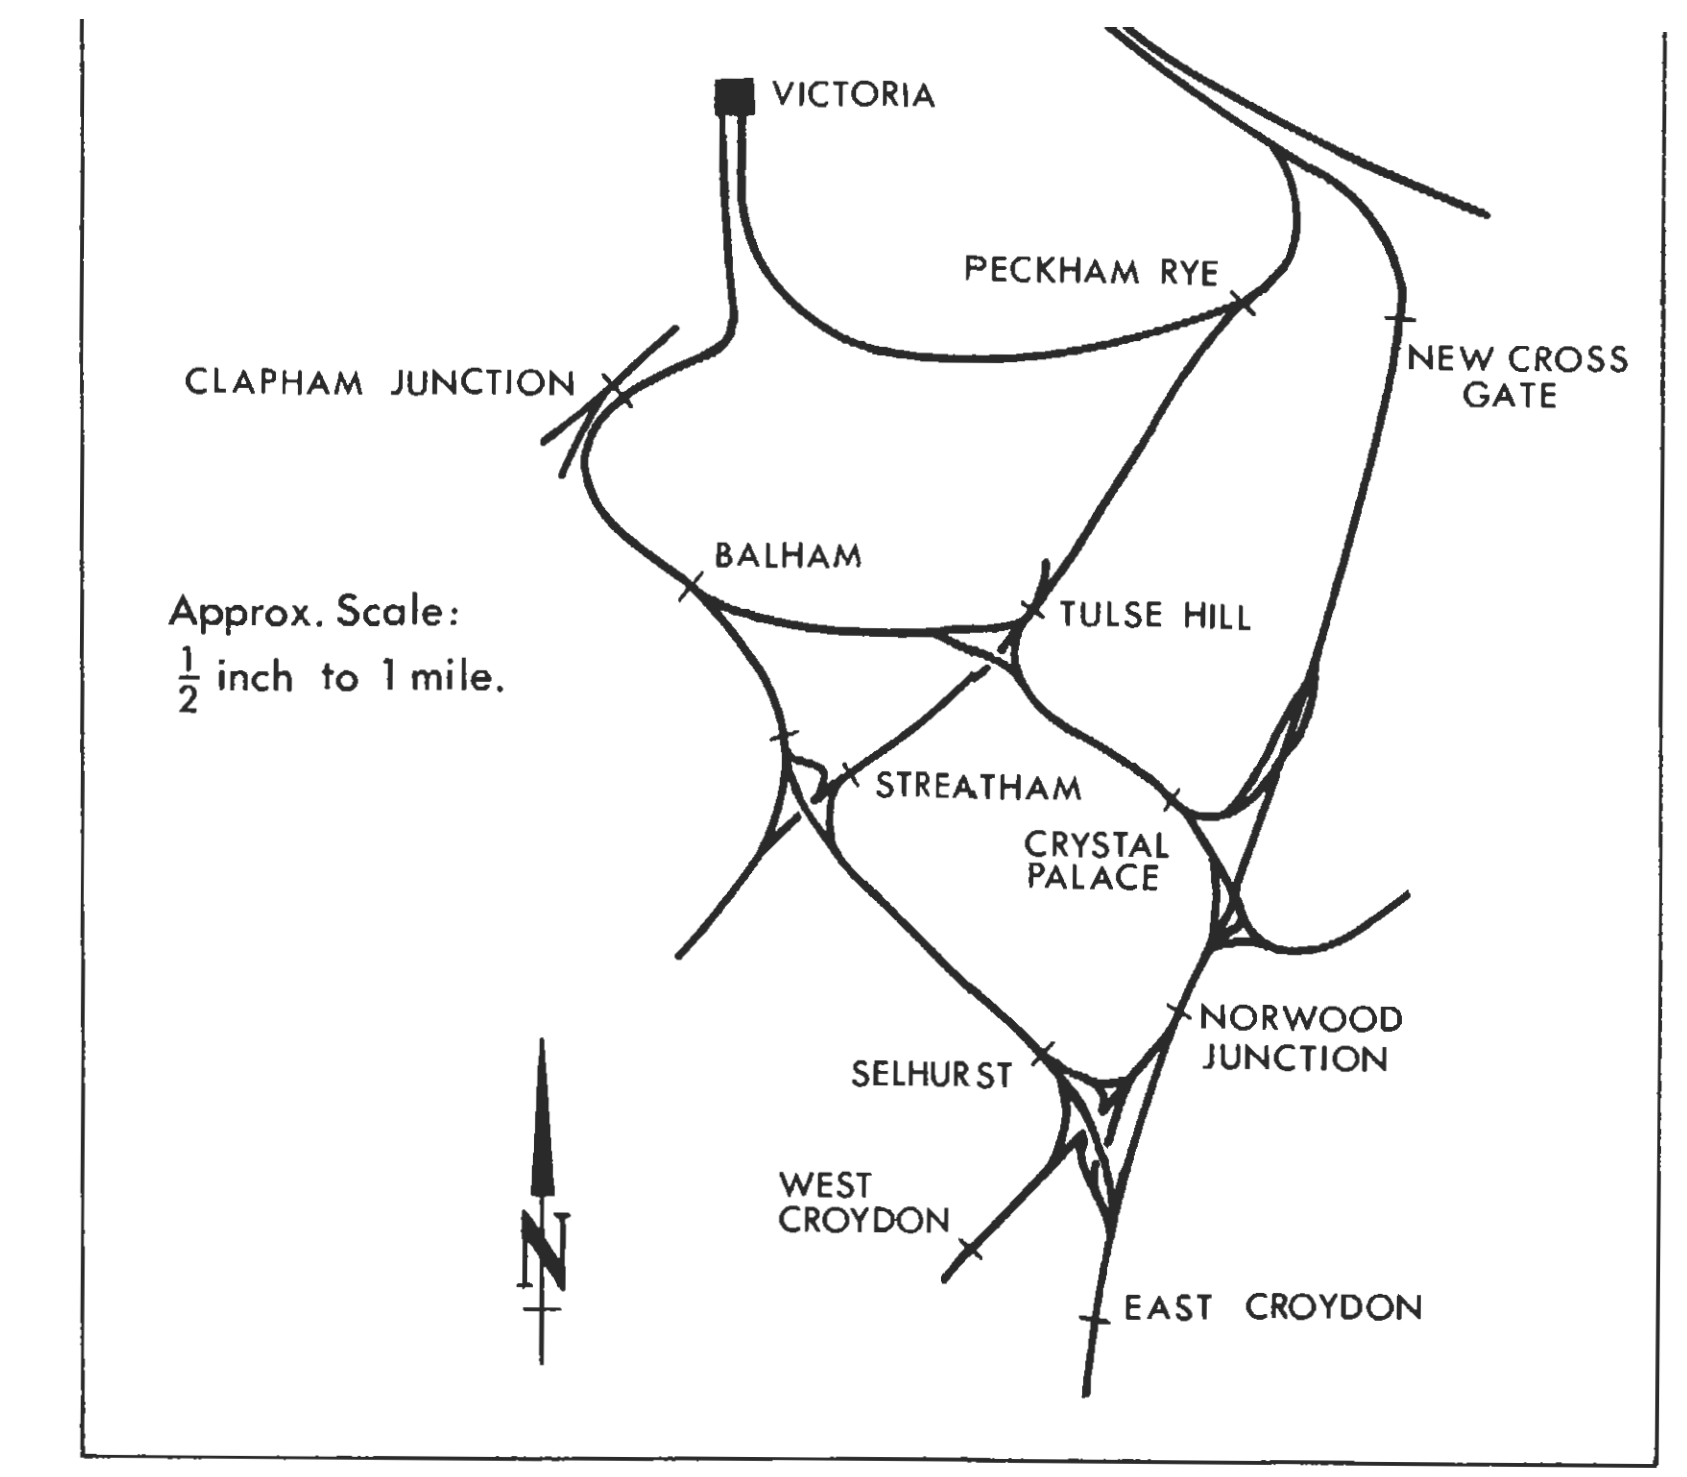
COLLISION AT NORWOOD JUNCTION

2. The attached diagram shows the three routes by which trains can approach Norwood Junction on the Up Local line, from East Croydon, from West Croydon and from Selhurst. These routes converge about 1,000 yards south of Norwood Junction within the control area of Gloucester Road Junction, in a series of non-conflicting junctions in which the Down Lines are carried over the Up lines on a flyover. The gradient from the junction towards the station is rising at 1 in 620, steepening to 1 in 185 into the platform.
