MINISTRY OF TRANSPORT

RAILWAY ACCIDENT

**Report on the Collision
that occurred on 4th January 1969
between Paddock Wood and Marden**

IN THE
SOUTHERN REGION
BRITISH RAILWAYS

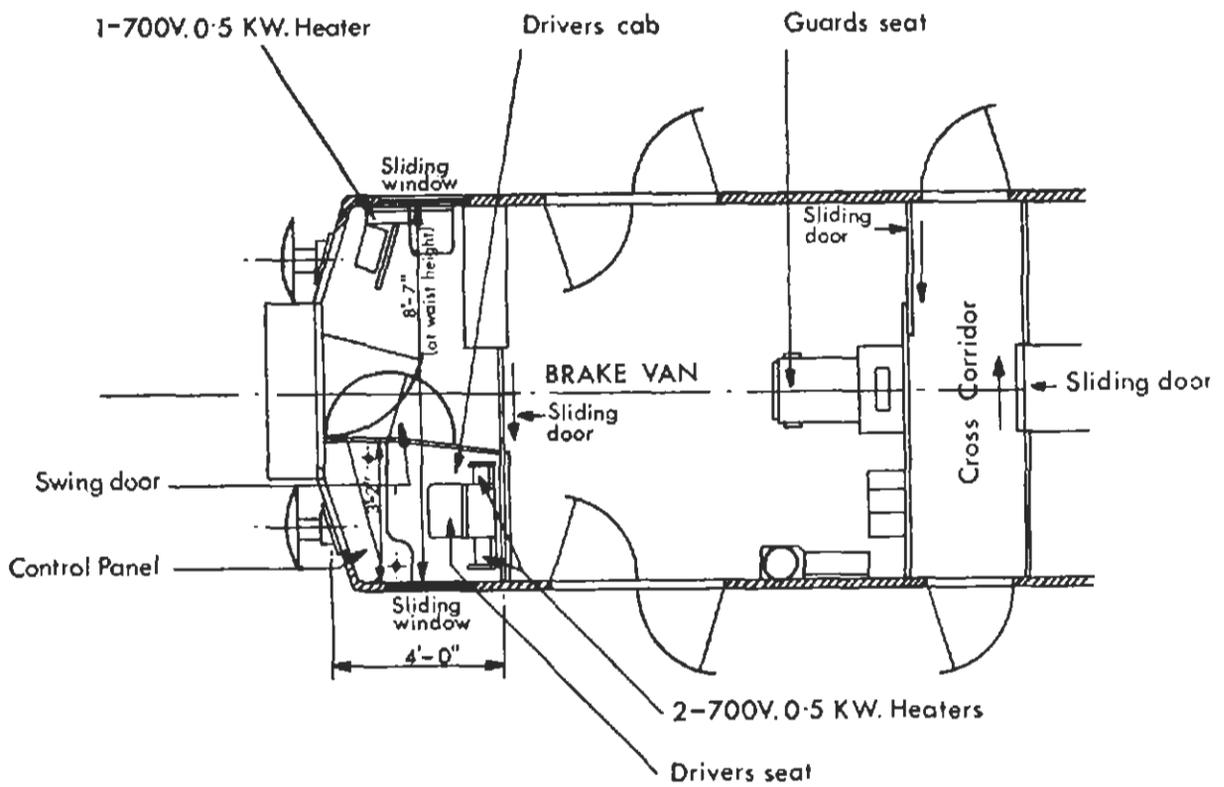
23. The leading motor coach (the leading coach in the train) was divided by vertical cross panels and partitions (bulkheads) into six differently sized compartments, the leading three of which are shown in the sketch opposite:

HEIGHT OF LEADING COMPARTMENT 7'-8"
AT HIGHEST POINT.

The brake van gave access ahead to the leading compartment through a sliding door (with a lifting catch) in its forward bulkhead, and thence through a swing door (usually kept locked open when the driver is in his cab) in the fore-and-aft partition that separated the driver's cab from the rest of the leading compartment. A sliding door in the offside end of the brake van's rear bulkhead gave access to the cross corridor which had ordinary outwards opening coach swing doors at each end for passenger entry, and a sliding door giving access to the leading passenger compartment. The brake van had double swing doors in each side for luggage loading.

30. When the leading coach of the express plunged to the left down the side of the embankment it must have rolled over and ploughed forward when already upside down, since its vertical cross panels and partitions had been folded back in the complete demolition of its bodywork. It finished up upside down at the bottom of the embankment and roughly parallel with the track, with its badly damaged underframe acting as a roof to the wreckage beneath it and with its bogies torn off: what had been its leading (motor) bogie was found alongside the third coach, and its offside cab corner was found on the bank beyond the Up line near the sixth coach of the train, and was almost the first item in the trail of wreckage. The fixed buckeye coupling between the first and second coaches parted and the second coach was free to take its own path and it finished up ahead of the first coach, lying on its near side and partly along the side of the embankment, with its near side torn out, extensive other damage to its body particularly at its leading end, and its underframe badly damaged. The third coach, which jack-knifed between the second and fourth coaches with its couplings holding, was badly damaged at its leading end only, one corner being torn out and the other pushed in with its corner pillar pushed out: both solebars were bent and one side of the underframe, and some of the underframe equipment, was damaged. Its near side leading end and the trailing end of the second coach finished up on the edge of the upturned underframe of the leading coach. That the damage to this coach, apart from its leading end, was relatively light compared with that to the two coaches ahead of it is best brought out by the fact that, in the Chief Mechanical and Electrical Engineer's Departmental Report on the damage to the train, it could be itemised in detail in a fairly short list, whereas the best that could be said of the leading coach was that it was "completely demolished" and of the second coach that it was very severely damaged. Damage to the other five coaches was slight, although, as was to be expected in view of the rapid deceleration involved, a number of seats were carried away or displaced.

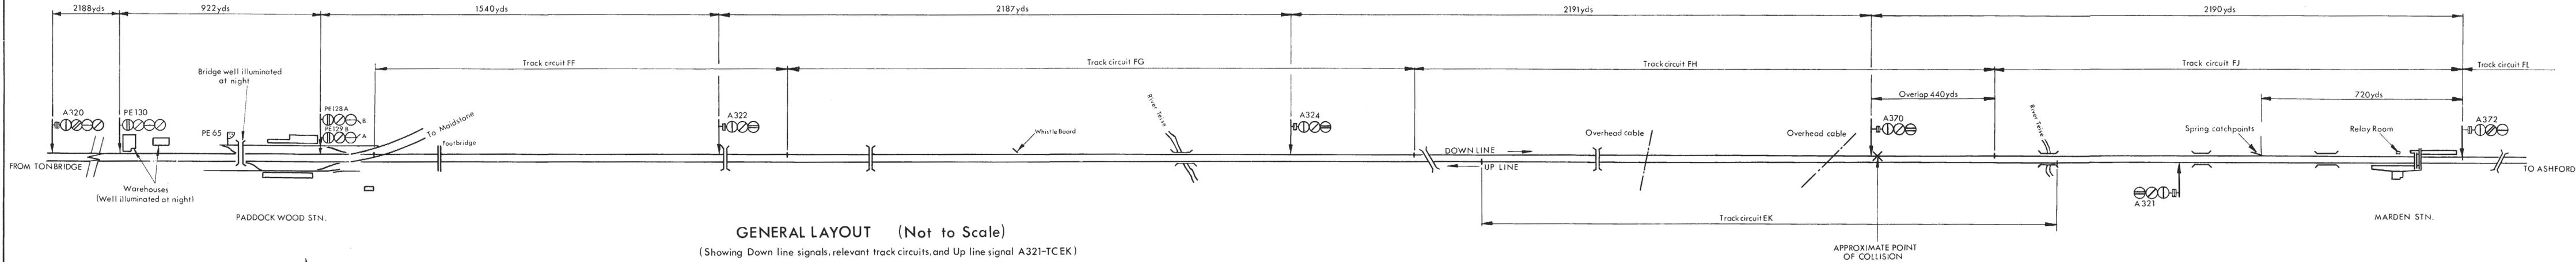
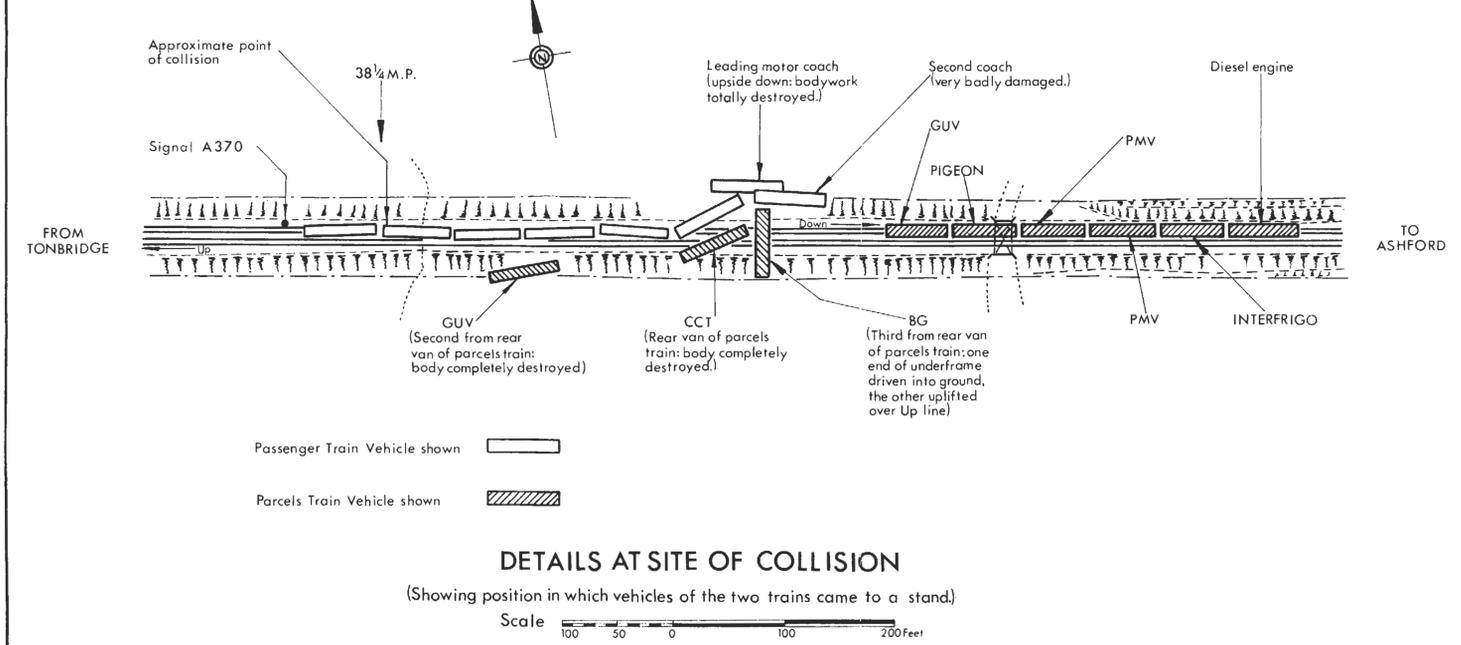
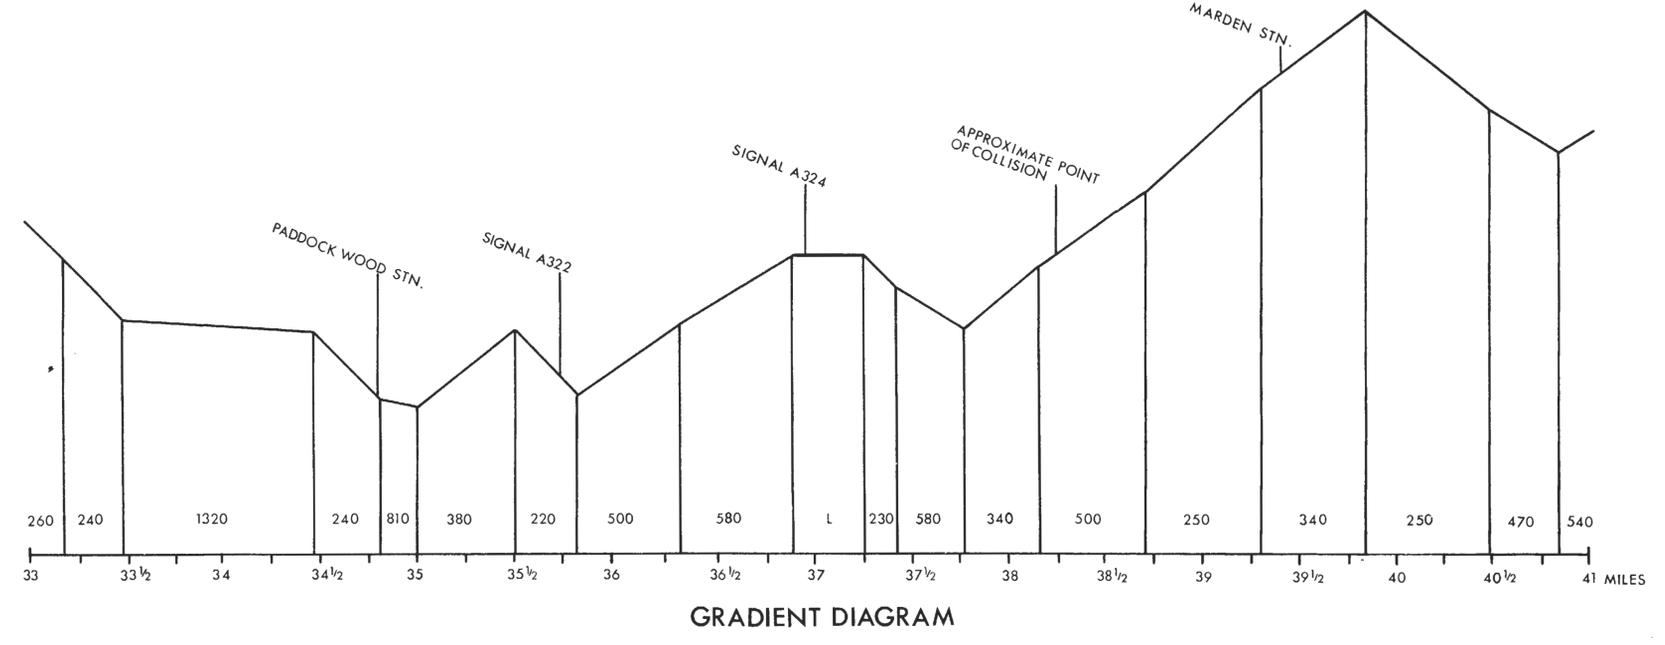
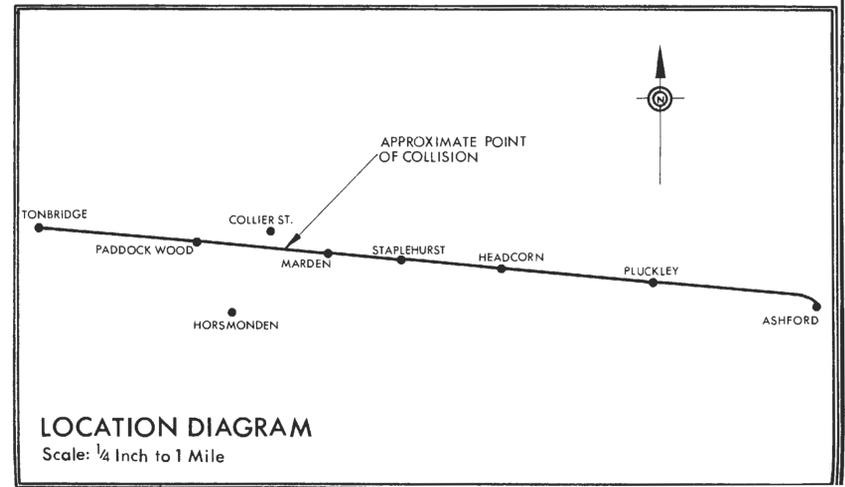
COLLISION NEAR MARDEN-4th. JANUARY 1969

1. Marden is a wayside station on the Southern Region Main line between London and the Kent Coast via Tonbridge and Ashford. The attached Plan shows the general layout of the line and signals, the gradients, the approximate point of impact, and the positions in which the vehicles of the two trains came to a stand.
