DEPARTMENT OF TRANSPORT

RAILWAY ACCIDENT

Report on the Derailment that occurred on 12th February 1976 at Shortlands Junction

IN THE
SOUTHERN REGION
BRITISH RAILWAYS

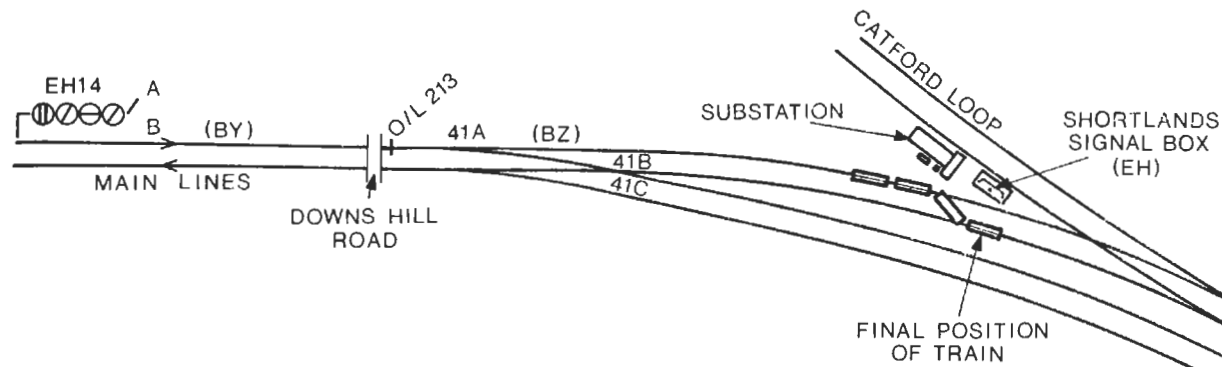
SIGNALLING DIAGRAM
Fig. 2

1. As shown in Figure 2, Shortlands Junction Signal Box lies between the Main lines and the Branch lines which are known as the Catford Loop and which connect some 500 yards north of Shortlands Station. At this point the Down and Up Main lines from Victoria have divided into the Down and Up Slow lines to the north and the Down and Up Fast lines to their south, and the Catford Loop lines have connections to both. There is a large unmanned sub-station outside the signal box on its west side. Shortlands Station consists of two island platforms serving the Slow and Fast lines respectively which pass over two parallel bridges immediately north of the station; the bridges have a headroom clearance of only 12 feet.

4. The layout of the junction is illustrated in Figure 2. Certain signals, including the Down Slow and Fast Platform signals EH 8 and EH 16, can be set to work automatically with crossover No. 47 set Normal so that the signalman does not have to reset those routes after a train has passed. Signal EH 14 will only clear to EH 16 on the Down Fast line if points No. 47 are set Normal or Reversed. The route is approach locked when Signal EH 14 is displaying a proceed aspect and track circuit CA is occupied until BZ or BY is occupied. Route 14A to signal EH 8 requires points No. 41 Reversed and route 14B requires them Normal. Once track circuit CA is occupied and signal EH 14 is showing a proceed aspect, the route, and hence points No. 41, are approach locked until either the train has passed or 2 minutes have elapsed. Once route EH 14B is set to signal EH 16 points No. 47 are locked Normal or Reverse whichever way they are set until track circuit BZ is occupied and BY is clear or 2 minutes have elapsed.

31. The derailment was caused because the train was driven past Signal EH 14 at Danger and the signalman then operated the points before track circuit BZ, the occupation of which would have locked them, was occupied.

43. At each site, had the occupation of a separate overlap track circuit beyond the signal protecting the junction locked the facing points on which the trains became derailed, the accidents would not have occurred. At Earlswood this can be achieved when the signalling is replaced in 1977. Signals CR 28 and 29 will then be replaced by a single colour-light signal positioned between the two existing signals and a separate overlap track circuit should then be provided.

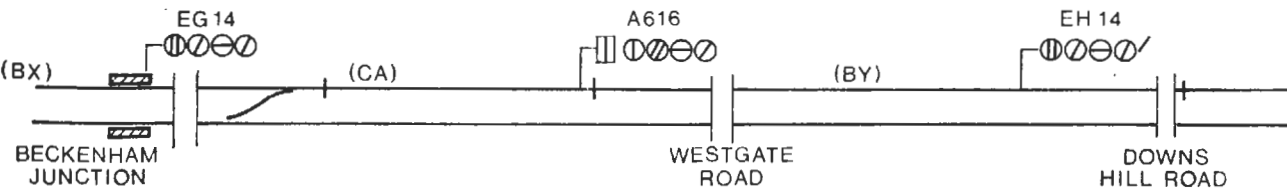
DETAIL DIAGRAM
Fig. 3

5. The berth track circuit BY is extended to give an overlap of 213 yards beyond signal EH 14, terminating 2 yards short of the tips of the blades of facing points No. 41, which are one yard on the Shortlands side of Downs Hill Road bridge. The signalman also controls detonator placers on all six lines outside his signal box.

8. The right-hand switch of No. 41 facing points was bruised and there was a mark of a wheel derailing towards the four-foot from the six-foot stock rail. The tip of the left-hand switch was also bruised, and the marks on it suggested that a tyre had passed on the stock rail side of it. The front of the train came to a stand on the Up Slow line 350 yards past the points. Only the second coach was derailed all wheels and marks on the sleepers showed that its leading bogie was dragged into derailment near the switch diamonds, while its trailing bogie became derailed on the Down Slow line nearer to No. 41 facing points than to the switch diamonds. The rear two cars followed on the Down Slow line and were not derailed. Only the second car of the train was damaged. Fifty feet of rail was buckled and also the diamond switches. 48 base plates and 40 conductor rail insulators were broken and 6 switch and crossing timbers required replacing.

30. The points must have moved between the bogies of the second coach, ie while the train travelled a little over 38 feet, for the marks on the switch blades indicate that they were moving when the innermost wheel sets passed over them. As it takes 2 seconds for the points to move, the train was probably travelling at about 25 to 20 mile/h as Driver Maunsell said it was. The relays had to operate and the facing point lock unbolt prior to this which took about $2\frac{1}{2}$ seconds; the front of the train was therefore at least 13 yards short of the tip of the facing points when Signalman Rubie set the route and at this point the train would hardly be visible under the bridge.

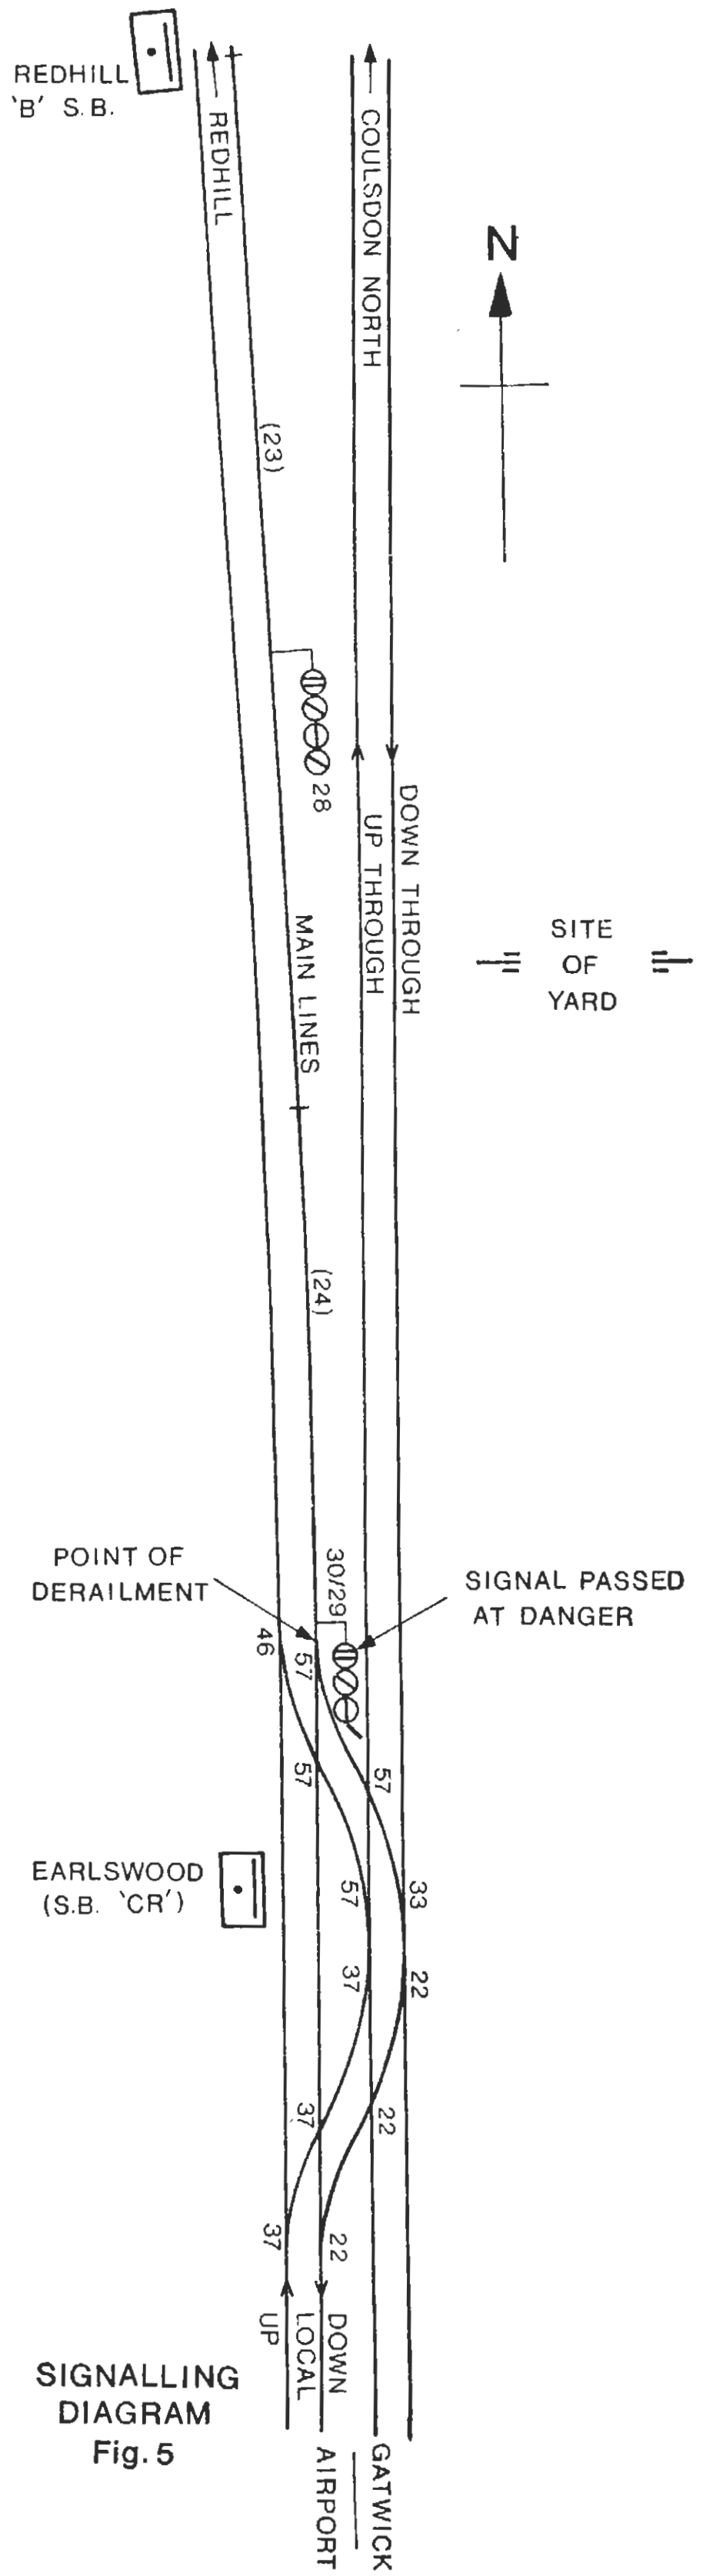
SIGNALLING DIAGRAM
Fig. 5

35. A sketch of the junction is shown in Figure 5 at the end of this report. Absolute Block applies between Earlswood and Redhill 'B' Signal Boxes 831 yards in rear using Sykes 'Lock and Block' instruments. Although a 70 mile/h speed restriction applies over the line, there are 30 mile/h restrictions through the connections from the Down Redhill platform line and through the Down Main to Down Fast line connection over which the train was signalled. The yards of the former Redhill engine sheds stand on the Down side of the 'Through' lines between the two signal boxes.

37. The signalman had previously set the route for the 18.02 Victoria to Gatwick Airport train from the Down Through to the Down Local line via points No. 22 reversed and was in the act of setting the route for the Brighton train from the Down Main to the Down Through line via points No. 57 reversed and No. 22 Normal when the front of the train passed over No. 57 facing points as they were moving, and travelled a further 50 yards with its leading bogie derailed before coming to a stand. The train suffered little damage.

38. A single track circuit 24T forms the berth and 49-foot overlap track circuit of signal CR 29. This signal stands only 54 feet from the tips of No. 57 points which are track locked by track circuit 25T commencing only 5 ft 5 in before the tips of the switch blades. As at Shortlands it takes about 4 seconds for points No. 57 to complete their movement after the operation of the controlling lever. The preceding signal No. CR 28 is approach controlled by the occupation of track circuit 23T when points No. 22 are reversed.
